# Extratropical cyclone damage to the seawall in Dawlish, UK: eyewitness accounts, sea level analysis and numerical modelling

The February 2014 extratropical cyclonic storm chain, which impacted the English Channel (UK) and Dawlish in particular, caused significant damage to the main railway connecting the south-west region to the rest of the UK. The incident caused the line to be closed for two months, £50 million of damage and an estimated £1.2bn of economic loss. In this study, we collate eyewitness accounts, analyse sea level data and conduct numerical modelling in order to decipher the destructive forces of the storm. Our analysis reveals that the disaster management of the event was successful and efficient with immediate actions taken to save lives and property before and during the storm. Wave buoy analysis showed that a complex triple peak sea state with periods at 4–8, 8–12 and 20–25 s was present, while tide gauge records indicated that significant surge of up to 0.8 m and wave components of up to 1.5 m amplitude combined as likely contributing factors in the event. Significant impulsive wave force of up to 286 kN was the most likely initiating cause of the damage. Refl

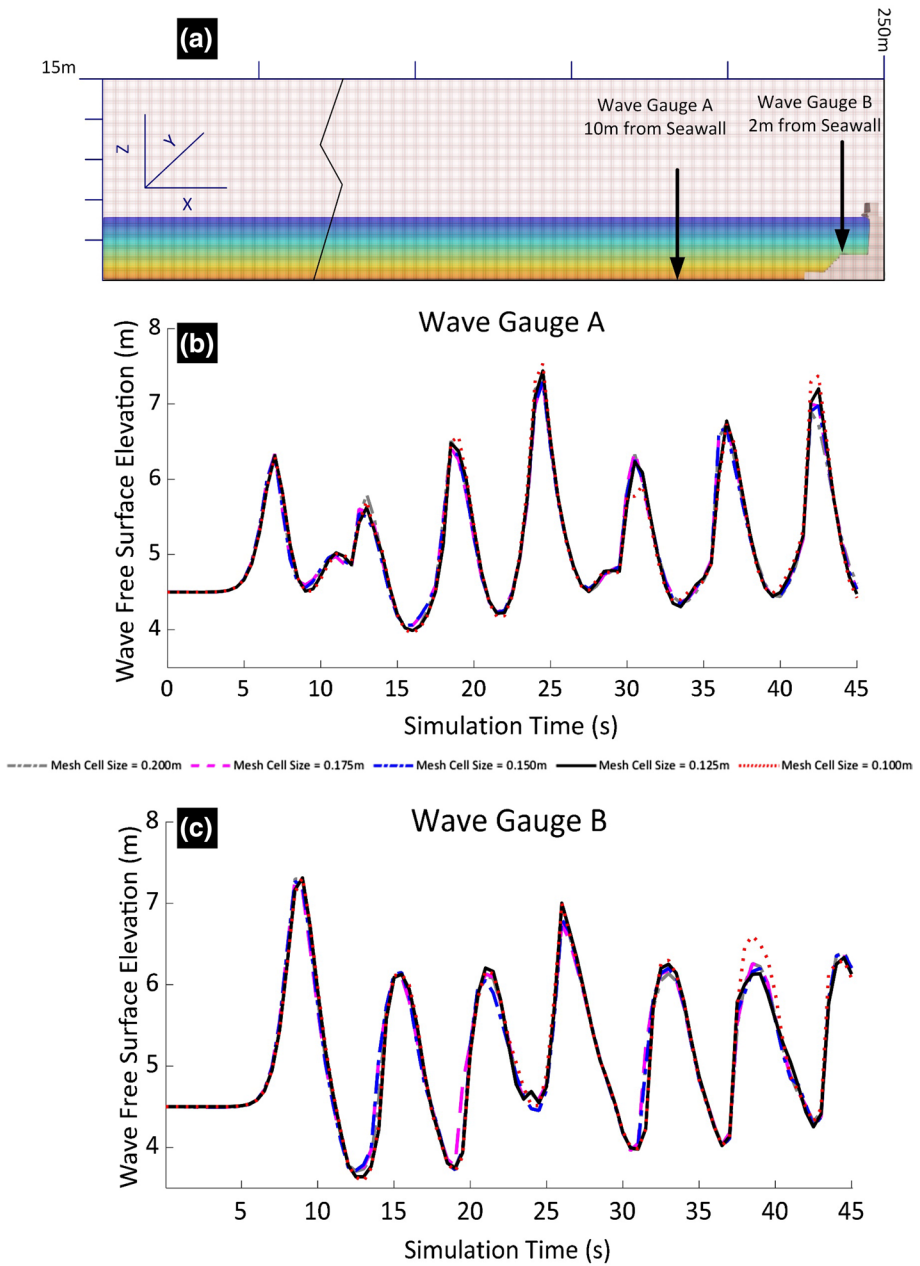
**Fig. 3** a The model seawall computational domain showing the location of two gauges A and B, where wave time series are recorded (not to scale). b and c Time series of wave oscillations at the gauges A and B considering different mesh cell sizes

Using Flow3D-Hydro, a model of the Dawlish seawall was made with a computational domain which is 250.0 m in length, 15.0 m in height and 0.375 m in width (Fig. 3a). The computational domain was discretised using a single uniform grid with a mesh size of 0.125 m. The model has a wave boundary at the left side of the domain (x-min), an outflow boundary on the right side (x-max), a symmetry boundary at the bottom (z-min) and a wall boundary at the top (z-max). A wall boundary implies that water or waves are unable to pass through the boundary, whereas a symmetry boundary means that the two edges of the boundary are identical and therefore there is no flow through it. The water is considered incompressible in our model. For volume of fluid advection for the wave boundary (i.e. the left-side boundary) in our simulations, we utilised the "Split Lagrangian Method", which guarantees the best accuracy (Flow Science, 2022).

In order to achieve the most efficient mesh resolution, we varied cell size for five values of  $\Delta x = 0.1$  m, 0.125 m, 0.15 m, 0.175 m and 0.20 m. Simulations were performed for all mesh sizes, and the results were compared in terms of convergence, stability and speed of simulation (Fig. 3). A linear wave with an amplitude of 1.5 m and a period of 6 s was used for these optimisation simulations. We considered wave time histories at two gauges A and B and recorded the waves from simulations using different mesh sizes (Fig. 3). Although the results are close (Fig. 3), some limited deviations are observed for larger mesh sizes of 0.20 m and 0.175 m. We therefore selected mesh size of 0.125 m as the optimum, giving an extra safety margin as a conservative solution.

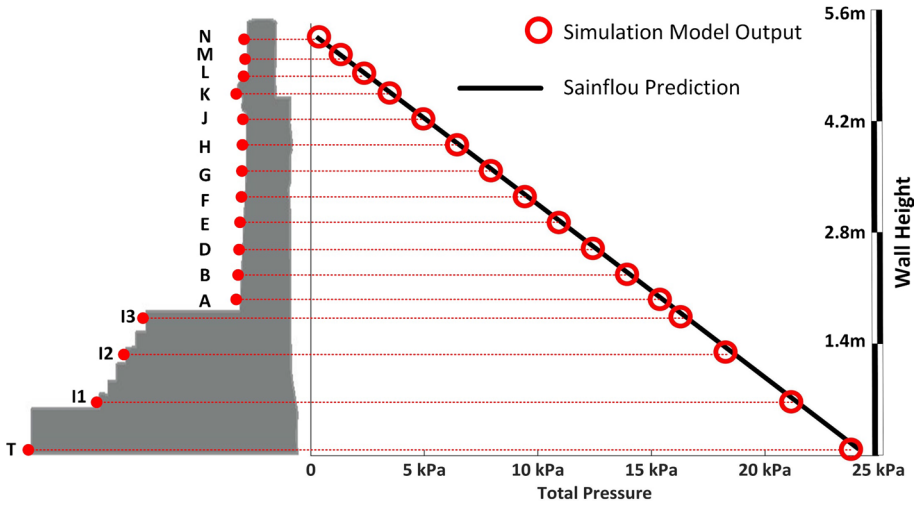
**Fig. 4** Validation of the computer model seawall showing the probe locations (with identifiers) where pressures are recorded and comparison of the simulated pressures for a linear wave (red circles) with those calculated using the theoretical equations of Sainflou (1928) (black line)

The pressure from the incident waves on the vertical wall is validated in our model by comparing them with the analytical equation of Sainflou (1928), Eq. (3), which is one of the most common set of equations for design of coastal structures (Fig. 4). The model was tested by running a linear wave of period 6 s and wave amplitude of 1.5 m against the wall, with a still water level of 4.5 m. It can be seen that the model results are very close to those from analytical equations of Sainflou (1928), indicating that our numerical model is accurately modelling the wave-structure interaction (Fig. 4).

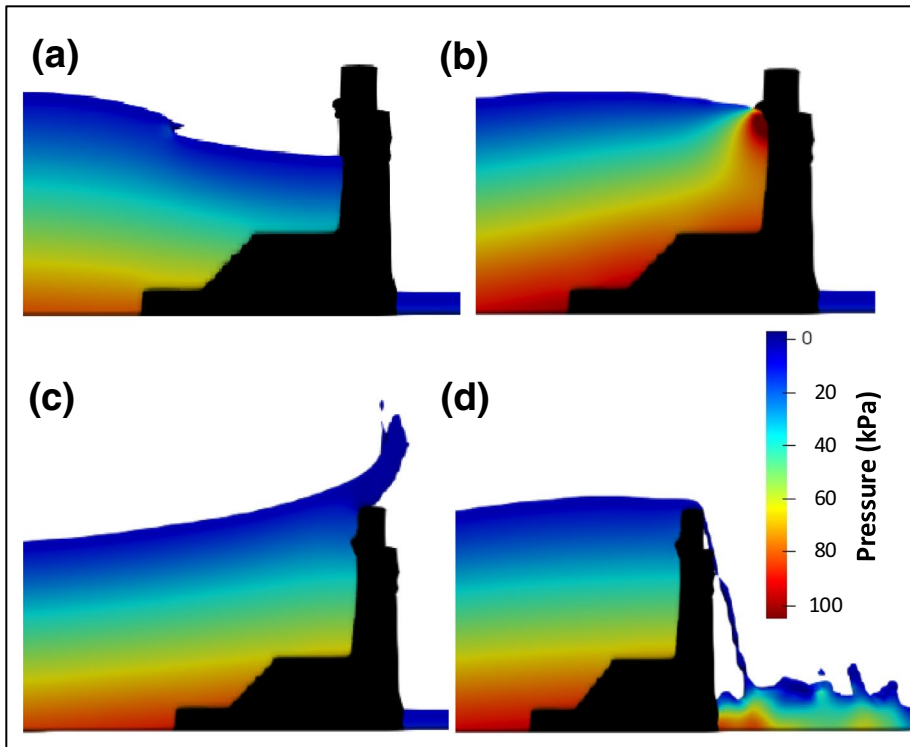
**Fig. 8** Wave pressure iso-surface due to Scn-15 (see Table 2 for details of this scenario). **a** Breaking wave at  $t=61$  s. **b** Maximum breaking pressure at parapet wall  $t=61\frac{1}{2}$  s. **c** Wave overtopping wall crown at  $t=62$  s. **d** Downward overtopping pressure on rail bed  $t=63\frac{1}{2}$  s

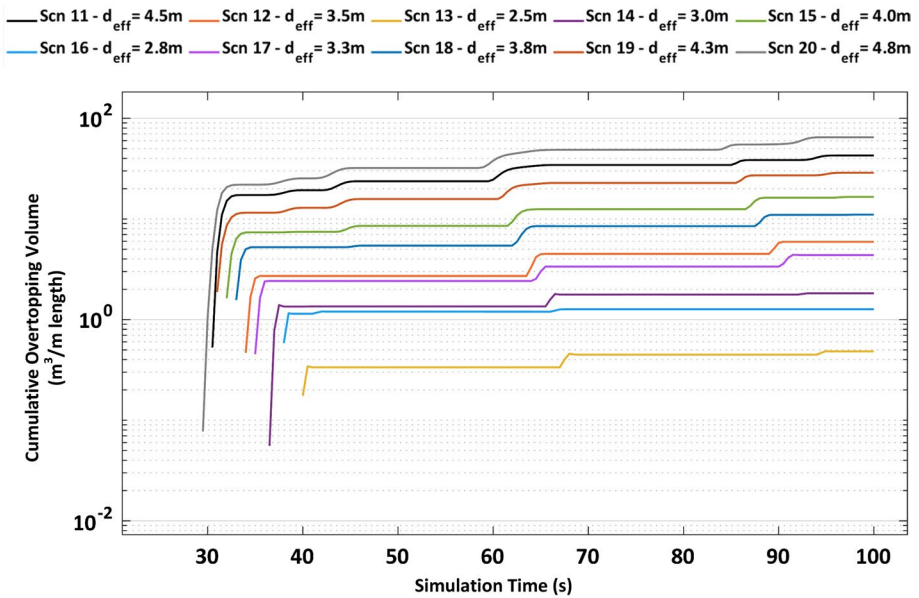
Fig. 15 Cumulative wave overtopping volumes per metre length of wall from scenarios 11–20 with wave amplitude of 1.5 m

as it determines the level of soil saturation, water pore pressure in the soil and soil erosion (Van der Meer et al. 2018). The maximum volume belongs to Scn-20, which is  $65.0 \text{ m}^3/\text{m}$

(m-cubed of water per metre length of the wall). The overtopping volumes are 42.7 m<sup>3</sup>/m for Scn-11 and 28.8 m<sup>3</sup>/m for Scn-19. The overtopping volume is in the range of 0.7–65.0 m<sup>3</sup>/m for all scenarios.
