Physical Fabric Survey of Hinemihī June 9-11 2003.

An important phase in this process has been to carry out a physical fabric survey, which was conducted by students from the Institute of Archaeology from 9th to 11th of June 2003. This was conducted to identify evidence of the various manifestations of Hinemihī from the different stages of her life history and to provide a context for the chronology of events and the production of a more effective biography. This understanding will provide a framework for future conservation options to be considered.

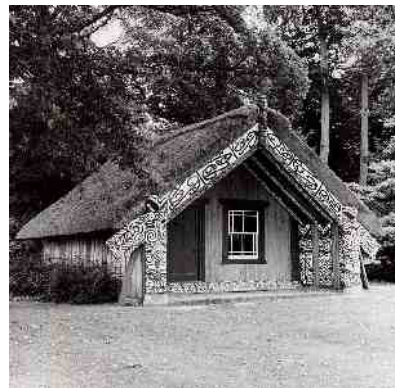
1980s Hinemihi

- **1980s Hinemihi**
following restoration by Draper & Sons (advised by M. E. Campin and John Perry) in which repainting of the carvings took place, and most significantly, a new front wall was added.

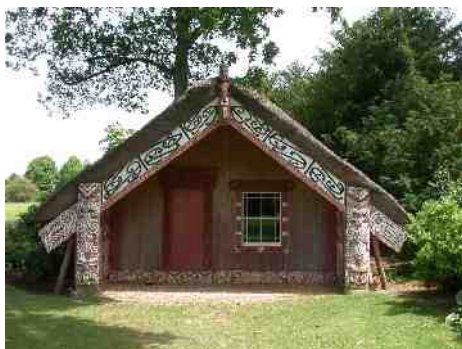
1995 Hinemihi

- **1995 Hinemihi**
following involvement of Ngati Hinemihi and the addition of new carvings created by Robert Rika and Colin Tihi

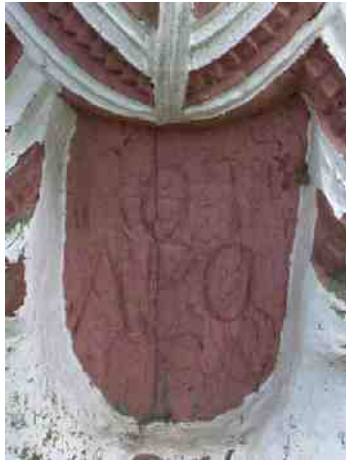
“Rotopopa”? North Amo

The base of the Amo shows a major central crack through the right eye and less significant adjacent cracking. The main cracks are evident on images from the 1880's (25) and have been a present on images of the carvings ever since. Of more concern is a loose fragment at the top of the main central crack on the base, which is in an area of paint loss down to the wood, and an area where the carving is vulnerable to further loss.

The sequence of paint layers appears to be: a thick pink/white surface overlying a darker reddish pink layer, with evidence of blue within this layered surface. In general, the white paint tends to flake badly, and the light pink paint is cracking and flaking revealing a darker pink layer beneath, which in places is also lost leaving the wood underneath exposed. The north side of the Amo is in poorer condition than the south side.

Algal and lichen growth is heavier on the recessed areas. This tends to prevail where the painted surface has been lost and the bare wood is exposed.

Carving of “KOTAPO..R” OR “ROT APO RA” could refer to “Rotopopa”.

Most of the structural cracking evident on the painted carvings appears to be old damage. This can be monitored annually to identify changes in the levels of damage. One carving - the south Amo - has an area of unstable wood that is loose and liable for further damage. This may need interventive treatment in the near future.

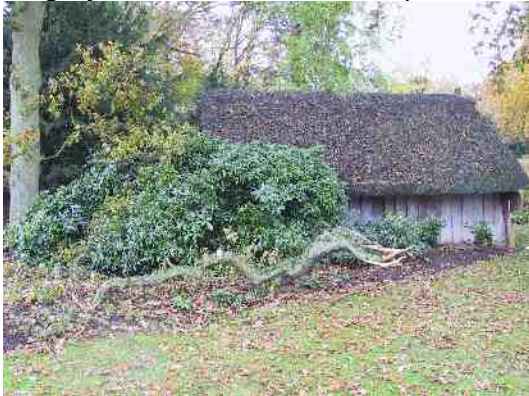
The surrounding large oaks present a more serious potential risk. During November 2002, two large branches fell close to Hinemihi presenting the risk of severe damage to the structure. These trees are regularly inspected for disease and risk of falling limbs, and tree surgery will be carried out if required.

Large fallen branch November 2002.

The condition of overhanging branches of the oak trees will need to be assessed and mitigation measures undertaken when required.

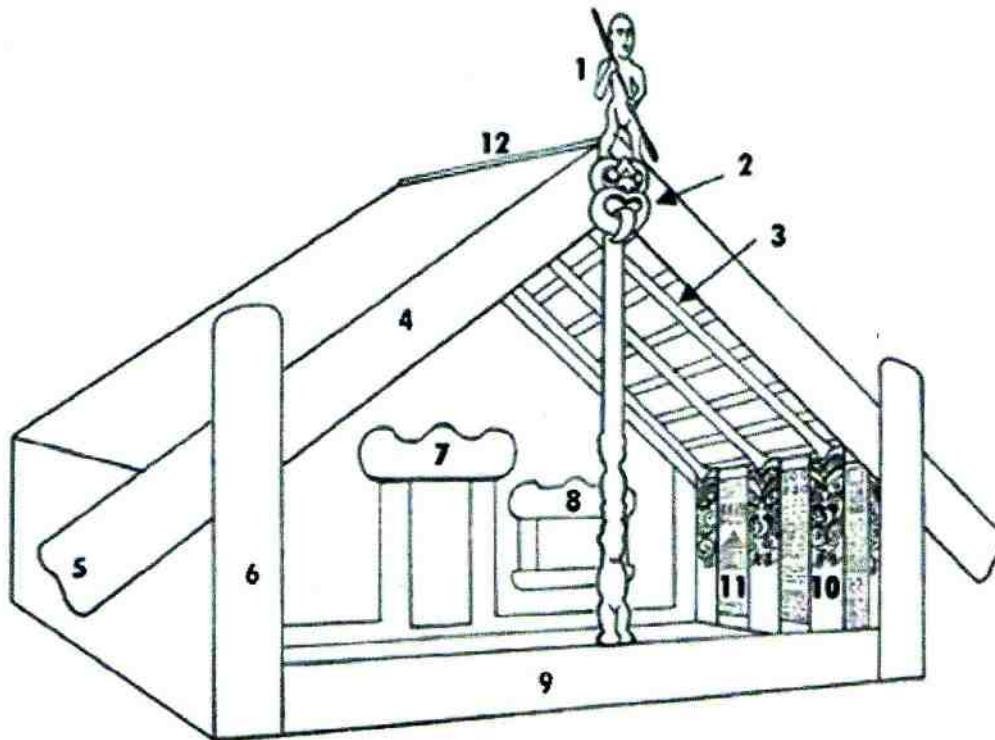
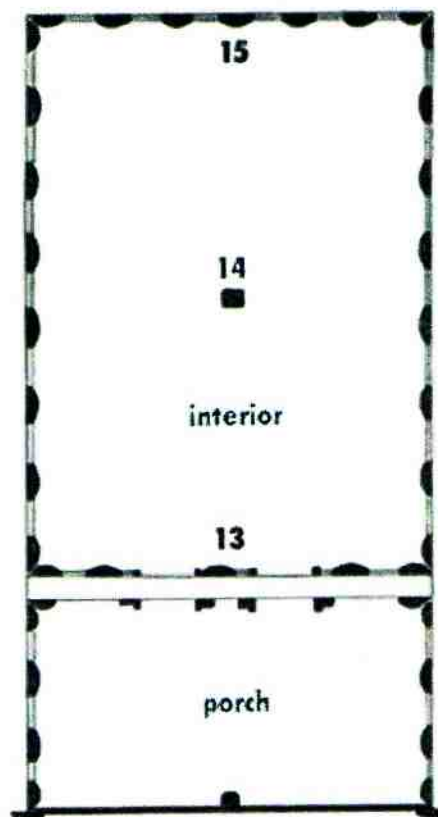
Architectural Elements of a Wharenihi (after Lubke 2003, Tischner 1971:37)

- 1. Tekoteko
- 2. Koruru
- 3. Heke
- 4. Maihi
- 5. Raparapa
- 6. Amo
- 7. Pare
- 8. Korupe
- 9. Paepae
- 10. Poupou
- 11. Tukutuku
- 12. Tahuhu
- 13. Poutahu
- 14. Poutokomanawa
- 15. Poutuarongo
