Feasibility Analysis for Repair of Large Diameter Hydro Turbine Shaft Based on Weldability Test and Welding Cycle Simulation

Dejan Momčilović^{1,a*}, Zoran Odanović^{1,b}

¹Institute for testing of materials IMS, Belgrade, Serbia

Keywords: fatigue, failure, turbine shaft, weldability, weld cycle simulation, repair, feasibility study

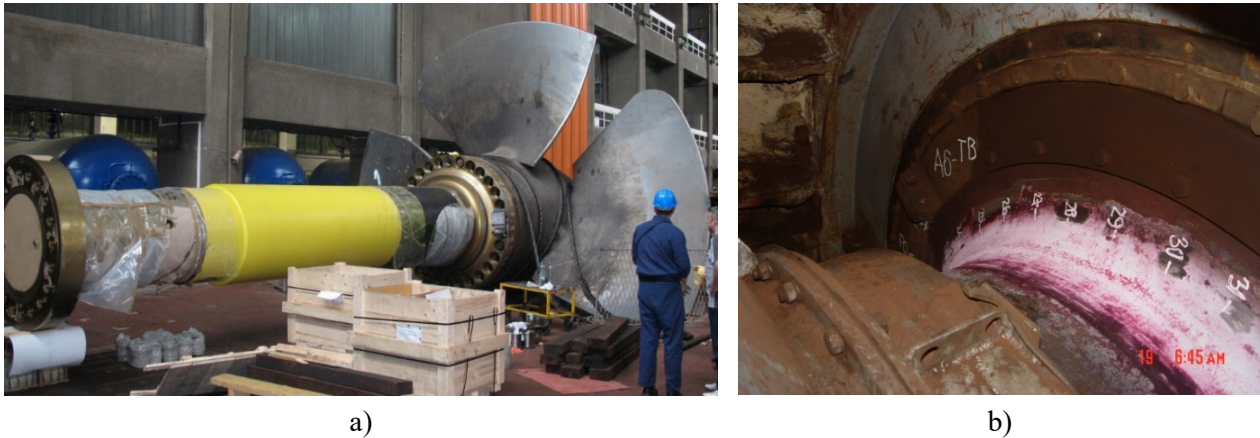
Fig. 1. Disassembled turbine shaft with runner, a) Transition (fillet) zone with cracks b)

Detailed failure analysis of hydro turbine shaft is presented in paper [3]. Briefly, this paper describes the failure analysis of turbine generator shaft Kaplan's 28 MW bulb turbine. The bulb turbine horizontal shaft is shown on Fig. 1a, and zone with cracks on Fig 2b. The turbine shaft is made by joining the forged and cast parts by slag welding, Fig 2. The shaft is manufactured as hollow, housing a servomotor inside it, for shifting the runner blades. The flange, on which transition radius the crack occurred, is made of steel casting of 20GSL (20Mn5) designation, according to GOST 97-88 [4].

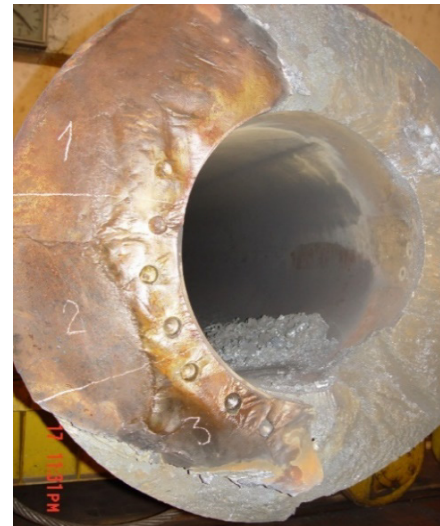
Fig. 4. Zone of through wall crack on the hollow shaft; zones 1, 2 and 3 represents crack growth front of the through thickness crack, and the rest of the surface was flame cut surface

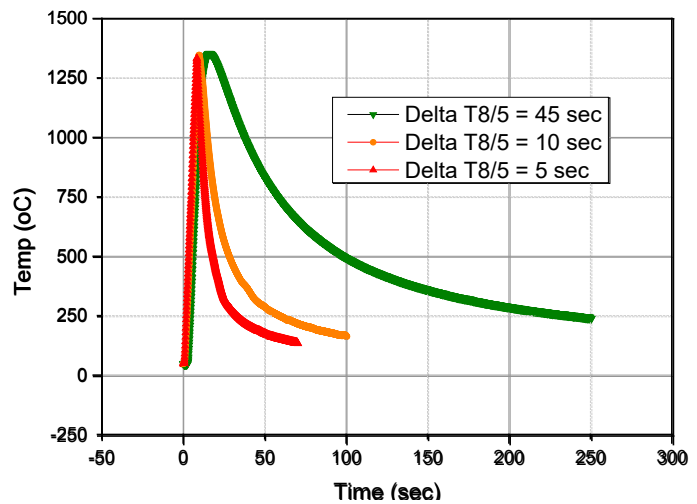
Fig. 8. Shape of simulated one-pass curves
