Extreme precipitation induced landslide event on 30 July 2019 in Jølster, western Norway

R  ther, D. C., Hefre, H. & Rubensdotter, L. 2022: Extreme precipitation induced landslide event on 30 July 2019 in J  lster, western Norway. *Norwegian Journal of Geology* 102, 202212.
<https://dx.doi.org/10.17850/njg102-3-4>

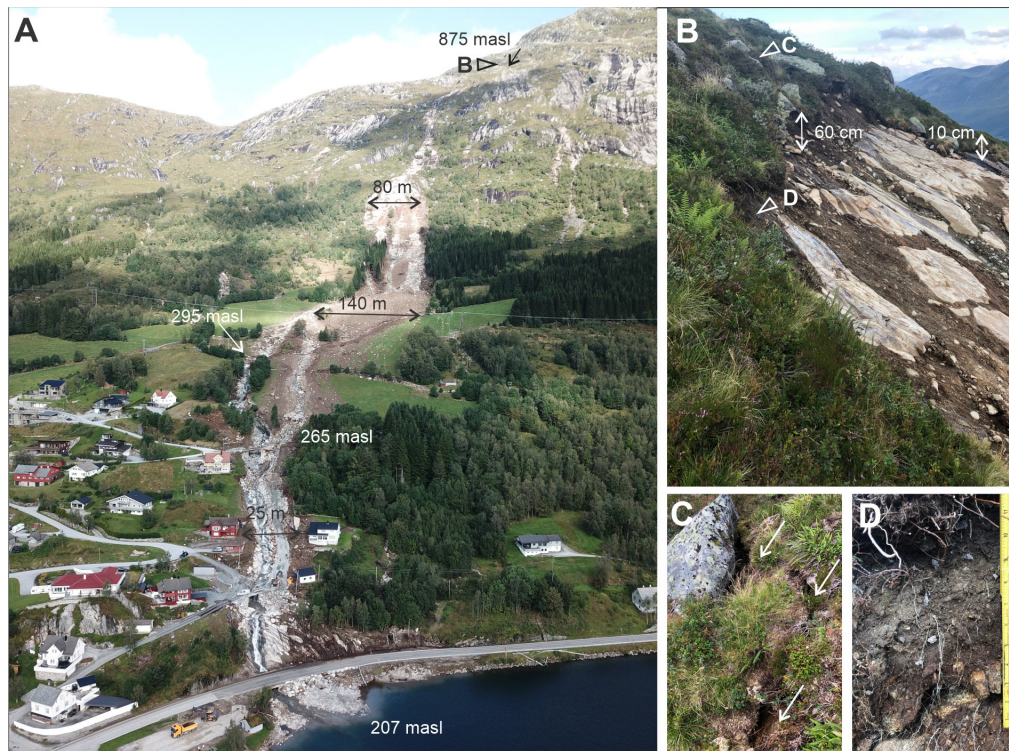
Figure 4. Vassenden or  rsetelva debris flow (referred to as Tindefjellet 8 in this study) (A): Birds-eye view illustrates the widening to 80 metres width over two cliff sections from 600 to 350 masl and further to a maximum width of 140 metres between 350 and 275 masl before getting channelized for the last 50 metres of drop height. (B): Source area of Tindefjellet 8, with scarp sediment depth and indication of where photos in C and D are taken. (C): Fissure one meter above and parallel to the backscarp. White arrows indicate potential water infiltration. (D): Soil profile in the backscarp with a 10 cm thick leached layer (E horizon).

This location is dominated by a large debris flow which destroyed infrastructure, endangered several houses and blocked the main E39 road along its path down to the lake J  lstravatnet at 207 masl (Figs. 2A, 3B & 4; *Tindefjellet 8* in Table 1). In the source area at 875 masl (Fig. 4A), the sediment depth at the backscarp varies from 10 to 60 cm of organic turf and podsol (Fig. 4B, D). The sliding plane is partly developed on bedrock, whilst pockets of weathered and unweathered till withstood erosion (Fig. 4B). One metre above, and parallel to the backscarp, an open fissure in the vegetation cover was observed after the event (Fig. 4C). One boulder could be identified 10 metres below the backscarp on pre-event aerial photos and was moved 15 metres downhill by the event, where it was deposited on top of smaller-sized rocks and boulders in the central part of the flow path.

At 295 masl the debris flow conflues with a debris flood in the river   rsetelva. This debris flood was highly erosive, in particular just before the confluence point where it eroded 2 metres deep into sedimentary deposits. Erosive forces intensified as the debris flood and flow joined, and from 265 masl the two landslide paths into a 3–4 metres-deep and maximum 25 metres-wide channel along   rsetelva, with levees locally 1–2 metres in height.

Seven smaller debris flows, debris slides and slumps occurred at Southern Tindefjellet (Figs. 3B & 4; Table 1). Our observations at this location and in Svidalen suggest the failure mechanism to be slumping where the failing material consisted of thin grass-bound topsoil (0.05–0.1 cm), whereas sliding was more common where soil profiles were in the order of 0.5–1 metre thick. The source areas are all situated above the forest line where vegetation is dominated by grass, heath and berry bushes with sporadic birch trees. Three weeks after the event, abundant signs of surface runoff and erosion could be seen at this location, also outside the landslides themselves. This included flattened grass, terrestrial and plant debris deposited by surface overland flow, as well as small-scale failures and slumps of grass-bound topsoil. None of the shallow landslide scars adjoin permanent streams and they accumulate runoff from moderately sized upstream areas (ranging from 2 500 to 13 000 m²; Table 1).

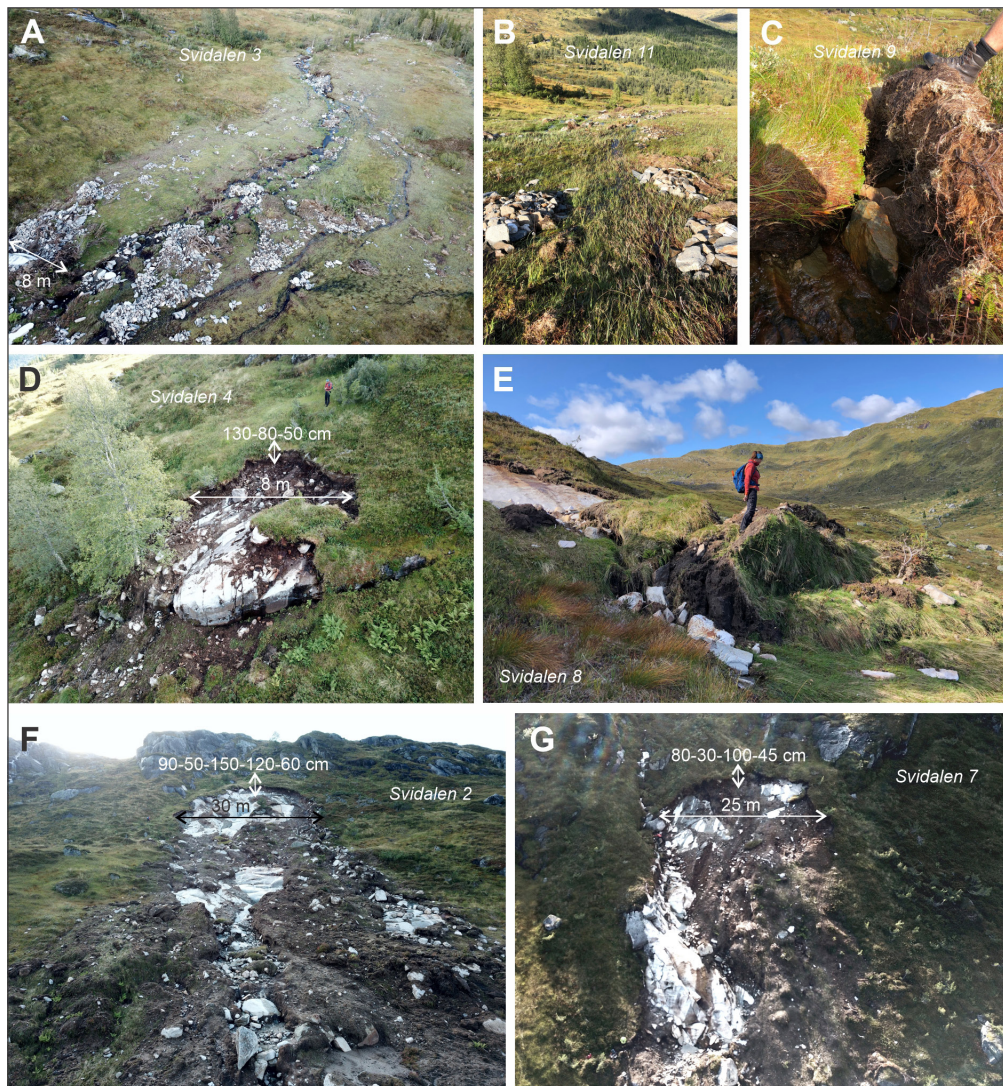
Figure 6. Debris floods, slides, avalanches and slumps in Svidalen (A, B): Debris floods; examples of deposition of material in mounds on alpine meadows. (C): Example of undercutting of regolith and overturning of grass-bound topsoil. (D) Debris slide which partly slid down a ledge, partly remained on top of the ledge. (E): Slumped grass-bound topsoil. (F, G): Two small debris avalanches with highly variable scarp sediment depth and character, partly eroded down to the bedrock.

A debris flood affected the river Svidalselva, damaged public infrastructure, private property and blocked the main E39 road at the river mouth at Svidalsneset. Whilst not destroying or endangering any infrastructure, a total of 12 small debris slides, avalanches, slumps and debris floods occurred in the valley of Svidalen, on the eastern slope of Tindefjellet (Figs. 2A, 3D & 6). The debris floods occurred in small tributaries to the stream Svidalselva. They involve erosion of weathered bedrock, in particular over steeper passages between 600 and 550 masl (>35 degrees), as well as undercutting of regolith and subsequent overturning (Fig. 6C) or slumping (Fig. 6E) of the grass-bound topsoil in gentler terrain between 550 and 500 masl (<30 degrees). Deposits built up in mounds on alpine meadows as slope angles drop to below 20 degrees (Fig. 6A, B). The debris avalanches and debris slides are all situated beneath minor cliffs or exposed bedrock, have moderate flow accumulation values and highly variable scarp sediment depths (Table 3). Just as for the large debris flow at *Vassenden 8*, an open fissure in the vegetation and upper soil could be observed one metre above and parallel to the backscarp debris slide *Svidalen 4* (Fig. 6D). The source areas of debris avalanches *Svidalen 2* and *7* (Fig. 6F, G) are in part eroded down to the bedrock, whilst in part the sliding plane is developed in grey or brown diamict.

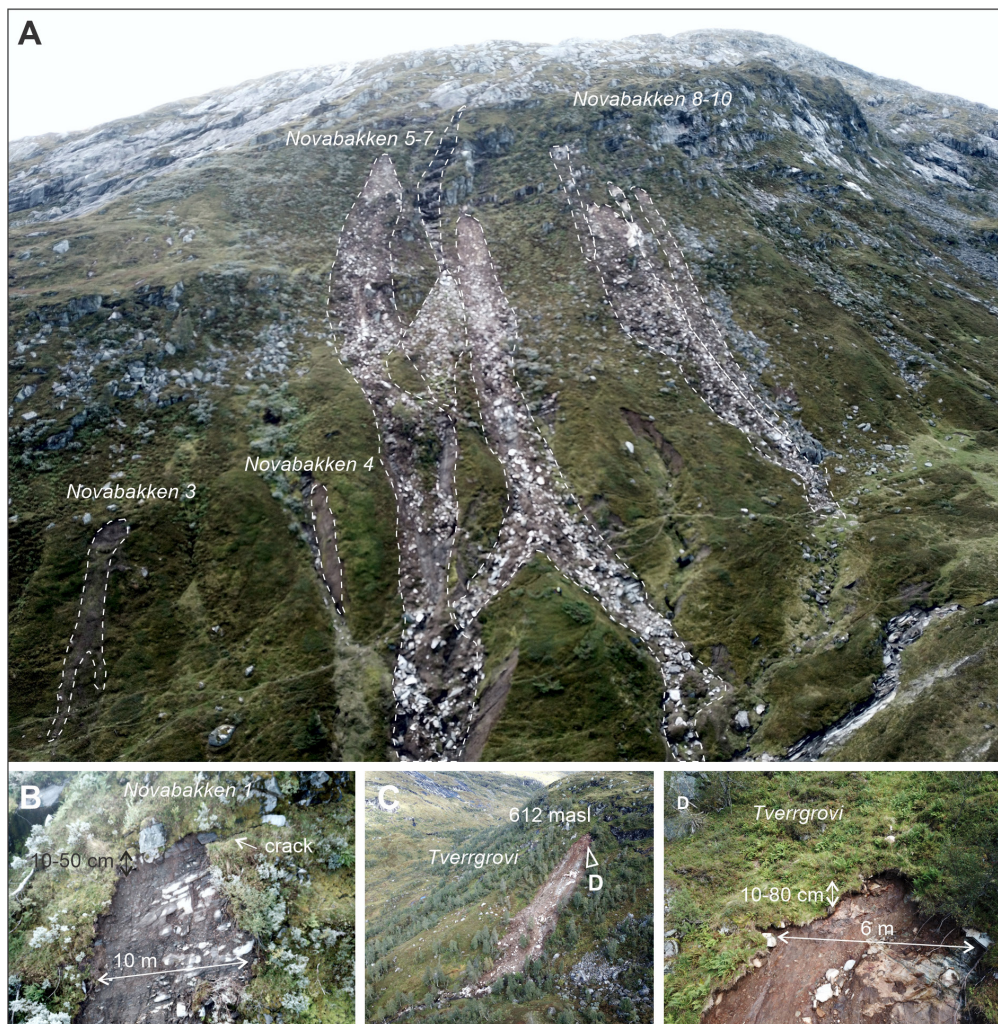
Figure 7. Superficial debris slides and flows at Novabakken and debris avalanche at Tverrgrovi. (A): Birds-eye view of debris slides and flows Novabakken 3–10. (B): Source area of a small debris flow at Novabakken 1 with a crack extending to the west from the backscarp. (C, D) Birds-eye view and source area of a small debris avalanche at Tverrgrovi.

At Novabakken on the northern slope of Tindefjellet, several superficial debris slides and flows as well as two rockfalls and a debris flood were identified from the 2019 J  lster event (Figs. 2A, 3D & 7). The debris avalanches at Tverrgrovi (Fig. 7C, D) and Storehola are also included in this summary (Table 4). Source areas are generally very steep (>35 degrees) and coarse-grained consisting of scree with soil development. In some source areas, thin soil was eroded down to protruding bedrock, but most debris slides and flows are very superficial as grass and bushes in the landslide paths frequently withstood erosion. Debris flows at Novabakken have the highest drop heights of around 100 metres and follow pre-existing channels developed in thick weathered material. For several of the debris flows and slides the surface area draining to the source area is very limited (mostly well below 500 m², Table 4). Source areas at these locations were not observed directly but from drone footage.
