Safety related study of Expanding Pin systems application in lifting and drilling equipment within Construction, Offshore, and Marine sectors

Ø Karlsen^{1,2,*} and H G Lemu²

¹ Bondura Technology AS, Bryne, Norway

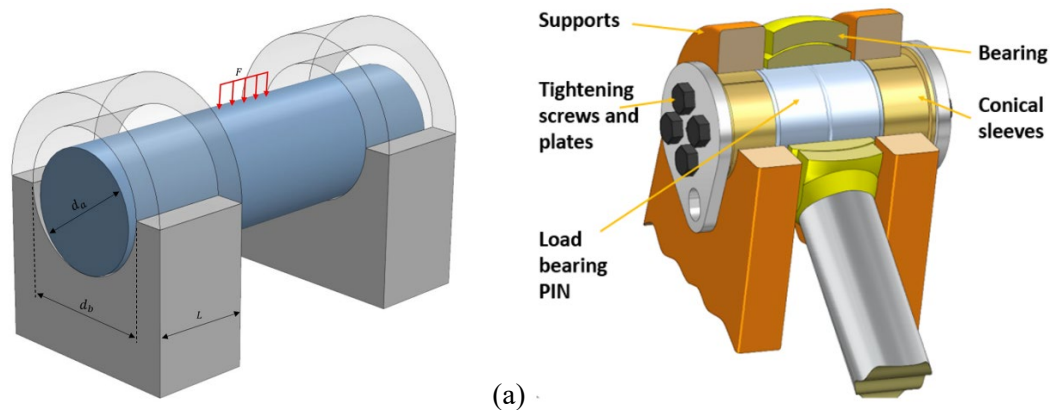
Figure 1. An illustration of pin in support – (a) standard cylindrical pin, and (b) expanding pin

Lifting and hoisting equipment such as cranes are often subject to strict rules and certifications due to the nature of the operations they are performing, and the risks involved. The dynamic loading could increase the stress level up to two times, or more [5], depending on the operational loads and internal joint clearance, and a twenty-fold increase in accelerations of pin movements. Lagerev and Lagerev [5,6] have investigated ways to increase the life of hinge lugs by eliminating backlash by use of elastic damping, and other techniques are to implement antifriction bushes, polymer coatings or different hardening methods on the adjacent contact surfaces [7]. Another technique to control rapid movements and reduce the dynamic reaction forces in the joints is the heave compensation approach [8-11], typically for offshore, maritime, floating wind cranes, and sub-sea operations. A floating structure such as a ship can have six degrees of movement; a) heave, b) sway, c) surge, d) roll, e) pitch, and f) yaw, which all can affect negatively lifting and loading operations. Without a compensation system, such uncoordinated relative movements can generate high dynamic and shock loads into the equipment and specially into the pinned joints, who can suffer friction wear, corrosion wear, fretting wear, and deformations which again can result in increased play in the joint, see Figure 1 (a), or even breakage of the pin.

The purpose of this study is to analyse the importance of use of expanding pins, Figure 1 (b), related to safety for personnel, equipment, and environment, on cranes, drilling equipment, and other heavy machinery. The study is based on analysis of previous publications, investigations, and reports, in addition to a questionnaire-based survey [14], and communication with some companies operating in the Norwegian and global energy area.

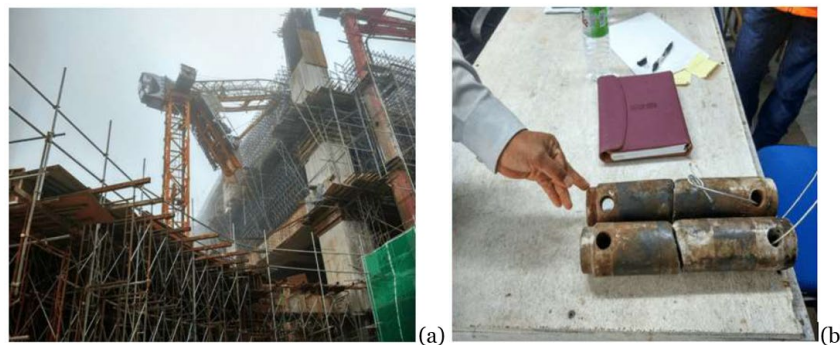
Figure 3. Tower crane accident – (a) crane after accident, and (b) broken pins

The Department of Occupational Safety and Health in Malaysia sent out a Safety Alert [17] in 2017 regarding a tower crane accident, due to failure of counter jib platform connection pin, see Figure 3. The safety alert indicates the breakage of the two cylindrical pins as the main reason for the accident, without further explanations.

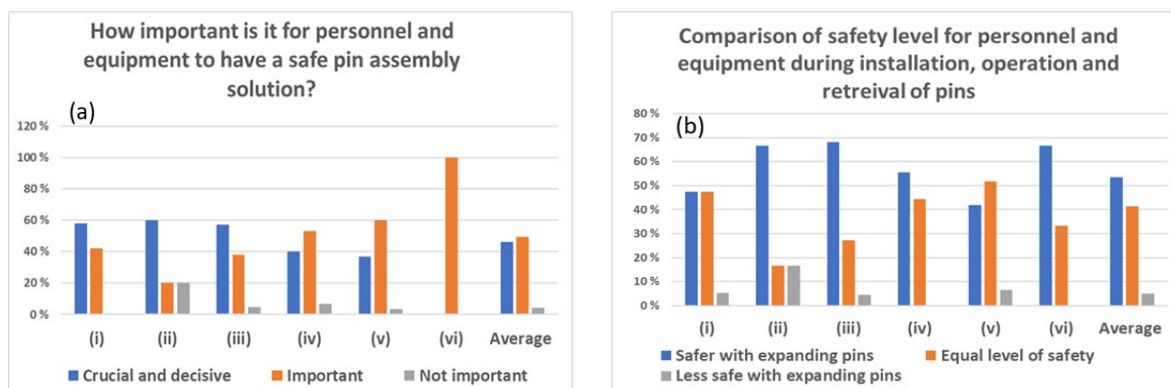
Figure 4. Statistics from questionnaire-based survey – (a) the importance of safe pin solution, (b) comparison of safety levels, (c) why safer with expanding pin, (d) the importance of avoid breakage, (e) risk of breakage, (f) comparing tear and wear with different pins, (g) the importance of quick pin installation and retrieval, (h) installation time, and (i) retrieval time

On the question of *safety level*, Figure 4 (b), the responders evaluate the safety level, as they define and experience it, for personnel and equipment, during installation, operation, and retrieval of pins, for the two different pin solutions in question. Figure 4 (c) shows the results from a following-up question for those who responded that the expanding pins are safer. Four specific alternatives plus one open (Other) are given, and the results show 97% of the responders chose the given alternatives, and only 3% gave an alternative reason. The responders’ main concerns regarding safety is related to personnel and equipment, and their economic appraisals and concerns are reported in a study by Karlsen and Lemu [14].

As demonstrated in Fig. 4 (b), 54% aimed at the expanding solution as the safest, and only 4% stating this pin as less safe. The stakeholder (ii), (iii), (iv) and (vi) clearly indicate this with a 65% average score on *Safer with expanding pins*. The reasons for *why* the expanding pin is considered safer Fig. 4 (c), there are two main reasons given, (1) *No sledgehammering needed*, and (2) *Easy and fast to retrieve*. These are the main reasons for all the defined stakeholders, (i) – (v). Retrieval of pins which are stuck in the support bore, due to cold-welding, corrosion, or deformation can be a high-cost and high-risk operation, with use of high-pressure hydraulic tools, flame-cutting equipment, welding and line-boring. Pin solutions which can prevent such high-risk operations are highly evaluated by the stakeholders.

For all the participants, the *importance of avoiding breakage* is naturally highly valued, with OEM (i), supplier to OEM (ii) and engineering (iii) scoring 79%, 80% and 71% on *Crucial and decisive*, with the others almost equally divided between *Crucial and decisive*, and *Important*, see Fig. 4 (d).

When it comes to the *risk of having pin/support breakage*, Fig. 4 (e) and/or *wear issues*, Fig. 4 (f), there is no one (0%) indicating that expanding pins are more exposed to breakage, than the std pin. It is relatively equally divided between *Less with expanding pins* and *Equal*, with 48% and 52% as total values, respectively. Analysing the tear and wear comparison between expanding pins and cylindrical ones, it shows that within each of the stakeholder segments (i) – (vi) in Figure 4 (f), it exists a clear

opinion and experience that there is less wear issues with expanding pins compared to standard pins, with 63% and 35%, respectively. Only 2% see more wear issues with expanding pin solutions.

The stakeholders have a clear opinion on the *importance of quick* installation and retrieval of pins, Fig. 4 (g), with 80% indicating that as *Crucial and decisive*, and *Important*. Service, Repair and Maintenance (v) have the highest score on *Not important* with 30%.

When comparing *installation and retrieval time* for expanding and cylindrical pins, Fig. 4 (h) and (i), respectively, most of the stakeholder segments (Figure 4 (h) (i) – (iv)) responds that the expanding pins are the fastest to install, and the total average states 50% for expanding pins as fastest, 34% as equal, and 16% stating standard pins as fastest. For the retrieval time the stakeholder segments (i) – (v), Figure 4 (i), responds that the expanding pin is the fastest to retrieve, and the corresponding numbers for the total average are 67%, 18% and 15%, respectively.
