Visible Corrosion Damage in Carbonated Reinforced Concrete

This study discusses visible corrosion damage due to carbonation in concrete balconies and facades. The focus of the study was to find out how the age of the structure, cover depth of concrete, carbonation coefficient, capillarity of concrete and the climate affect visible corrosion damage. The research data consist of condition investigation reports of existing concrete balconies and facades built between 1948 and 1996.

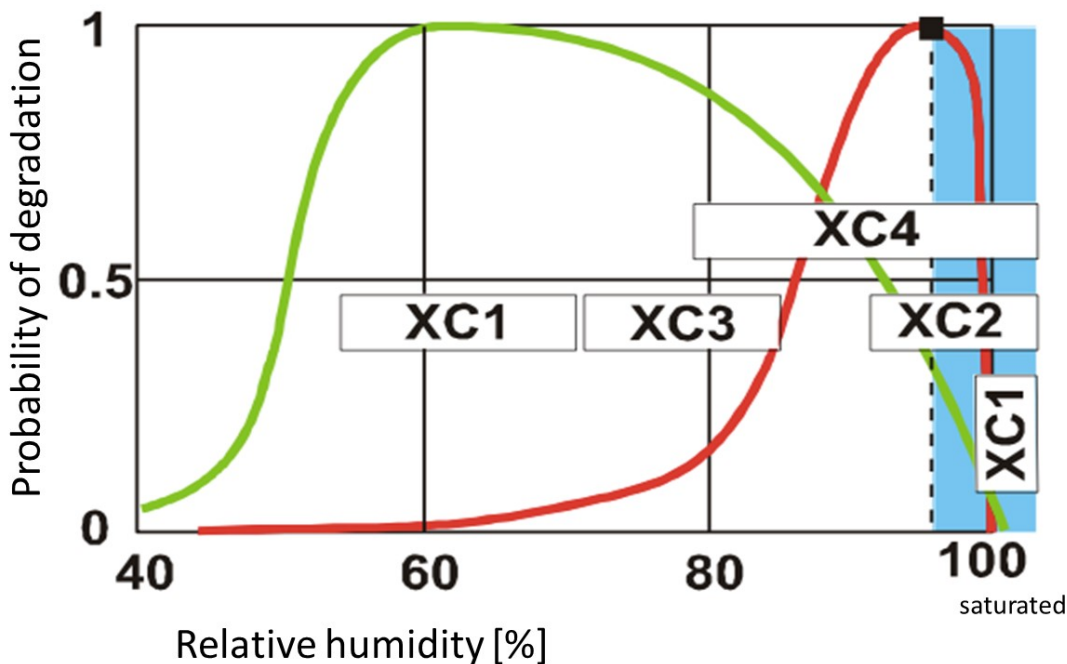
Figure 1 – Effect of relative humidity of concrete on carbonation rate of concrete and corrosion rate of reinforcement [12, 13].

From Figure 1 it can be seen the dependence of the corrosion of reinforcement and the rate of carbonation of concrete on relative humidity in different exposure classes. In the exposure classes XC3 and XC4, the carbonation rate slows down all the time as the corrosion rate increases. In exposure class XC3, the relative humidity is about 70-85 %. At 80 % humidity, the corrosion rate starts to increase sharply. Exposure class XC4 as a whole is in the area of rapid corrosion. The corrosion rate also peaks in the exposure class XC4 as the relative humidity approaches saturation. However, the peak corrosion rate is not usually observed [5]. It can be concluded that corrosion

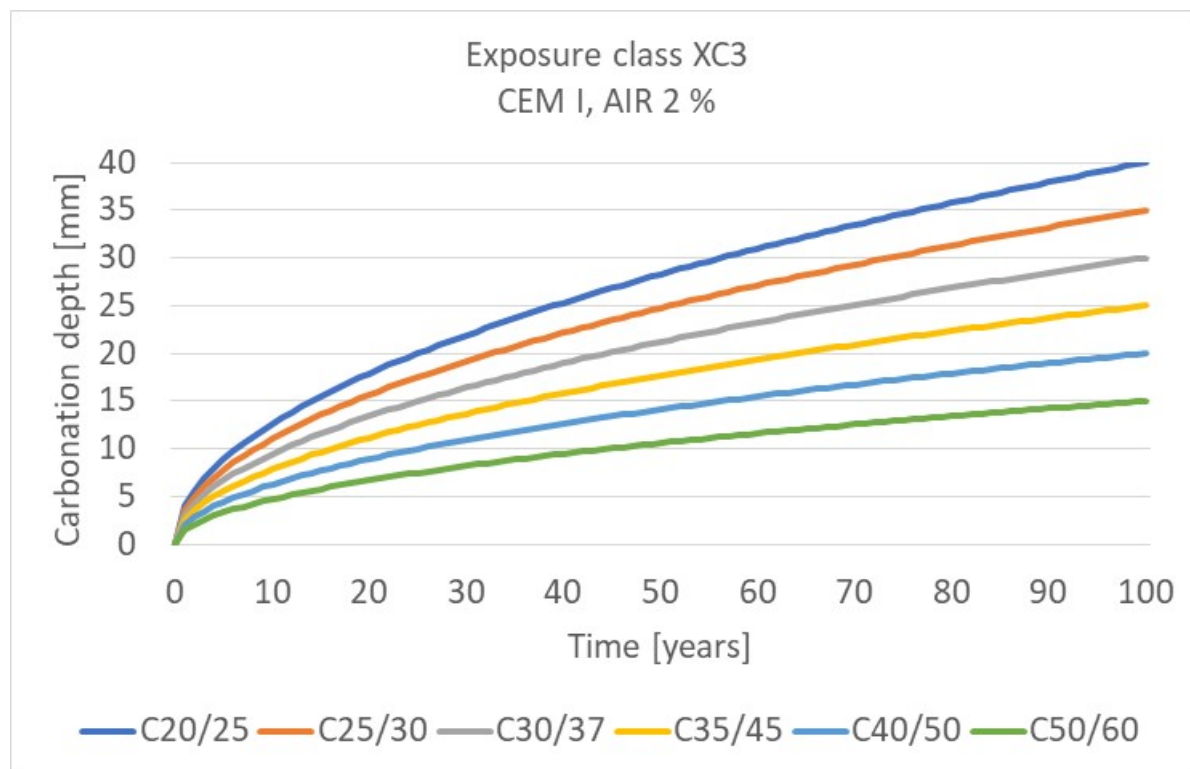
Figure 3 – Carbonation depth as a function of time in different strength classes according to publication BY68 [16].

The influence of strength class to service life of uncracked reinforced concrete structures can be estimated directly from Figure 3 [16]. The results from the research data are compared with Figure 3 (C20/25, C25/30, C30/37) in the following chapters.

Finnish national design guideline shows (Figure 3) rather pessimistic curves compared to collected data (Figure 4). In 25 years, the carbonation should advance to 28 mm in strength class C20/25 concrete, but the actual carbonation depth is 20mm for frame panels, 22 mm for slab panels and 16 mm for parapet panels.

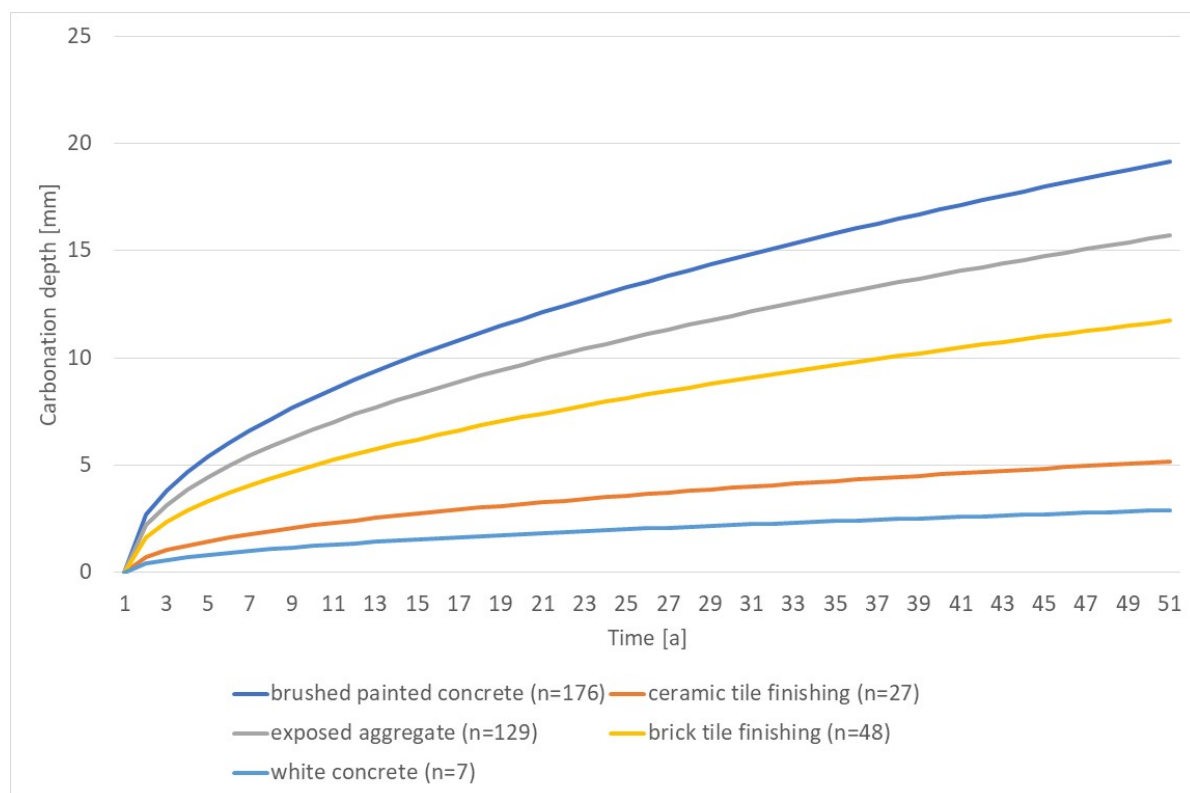
Figure 5 has been drawn by applying the average carbonation depth to Equation (5). Figure 5 shows the calculated data for precast facade elements.

Figure 5 – Carbonation depth as a function of time in different precast facade element types.

The different surface types shown in Figure 5 have greatly different carbonation rates from each other. The carbonation proceeds the slowest in ceramic tile finished concrete and white concrete.

The fastest carbonation occurs in brushed painted concrete. Exposed aggregate and brick tile finished concrete are in the middle of the extreme ends yet closer to the rate of brushed painted concrete.

In every element type the carbonation depth is much less than presented in national designing instructions. Even the fastest proceeding carbonation in brushed painted concrete reaches only a depth of 19 mm in 50 years, when in strength class C20/25 it should reach a depth of 28 mm. On other facades' surface types, the carbonation depth is 3 to 16 mm, which is greatly lower than the national instructions presume. The standard deviation is around the same with balcony elements excluding brick tile finishing concrete that has a standard deviation of ± 2.3 mm and white concrete with a standard deviation of ± 0.37 mm.

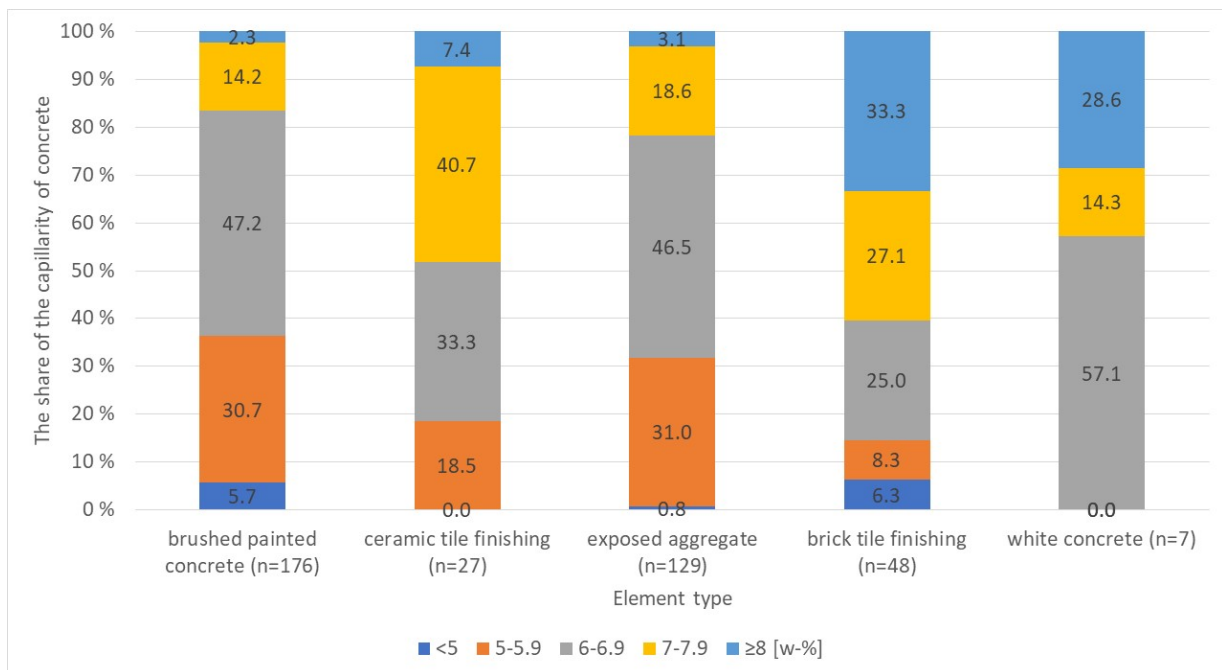
As seen on Figure 7, the capillarity of concrete varies considerably between different surface types in façade panels. Brushed painted, exposed aggregate and white concrete façade panels' capillarity is 6-6.9 w-% on average. The capillarity of ceramic tile finishing concrete is 7-7.9 w-% and brick tile finishing concrete has capillarity ≥ 8 w-%.

Figure 7 – Capillarity of concrete in different precast facade element types.

The average capillarity of concrete for precast facade elements varies between the surface finishes (see Figure 7). The carbonation coefficient is 2-4 mm/a^{0.5} for brushed painted panels, <1 mm/a^{0.5} for white concrete and 2 mm/a^{0.5} for other finishes. The correlation coefficient R² between capillarity of concrete and the carbonation coefficient is 0.08 for exposed aggregate facades, 0.00 for brushed painted facades, 0.00 for ceramic tile finishing facades, 0.01 for brick tile finishing facades and 0.23 for white concrete facades. Ceramic tile finishing, brick tile finishing, and white concrete facades have small sample sizes hence they have poor correlation coefficients. It can be stated that there is no correlation between capillarity and the carbonation coefficient because of high deviation of the carbonation coefficient.

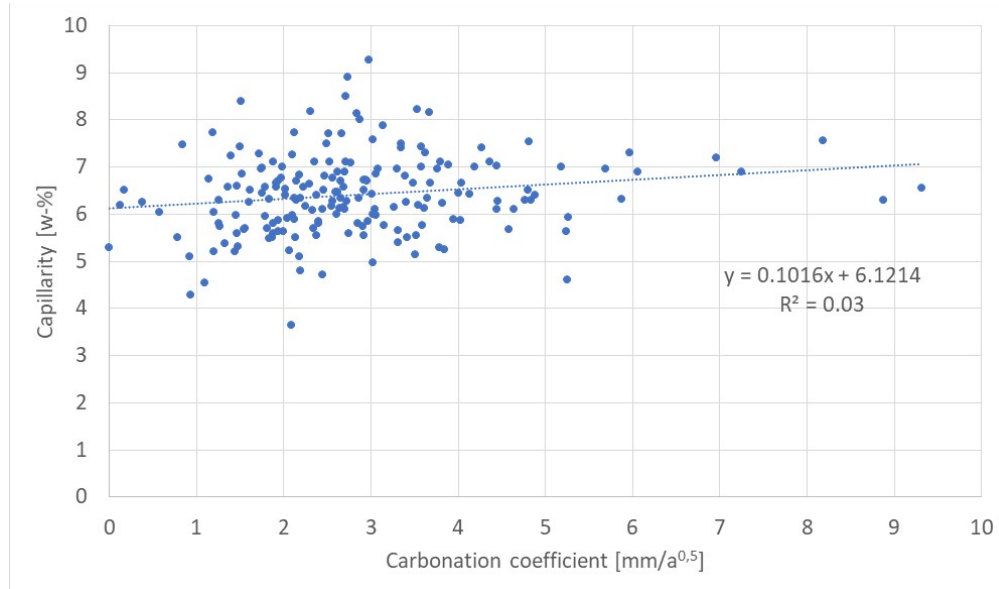
The relation between the capillarity of concrete and the carbonation coefficient was researched by fitting a line with the best correlation through the datapoints. The relation between capillarity and carbonation coefficient in frame panels is shown in Figure 8.

Figure 8 – Relation between capillarity of concrete and the carbonation coefficient in frame panels.

The average capillarity of concrete for precast balcony elements is 6-7 w-% while the carbonation coefficient varies between different element types. The carbonation coefficient is 1-3 mm/a^{0.5} for parapet panels, 2-4 mm/a^{0.5} for frame panels and 3-4 mm/a^{0.5} for slab panels. The correlation coefficient R^2 between capillarity and the carbonation coefficient is 0.03 for frame panels, 0.05 for the inner surface of parapet panels, 0.03 for the outer surface of frame panels and 0.02 for soffit of slab panels. In all cases the deviation of carbonation coefficient is high. Therefore, no correlation between capillarity and the carbonation coefficient can be seen. However, the carbonation coefficient of concrete increases slightly together with the capillarity of concrete.

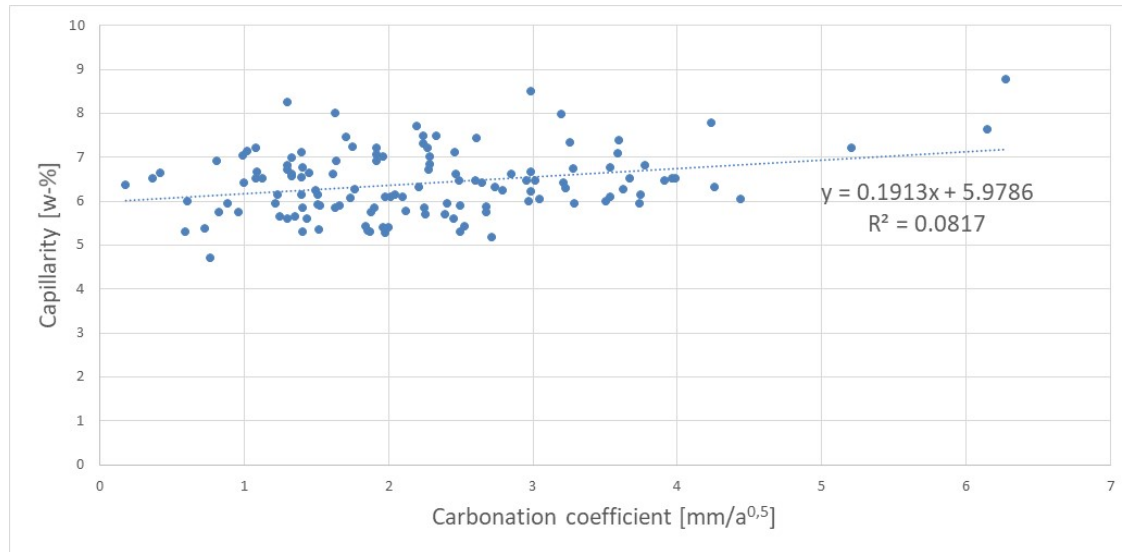
The relation between capillarity of concrete and the carbonation coefficient in exposed aggregate facade panels is shown in Figure 9.

Figure 9 – Relation between capillarity and the carbonation coefficient in exposed aggregate facade panels.

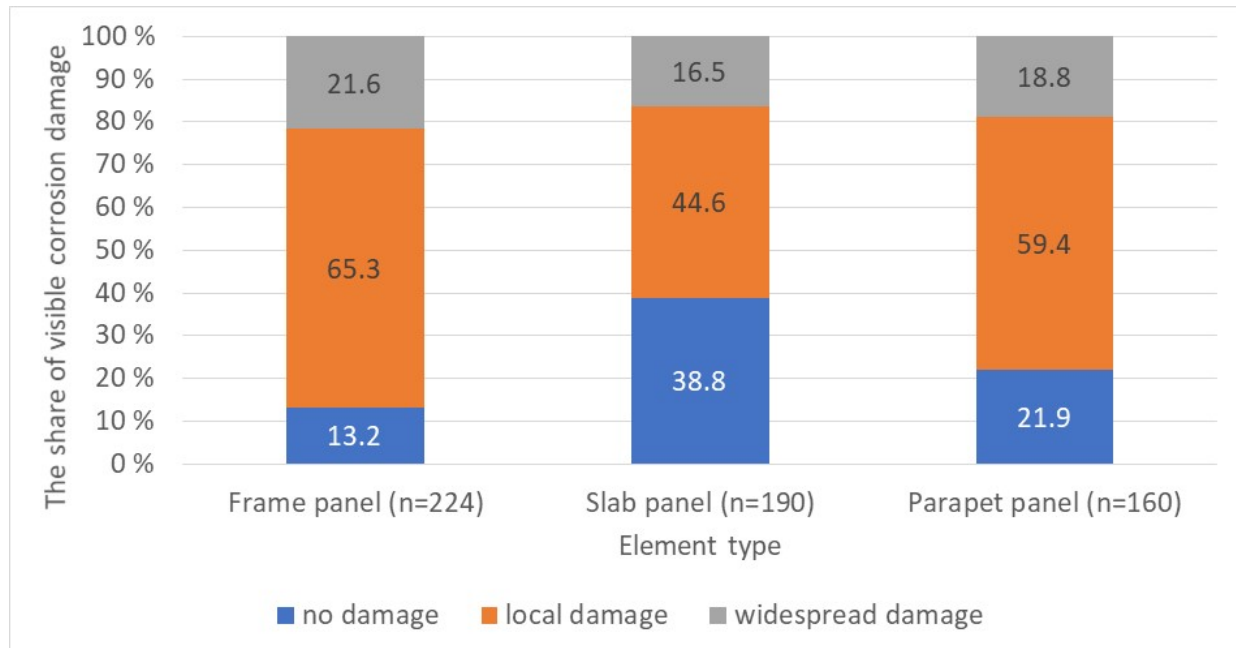
Corrosion damage has been divided into three groups: no damage, local damage and widespread damage. The amount of corrosion damage on different balcony element types is standardized in Figure 10.

Figure 10 – The standardized amount of corrosion damage in different balcony element types.

As seen on Figure 10, visible corrosion damage is detected most in frame panels. Slab panels have relatively less corrosion damage compared to other element types. This occurs because the soffit

of the slabs is covered from direct rain, while frame panels and the outsides of parapet panels are exposed to wind-driven rain (WDR).

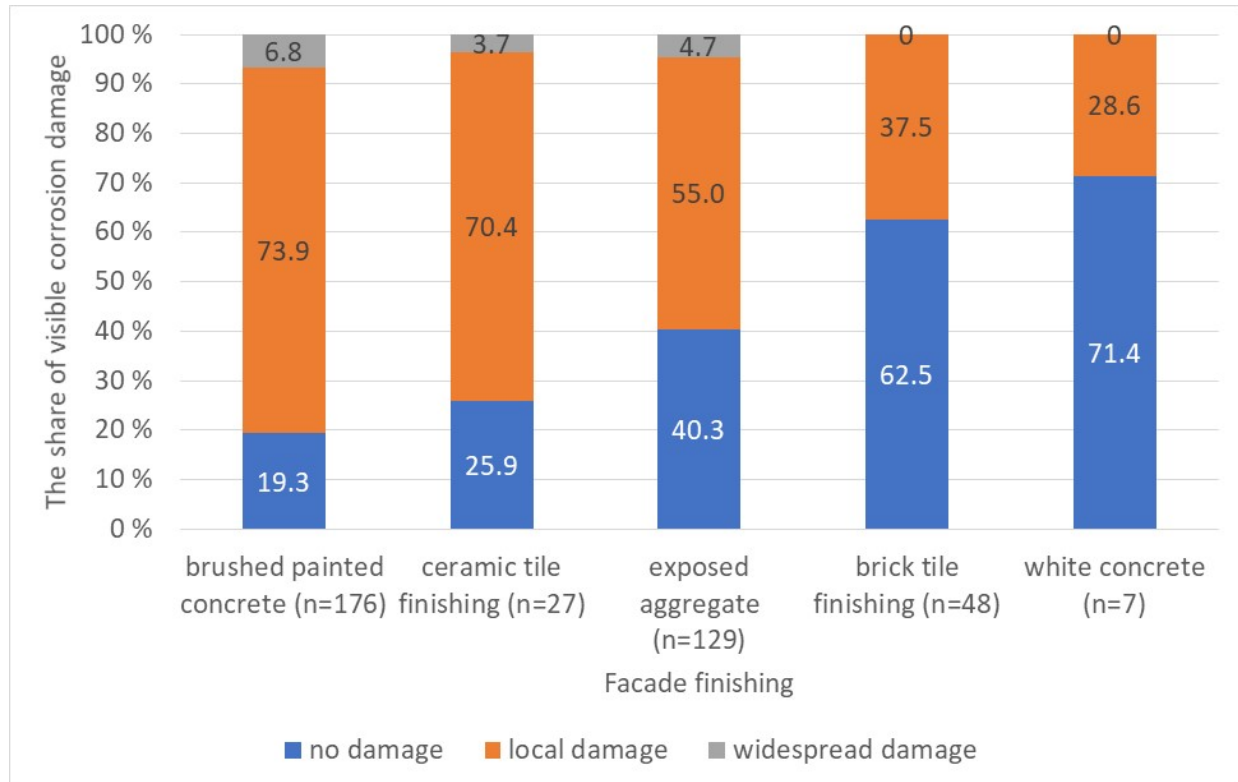
The amount of corrosion damage on different facade element types is standardized in Figure 11.

Figure 11 – The standardized amount of corrosion damage in different façade element types.

As seen on Figure 11, the amount of visible corrosion damage decreases while going right in the picture. Visible corrosion damage has been detected the most in brushed painted facades. The amount of fully damaged reinforcement is impalpable compared to balcony elements.

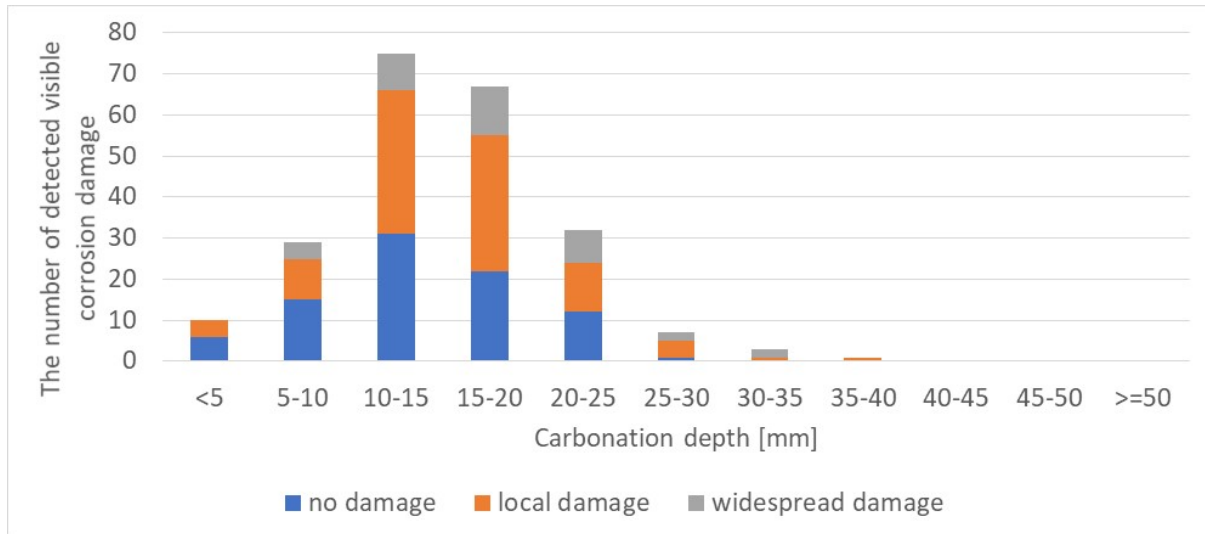
In Figure 12 is the amount of visible corrosion damage on different carbonation depths measured from the soffit of slab panels. Other balcony panels’ corrosion damage in different carbonation depths imitates the distribution shown in Figure 12.

Figure 12 – Amount of visible corrosion damage in different carbonation depths measured from the soffit of slab panels.

The carbonation has proceeded mostly to 10-15 mm from the soffit of the slab panels. The time that passes before the carbonation depth of 10 mm is reached, can be estimated by comparing Figure 12 to Figure 4. Frame elements reach the carbonation depth of 10 mm in 11 years, slabs in 14 years and parapets in 21 years. The carbonation depth of 15 mm is reached in 24 years for frame panels, 29 years for slabs and 46 years for parapet panels.

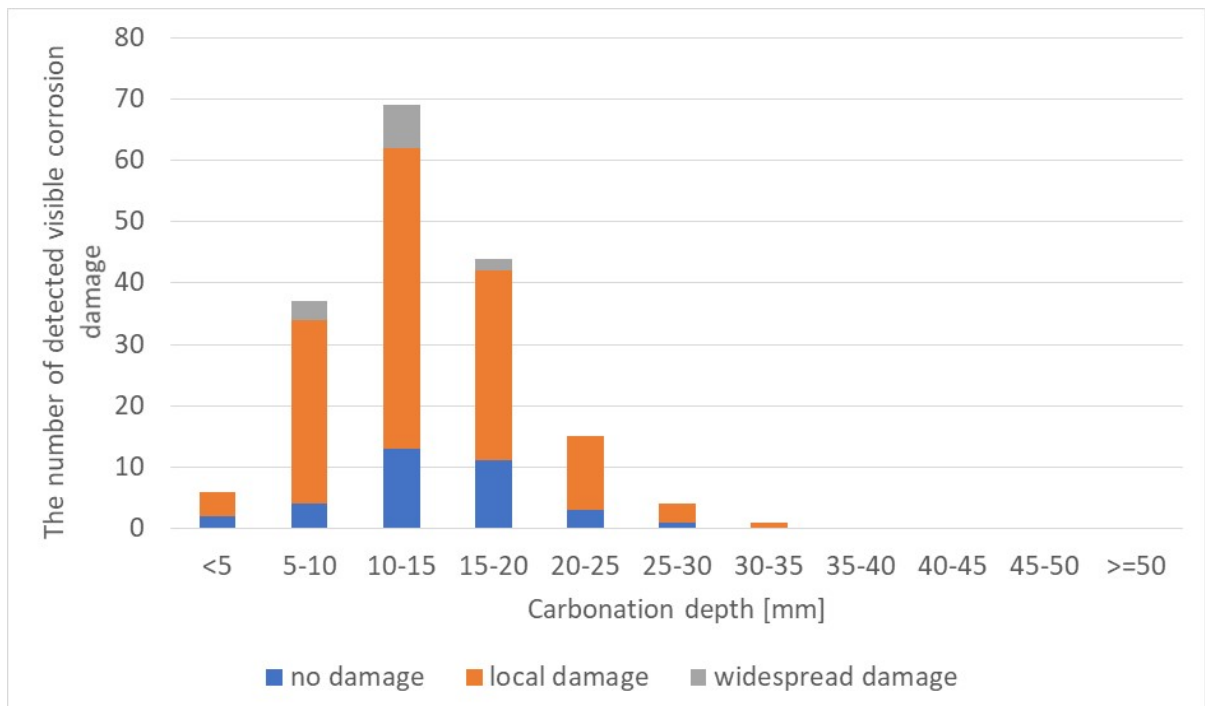
Figure 13 shows the amount of detected corrosion damage on different carbonation depths in brushed painted facade panels.

Figure 13 – Amount of visible corrosion damage in different carbonation depths on brushed painted facade panels.

Like balconies, brushed painted facade panels have a carbonation depth of 10-15 mm on average measured from the outside of the facade. By comparing Figures 13 and 5, the carbonation depth of 10 mm is reached in 14 years and 15 mm in 32 years. In Figure 14 is the amount of detected visible corrosion damage in exposed aggregate facade elements.

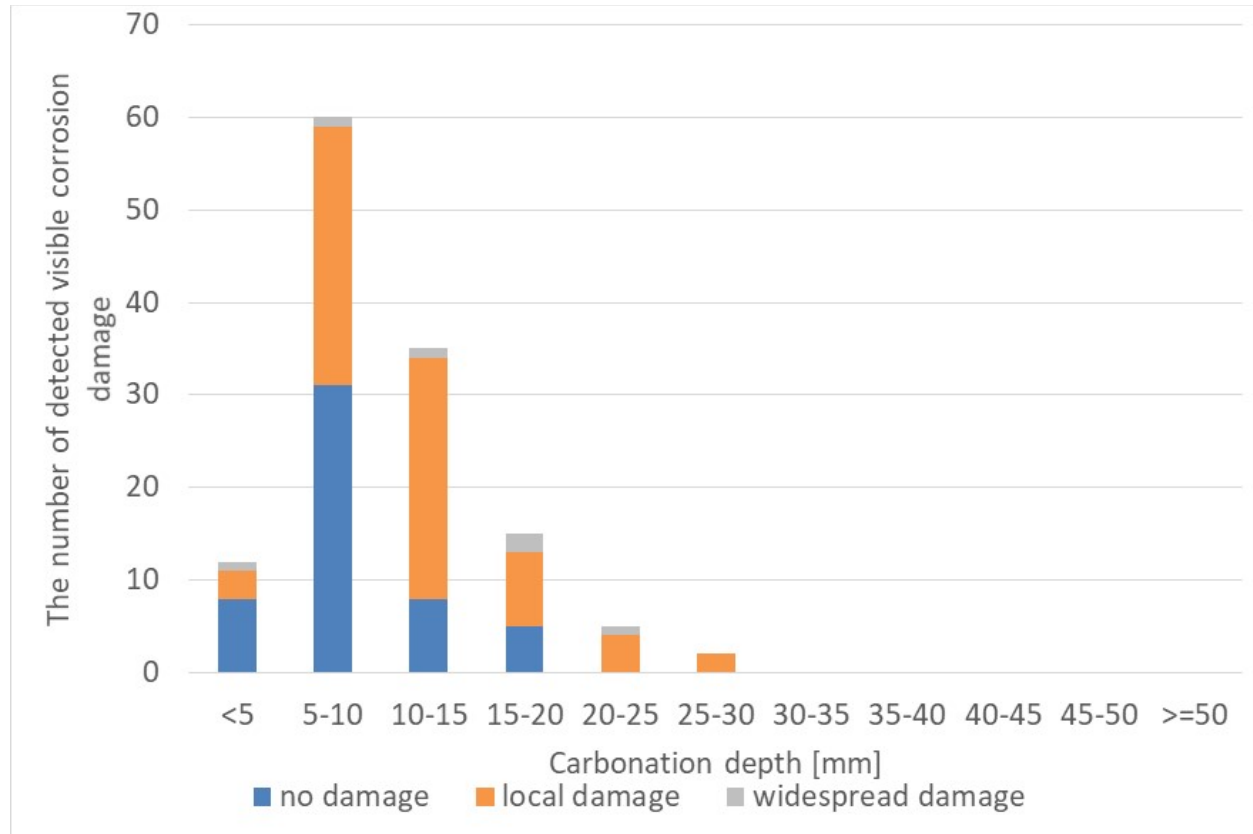
Figure 14 – Amount of visible corrosion damage in different carbonation depths in exposed aggregate concrete facade panels.

As seen on Figure 14, the carbonation of concrete has proceeded to the depth of 5-10 mm in exposed aggregate facade panels. The carbonation depth of 5 mm is reached already in 6 years and 10 mm in 21 years.
