Radiative Heat Transfer Analysis of Railroad Bearings for Wayside Hot-Box Detector Optimization

**RADIATIVE HEAT TRANSFER ANALYSIS OF RAILROAD BEARINGS
FOR WAYSIDE HOT-BOX DETECTOR OPTIMIZATION**

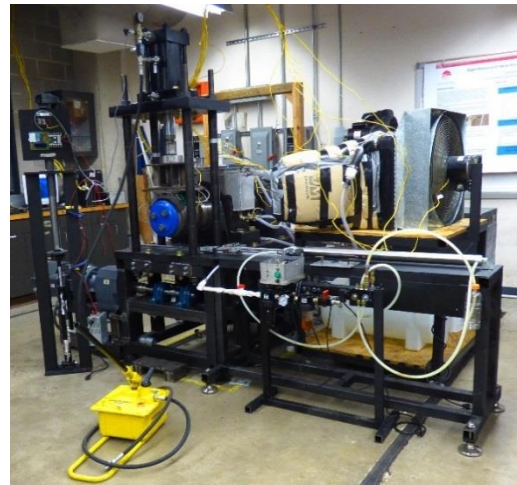
Figure 1. Single Bearing Tester (SBT)

The single bearing tester (SBT) design, pictured in Figure 1, allows for the test bearing to be suspended at the end of an axle with an overhead load pressing down on the bearing through an adapter. This setup also allows for lateral and impact loads to be applied as needed to mimic the conditions a railroad bearing experiences in field service. In order to duplicate the manner in which a hot-box detector (HBD) senses the bearing's temperature in a laboratory setting, a method had to be devised to move the sensor underneath the bearing at a prescribed travel speed. Figure 2 shows how a pneumatic system was employed to accomplish this task. A near frictionless rail-cart system was designed and assembled that could transport the infrared temperature sensor under the bearing. Two IR break sensors, spaced strategically under the bearing area, were utilized to collect time measurements used to calculate the speed of the cart as it passed under the bearing. The cart was attached to a pneumatic cylinder fed by a four-way valve which employed an Arduino Uno as the controller.

which correspond to bearing rotational speeds of 47 to 795 rpm. Speeds utilized in this study were 30, 45, 66, and 85 mph (48, 72, 106, and 137 km/h, respectively), which correspond to rotational speeds of 281, 421, 617, and 795 rpm, respectively. As can be seen in Figure 1, an overhead load is applied to the railroad bearing via a hydraulic cylinder. The two loads generally tested are 17% and 100% of a fully-loaded railcar. The 17% load setting corresponds to an empty (unloaded) railcar and translates to approximately 5848 lbf (26 kN) per class K or F bearing, whereas, the 100% load setting corresponds to a fully-loaded railcar and translates to 34.4 kips (153 kN) per class K or F bearing. The data collected for this study utilized the 100% load setting since fully-loaded railcars are at a higher risk of bearing burn-off than empty railcars. The last parameter, IR sensor travel speed, is the descriptor of the speed at which the pneumatic cylinder pushes the sensor. It was desired to reach speeds of 30 mph (48 km/h), however, with the current setup, only speeds of up to 7 mph (11 km/h) were achieved. Higher IR sensor travel speeds can be achieved through some modifications to the current pneumatic system, but the goals of this study were met with the current system.

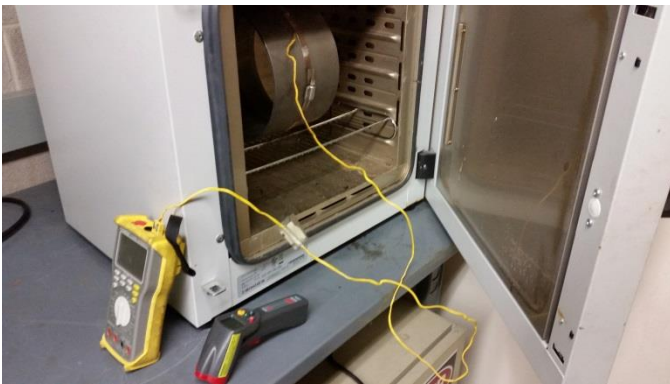
Figure 9. Oven test setup. The K-type thermocouple can be seen attached using a hose clamp. The thermocouple multi-meter can be seen attached at the other end of the thermocouple.

Testing was also conducted to establish the behavior, in a non-dynamic environment, of the MICRO-EPSILON infrared temperature sensor that was employed in the HBD simulation system. A bearing cup was placed in an oven with a K-type thermocouple attached as the control measurement. An infrared gun and the MICRO-EPSILON IR temperature sensor were then used to measure the temperature of the bearing at a number of different heat settings. Figure 9 is a picture of the setup used for this testing. The data of the IR temperature sensor agreed very well with those of the infrared gun and differed by no more than 2°C (~4°F) from the K-type thermocouple data at the highest heat setting tested (~100°C).

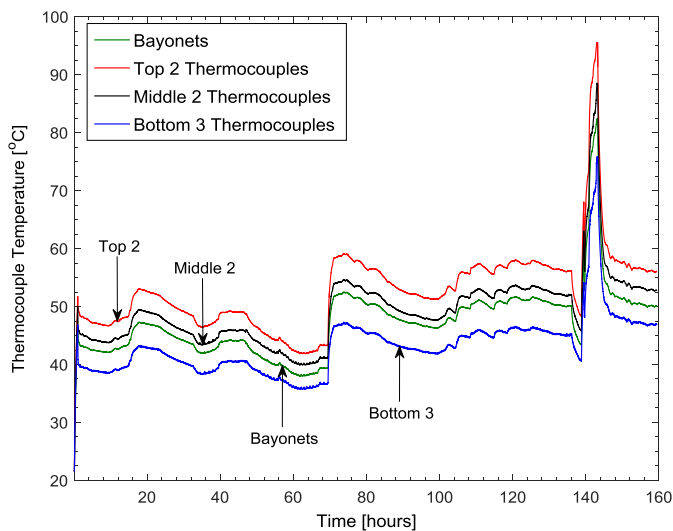
Figure 10. Thermocouple temperature histories for the duration of one experiment. The data shown represents the average temperature data of the thermocouples in each of the specified locations.

In service, railroad bearings are loaded over the top hemisphere of the cup (outer ring) and unloaded over the bottom hemisphere of the cup. Hence, the temperature of the bearing tends to be higher at the top region where the load is applied, and decreases moving away from the top towards the bottom hemisphere of the cup. Figure 10 demonstrates this dynamic thermal performance for one of the bearings tested in this study. This plot shows temperature data from the seven thermocouples that are placed around the circumference of the bearing as well as the four bayonet thermocouples described in the experimental setup section and pictured in Figure 7. Looking at Figure 10, it becomes apparent that there is a distinct difference in the thermocouple temperatures based on their position around the bearing as mentioned earlier

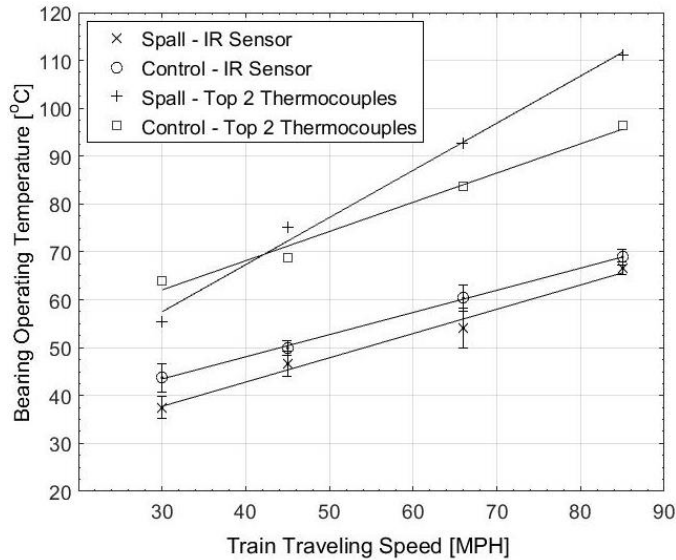
Figure 12. Infrared sensor and thermocouple average temperature readings versus the train traveling velocity.

Figure 12 shows the thermocouple and infrared sensor temperatures versus train traveling speed. Note that the infrared sensor temperatures displayed in Figure 12 are average temperatures of all the data that was collected from the four sensor paths, shown in Figure 5, in much the same way a HBD infrared sensor in field service would scan a large portion of the bottom surface of the bearing. This data shows a clear discrepancy between the infrared sensor temperature data and the onboard thermocouple data (average temperature of top two thermocouples). This difference in temperature is hereafter called “IR sensor error.” Figure 12 also shows that the IR sensor error increases as the train traveling speed increases. The bearing operating temperature increases with the train traveling speed since it is directly proportional to the bearing rotational speed. Since the bearing operating temperature is dependent upon its rotational speed, it would also seem that the IR sensor error (i.e., temperature difference between IR sensor readings and thermocouple readings) is also a function of temperature. The higher the bearing operating temperature is, the larger the IR sensor error, which is consistent with the results plotted in Figure 11. More importantly, it seems like the infrared sensor fails to

differentiate between a healthy defect-free bearing (i.e., control) and a defective bearing with a cup (outer ring) spall.

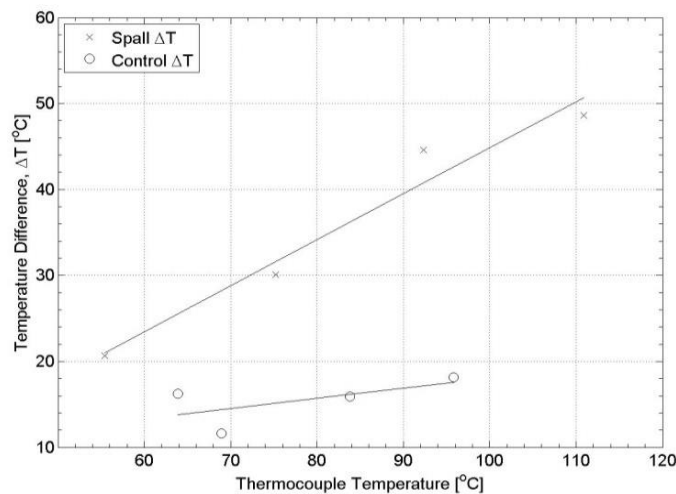
Figure 13. IR sensor error versus the top two thermocouple average temperature for both the spalled and control test bearings for the outboard raceway region.

The IR sensor error dependence on the bearing operating temperature is explored further in Figure 13, Figure 14, Figure 15, and Figure 16 which provide data for the outboard raceway, spacer ring, inboard raceway, and inboard seal regions, respectively. These figures examine the difference in temperature between the IR sensor reading and the top two thermocouple average temperatures for both the spalled and control bearings for all the regions tested (see Figure 5 and Figure 6). Figure 17 provides the average IR sensor error as a function of temperature for both the spalled and control test bearings for all the scanned regions.

Looking at Figure 13 through Figure 17, it can be seen that the IR sensor error increases almost linearly with the operating bearing temperature. It can also be observed that the increase in the IR sensor error is more drastic for the case of

the defective (spalled) bearing as compared to the healthy (control) bearing, especially for the scanned outboard raceway region data. A definitive change in slope can be noticed in the cases for the outboard raceway, spacer ring, and inboard raceway regions, with the slope discrepancy getting less pronounced as we move inward from the outboard raceway region towards the inboard raceway region. Furthermore, it seems like the IR sensor error for the two test bearings, spalled and control, also gets closer as we move inward. For the case of the scanned inboard seal region data, Figure 16, it seems like the two slopes for the two test bearings are very similar with the IR sensor error being slightly higher for the control bearing as compared to the spalled bearing. One explanation for the latter behavior is that the inboard seal region does not seem to be sensitive to the effects of the spall present on the bearing cup (outer ring); hence, scanning the temperature of that region will not meaningfully differentiate between a healthy versus a defective bearing.

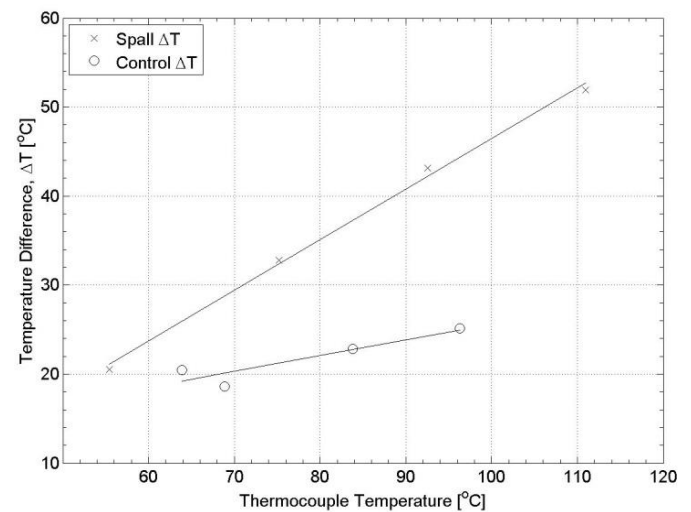
Figure 14. IR sensor error versus the top two thermocouple average temperature for both the spalled and control test bearings for the spacer ring region.
