## Effect of one-year corrosion on steel bridge materials in the maintenance stage with the Charpy impact test method

### Abstract

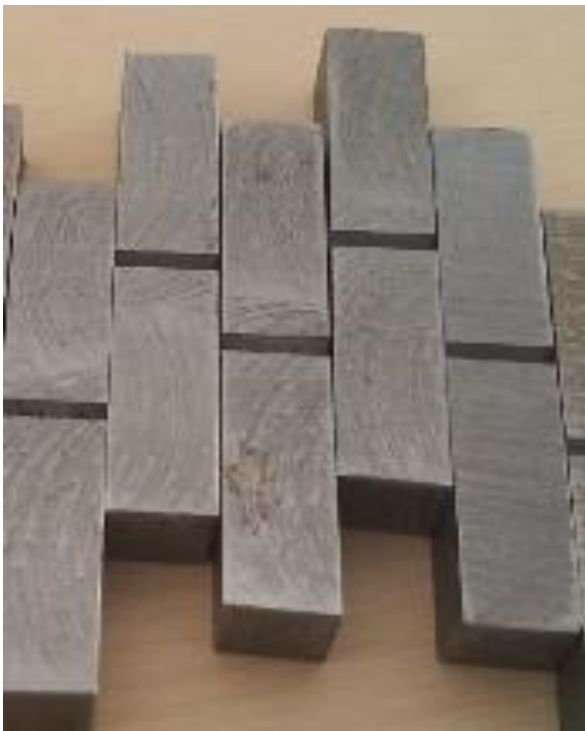
In the process of making this impact test object, steel material with grade JIS G3106 SM-490 is used which is very much and is commonly used in bridge construction both in Indonesia and in other countries. The standard size of each test object is adjusted to ASTM E23-18 [43]. The process of making the test object itself was carried out at the Mechanical Engineering Laboratory of the Jakarta State Polytechnic using a 3-axis CNC, MORI SEIKI MV-45/40, made in Japan. Test objects that have been made according to standards are shown in Figure 2.

Figure 2. Test the object before it is corroded

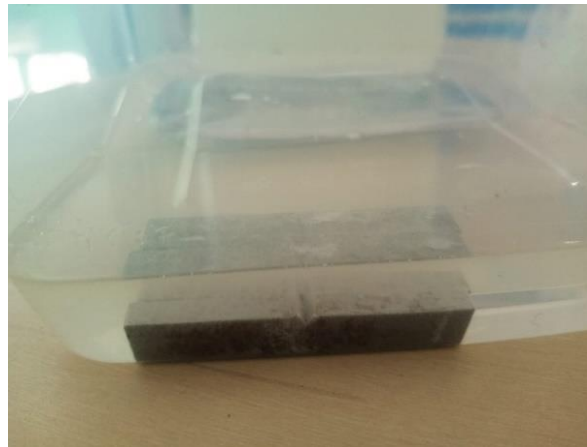
After making the test object, then the corrosion process is carried out using a mixture of distilled water mixed with Sulfuric Acid ( $H_2SO_4$ ) ASTM G31-21. 2021 [44]. The corrosion process using Sulfuric Acid ( $H_2SO_4$ ) for research has been widely used and is still frequently used today which aims to determine the rate of corrosion reactions in steel [45, 46, 47, 48, 49]. When the mixture of distilled water and  $H_2SO_4$  is ready, the specimen is dipped into the mixture for a day. After a day of immersing the test object using a mixture of solutions with a percentage of  $H_2SO_4$  content of 30%, 40%, and 50%, then removed from the mixed solution and placed in a room that has a room temperature of approximately  $25^{\circ}C$  so that the oxidation process occurs, and the test object corrodes [44]. The duration of corrosion on the specimen for the impact test in this study was carried out in five variations, namely 1 week, 2 weeks, 3 weeks, 4 weeks, and 52 weeks or one year. The implementation of immersing the test object in a mixed solution with a predetermined percentage of  $H_2SO_4$  is shown in Figure 3, and the test object that has been corroded is shown in Figure 4. The  $H_2SO_4$  used in this study is a product from the manufacturer Chepy Elkimy Chemindo, and the  $H_2SO_4$  content is 98%.

Figure 3. Immersion of Test Objects

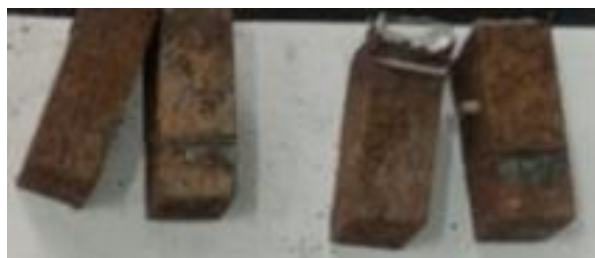
Figure 4. Test object after being corroded

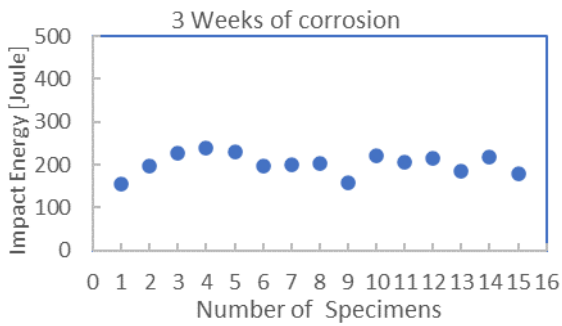
Subsequent tests were carried out with specimens that had been corroded for 3-weeks. This test also shows the same test results with the tendency of the results obtained from the test object without corroding, as shown in Figure 8. The data obtained from this test object shows results with close impact energy between the test objects, which is still around 200 Joules.

Figure 8. Impact test results with 3 weeks of corrosion

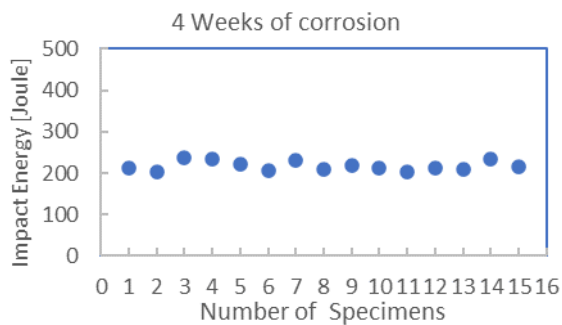
The test was continued with the corroded specimen for 4-weeks. Like the previous tests, at this stage, it also showed the same test results with the tendency of the results obtained from testing the test object without corroding, as shown in Figure 9.

Figure 9. Impact test results with 4-week corrosion

The data obtained from this test object showed results with a close impact energy between one test object and another, which is still around 200 Joules.

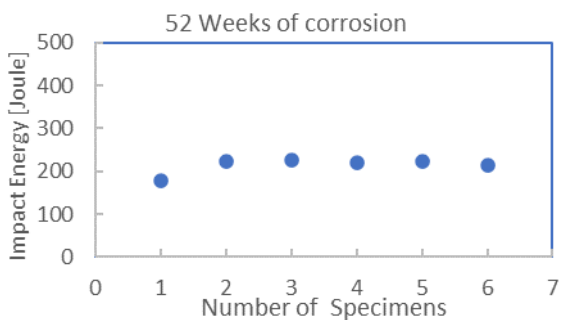
Subsequent tests were carried out on specimens that had been prepared for a 52-week or one-year corrosion period. The results obtained were still the same as previous tests, namely testing of specimens without corrosion and specimens with corrosion at 1-week, 2-week, 3-week, and 4-week respectively. At this stage, it also shows the same test results, as shown in Figure 10. The data obtained from this test object also still shows results with a close impact energy between one test object and another, which is still around 200 Joules.

Figure 10. Impact test results with 52-week corrosion

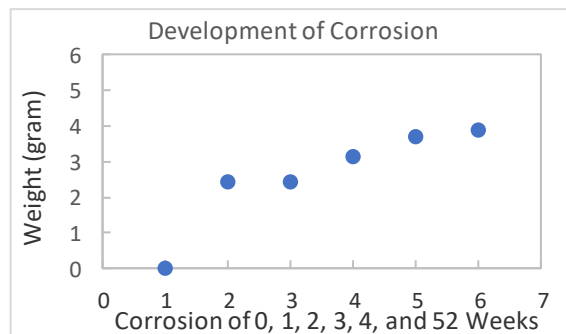
Specimen weighing was carried out before and after corrosion to determine the development of corrosion on the surface of the test object. The first weighing is carried out for specimens without corrosion which is called 0-week corrosion. Then proceed with specimens that have been corroded for 1 week, 2 weeks, 3 weeks, 4 weeks, and specimens with 52 weeks corrosion. The weighing results that describe the corrosion rate are shown in Figure 12.

Figure 12. Development of corrosion from 0-week to 52 weeks
