Research article

Diagnostics and reconstruction of bearing units

Citation: Ishchenko, A.A., Butsukin, V.V., Artiukh, V.G., Chernysheva, N.V. Diagnostics and reconstruction of bearing units. Magazine of Civil Engineering. 2023. 117(1). Article no. 11705. DOI: 10.34910/MCE.117.5

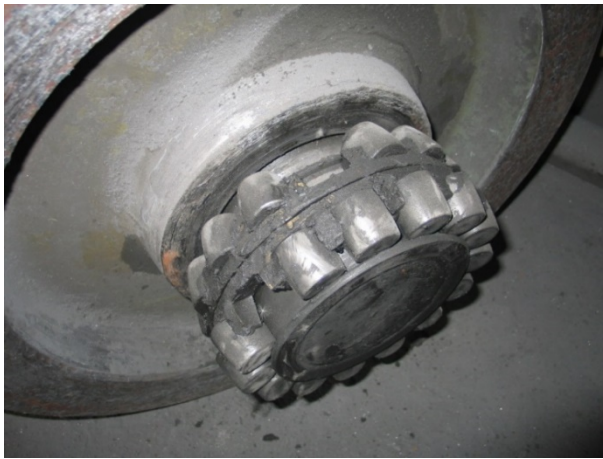
Disassembly of failed bearing assembly of the running wheel during repair showed presence of traces of thickening and oxidation of lubricant (so-called 'lubricant coking'). General view of this unit is shown on Fig. 1. Traces of the bearing rotation in its housing were revealed on the outer surface of the outer ring of the bearing.

Figure 1. Coking traces of lubricant on the running wheel bearing details.

Failure of running wheel bearings at moderate vibration rates of the unit may be due to phenomenon of thickening and oxidation of lubricant ('lubricant coking') revealed during disassembly of defective unit shown on Fig. 1. On the investigated crane this phenomenon was noted: in bearings located on side of heat effect acting from moving ladle with hot steel leading to elevated temperature of the bearing assembly

details and in irrational lubricant supply device designed during development of the crane. Coking of the lubricant leads to increase of torque of resistance between rolling elements of bearing and their rolling path; the torque of resistance becomes greater than torque fixing fit of the bearing outer ring in the bearing housing which ultimately leads to wear of the bearing seat and appearance of additional shock loads due to appearance of gaps. Temporarily rebuilt converter trunnion assembly of the converter support ring worked, as indicated above, from March to June and it was dismantled due to destruction of the composite material. Temperature in zone where the composite was located was around 140 °C (before repair measurements on operating converter showed temperature of about 60 °C in this zone at permissible operating temperature of the applied composite material of 80 °C). Thus, it can be stated that the composite material can withstand significant loads in compliance with temperature limits that in this case made it possible to solve problem of starting the converter and using it in time interval necessary to prepare for replacement of the support ring and bearing.

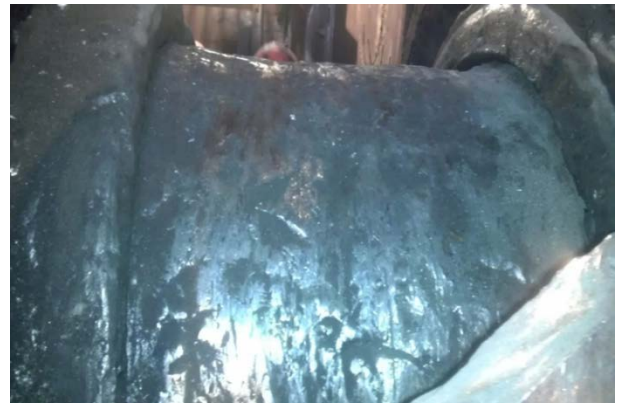
Below there is example of repairing a bearing assembly that has failed as a result of coking lubricant. As mentioned above, the repair of the bearing assembly according to the temporary option was carried out for surfaces being in contact with destroyed spherical double-row roller bearing on the trunnion (850 mm in diameter) of the bearing ring of the 300 tons converter from the drive side (refer to Fig. 2).

Figure 2. Surface of the trunnion of the converter support ring after the destruction of the bearing.

The unit is slow-moving (about 1 rpm) so its failure was not diagnosed in a timely manner. Due to its degree of damage done to the trunnion seating surface was very high. As it is seen on Fig. 2, the trunnion surface after contact with destroyed bearing elements and rollers is covered with dents and has noticeable wear of outer diameter surface. Such damage done to the bearing seat on the trunnion makes it impossible to further use the trunnion without dismantling and subsequent laborious restoration.

Considering that the trunnion is made as one piece with the converter support ring solution seems to be obvious. It is to order a new ring and a new bearing keeping in mind its unique characteristics both in size and design. But this rather long way did not exclude necessity of putting the converter into operation with some kind of temporary technical solution until moment of overhaul with installation of a new support ring and bearing.

It was decided on this support to switch temporarily to a sleeve bearing. To implement this idea it was necessary to restore the trunnion surface and install assembled cage on it which would subsequently be used as trunnion surface being in contact with inserts of sliding bearing. It was proposed using composite material 'Multimetall Stahl 1018' produced by company 'Diamant Metallplastik GmbH'. Technical characteristics of 'Multimetall Stahl 1018' are given in Tab. 2 [13, 14].

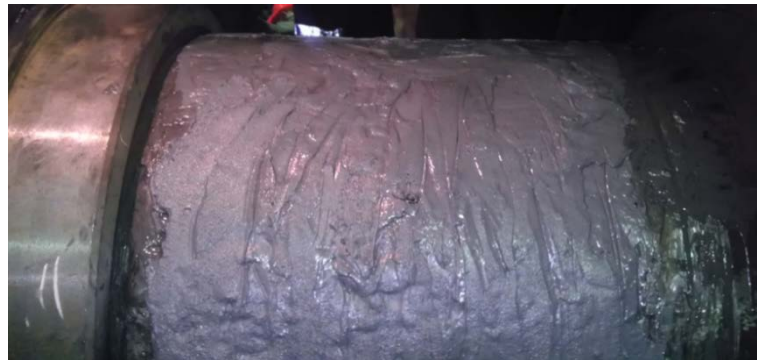
However, doubts arose whether the material could withstand part of weight of the converter with steel acting on the support. Theoretical calculations have confirmed possibility of using the composite when temperature of contact details does not exceed 80 $^\circ\text{C}$. Preliminary temperature measurements showed that its values within area of the trunnion do not exceed 60 $^\circ\text{C}$, hence restoration of the bearing surface of the trunnion was performed using the composite. Technology of using the composite and restoring the trunnion is illustrated on Fig. 3. The stages of this work included: degreasing the trunnion surface, preliminary installation of two parts of assembled cage 50 mm thick on base screws and centering it along axle of the trunnion, then dismantling the cage, applying the composite material (refer to Fig. 3a) and subsequent installation of the cage on the base screws with further connection of both parts with screws installed in

recesses relative to their working surface. Excess of the composite is visible, squeezed out through control holes which confirms complete filling with the composite of cavity between the old trunnion and inner surface of the cage (refer to Fig. 3b).

Figure 3. Stages of the trunnion restoration: a) the composite application; b) installation of the assembled cage.

Rebuilt according to this temporary scheme unit worked from March to June and was dismantled due to failure of the composite material because temperature in zone where the composite was located increased (when outside temperature increased) and during its destruction it was around 140 °C.

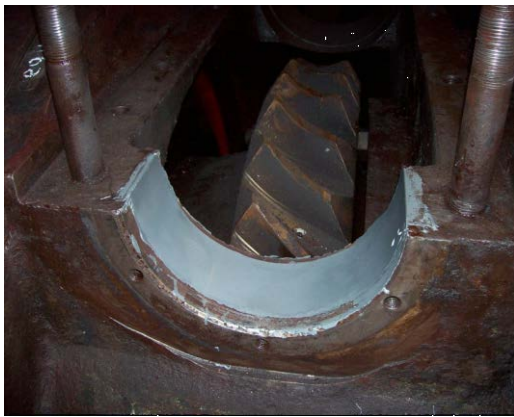
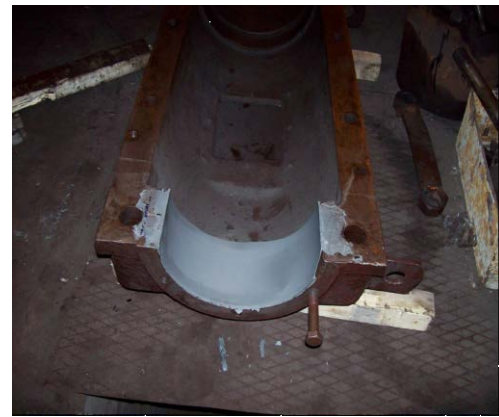
Fig. 5. Restored housings worn surfaces being in contact with rolling bearing: a) bottom housing; b) top housing.

The gearbox housing of the screw-down mechanism of the hot thick strip rolling mill rolling stand with full restoration of performance of worn surfaces being in contact with rolling bearings using the composite material has been successfully operated for three years that exceeds service life of such units restored using known technology including dismantling, moving to specialized section of mechanical workshop, machining in order to remove defective layer, followed by cladding and precise machining.

The restoration technology with formation of worn surfaces of the housings by the composite material using the polished template showed greater load-bearing capacity of restored assembly in comparison with traditional restoration method. This feature can be explained by fact that polished outer ring of bearing contacts restored by the composite material surface and formed, as shown above, using the polished template. At traditional technology of restoring support surface after its machining with milling cutter makes bearing outer ring to be sat on tops of microroughness of milled surface. Even with slight dynamic loads these tops of microroughness can be pressed down which is reason for subsequent wear of bearing seat [15–25].
