Article

Influence on Pitting Corrosion Resistance of AISI 301LN and 316L Stainless Steels Subjected to Cold-Induced Deformation

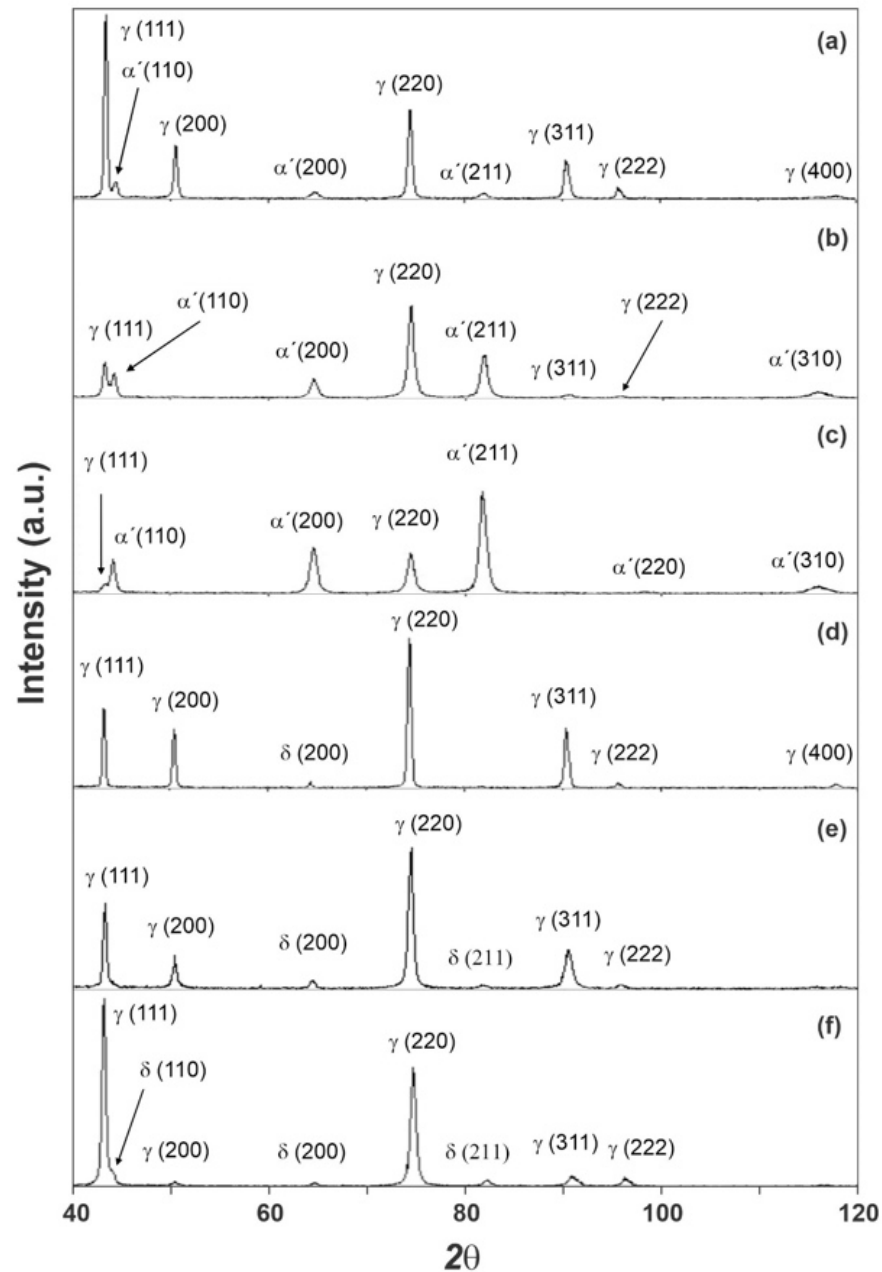
Figure 1. Diffractograms obtained for the A0 (a), A1 (b), A2 (c), B0 (d), B1 (e), and B2 (f) samples.

The sample diffractograms obtained for the A0, A1, A2, B0, B1, and B2 samples are shown in Figure 1. In the case of the B samples, which have an austenitic matrix, the fraction of the second phase does not vary with the deformation. The appearance of the α' martensite phase at room temperature is not normally observed at the strain levels used in AISI 316 steels [39]. However, it is observed that, when subjected to cyclical deformations [40,41], this observation sustains the conclusion that the only phase that meets the observations, within the experimental conditions used here, was the ferrite (δ) phase that is formed during the solidification of the ingot [42]. This was also described by Nebel and Eifler, with a AISI 321 steel dowel in a fatigue study [31]. Hence, the small variation may be attributed to heterogeneity of the original sheet.

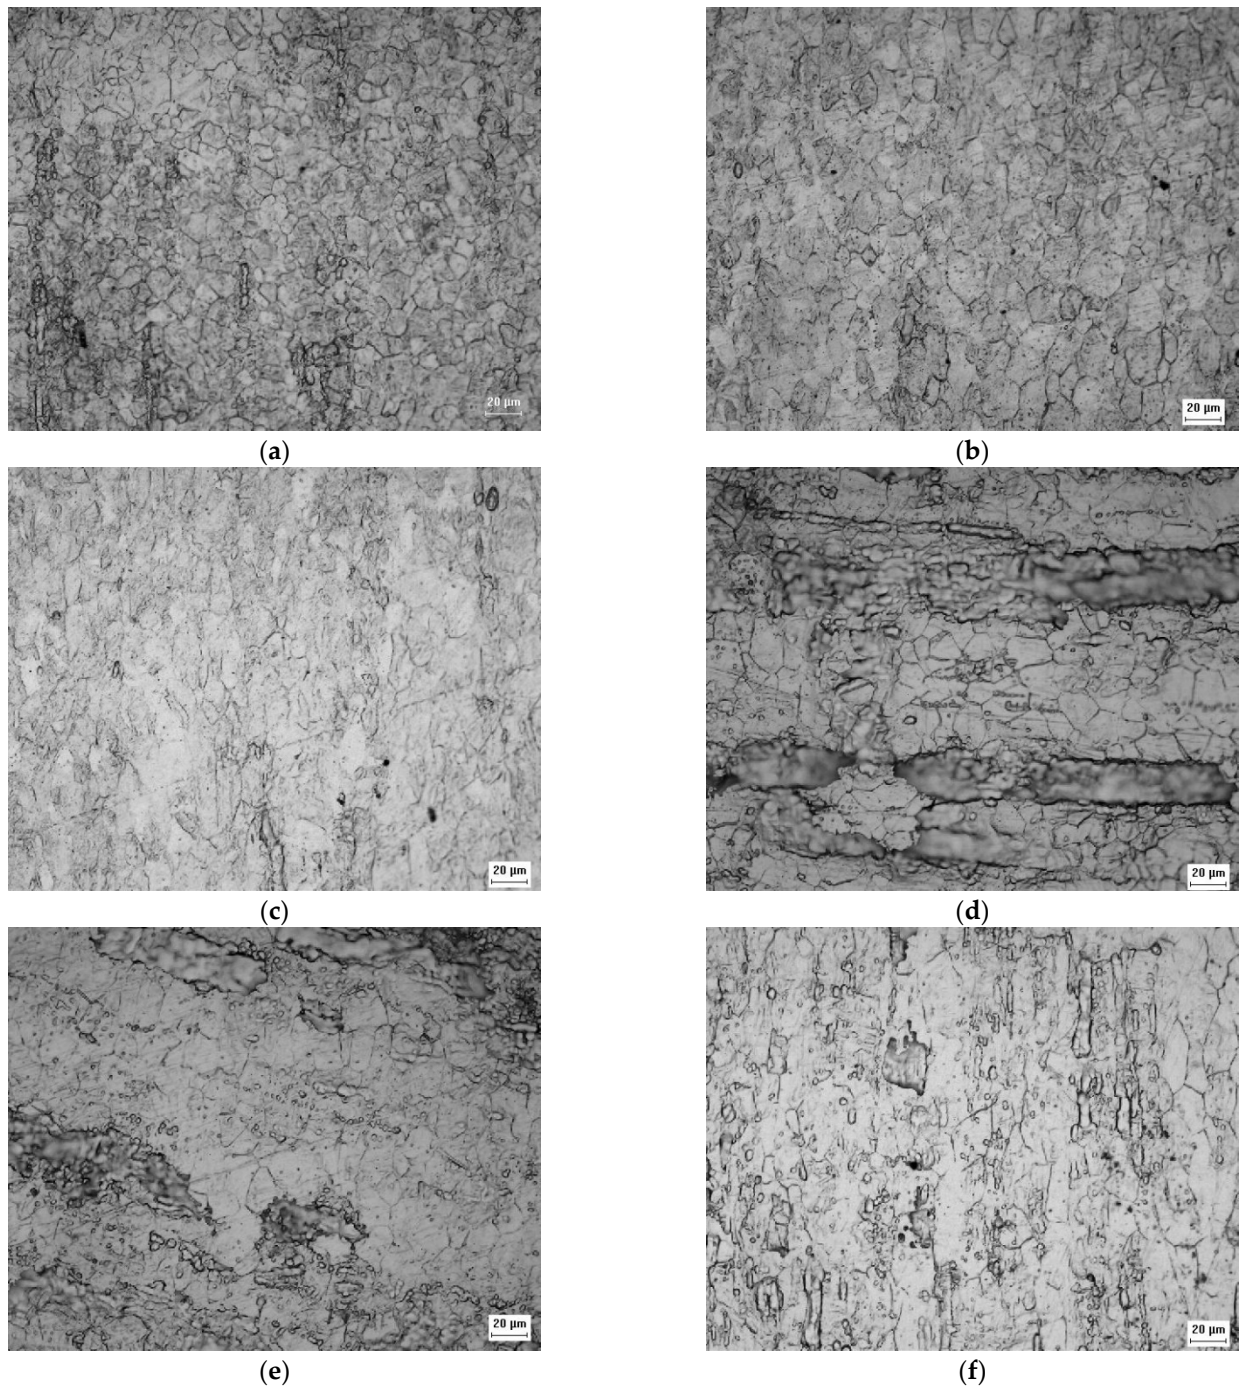
Figure 2. Micrograph of the A0 (a), A1 (b), A2 (c), B0 (d), B1 (e), and B2 (f) samples acquired by optical microscopy with $\times 500$ magnification showing the appearance of austenitic grains after electrolytic attack.

Figure 2 show the appearance of the austenitic grains obtained under the studied conditions. The grain size (GS) of the initial A0 and B0 samples (Figure 2a,d) were equal

to $14.75 \pm 0.74 \mu\text{m}$ (ASTM No. 8.7 grain) and $24.75 \pm 1.24 \mu\text{m}$ (ASTM grain n° 7.3), respectively, but the imposition of deformation caused the hardening of the grains and the change of their aspect ratios, as observed in Figure 2b,c,e,f.

causing greater distinction between the α' and γ phases presented in the other samples. The deformation caused grain hardening in the studied steel (Figure 2f), affecting its mechanical properties by increasing its resistance, flow stress, hardness, and fragility, and by reducing its malleability, ductility, and resistance to corrosion [45].

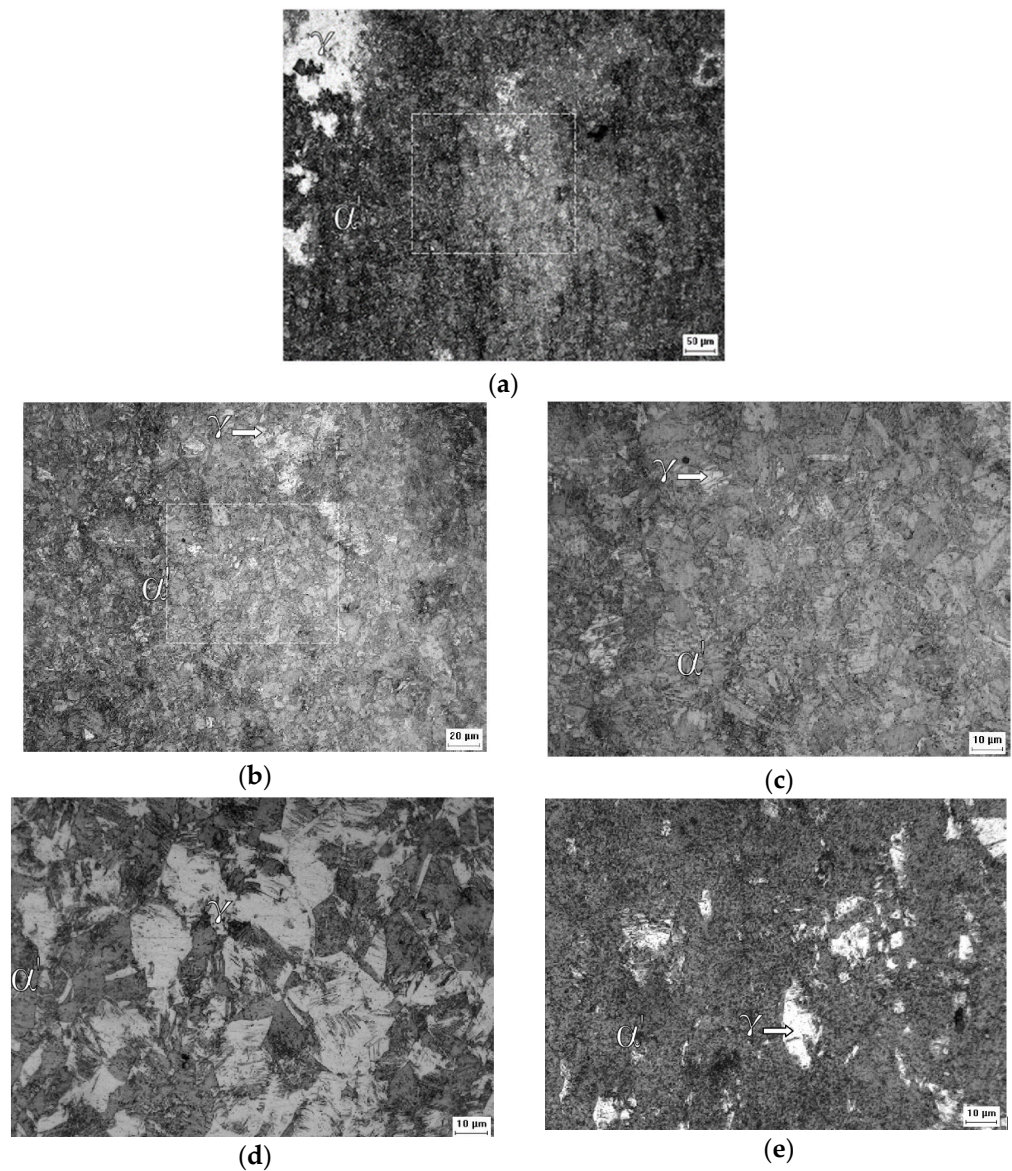
Figure 3. Micrographs of the A0 sample at $\times 200$ (a), $\times 500$ (b), and $\times 1000$ (c), and of the A1 sample at $\times 1000$ (d) and of the A2 sample at $\times 1000$ (e) magnification after the Behara's reagent attack.

Figure 3 corresponds to the initial condition of the AISI 301L steel, and the γ and α' phases can be seen; the optical microscopic analysis indicated that the distribution of the γ phase is irregular. A superior magnification confirmed that the phases are really intertwined and that the α' phase is in the form of plaques, appearing in higher proportions than the γ phase.

Figure 3 shows a higher proportion of martensite (α') than austenite (γ) in the A0 sample, which increased with the increasing of the rolling reduction. Contrary to what was observed in XRD, the VF measurements by image analysis led to different results, proportional to the chosen microscopic magnification, see Table 6 [43]. For the 301LN steel, the imposition of deformation caused a reduction in the aggregation of the grains,

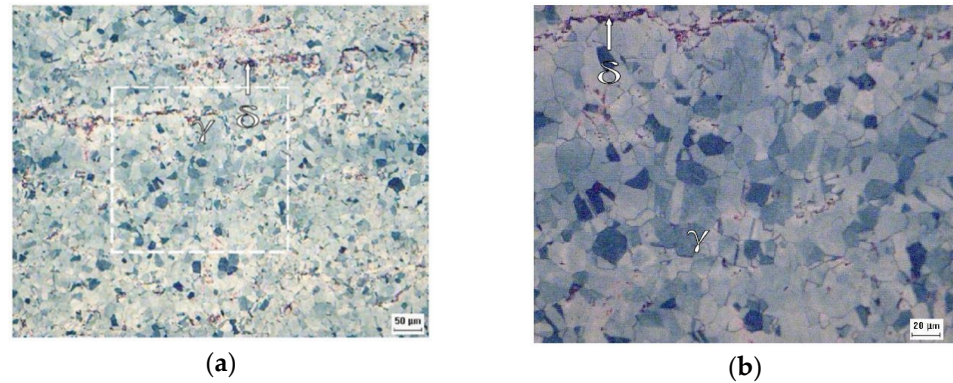
Figure 4. Micrographs obtained by optical microscopy of the B0 sample at $\times 200$ (a) and $\times 500$ (b) of magnification after the Behara's reagent attack.

Figure 4 confirms that the 316L steel plate was in the normalized condition with recrystallized austenitic grains. It is possible to perceive the presence of a second phase, i.e., the δ ferrite phase, according to the XRD analysis.

Comparison between Figures 5a–c and 4 suggests that the volumetric fraction of the delta ferrite phase did not change from the B0 sample to the B1 sample, as expected and indicated by the XRD analysis.

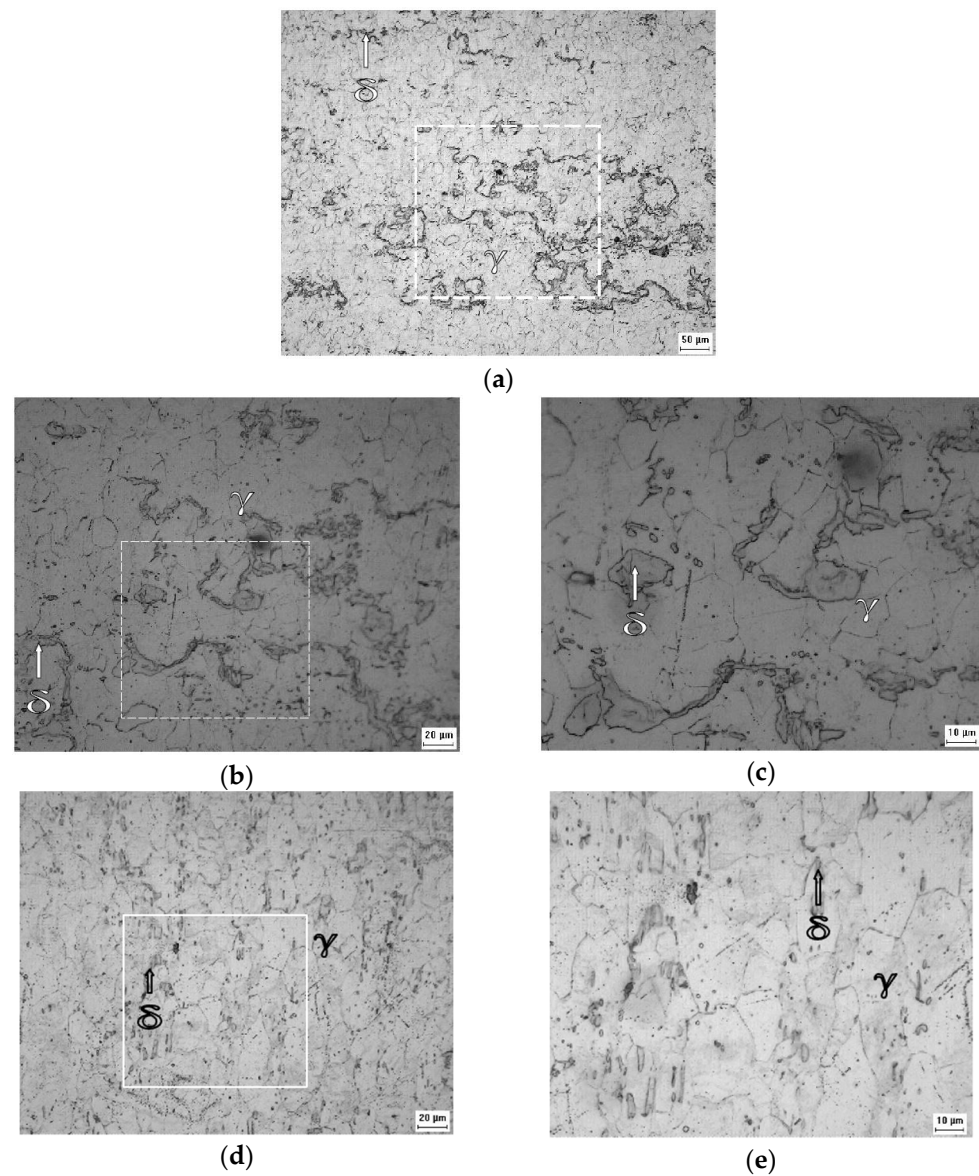
Figure 5. Micrographs obtained by optical microscopy of the B1 sample at $\times 200$ (a), $\times 500$ (b), $\times 1000$ (c), and of the B2 sample at $\times 500$ (d) and $\times 1000$ (e) of magnification after the Vilella's reagent attack.

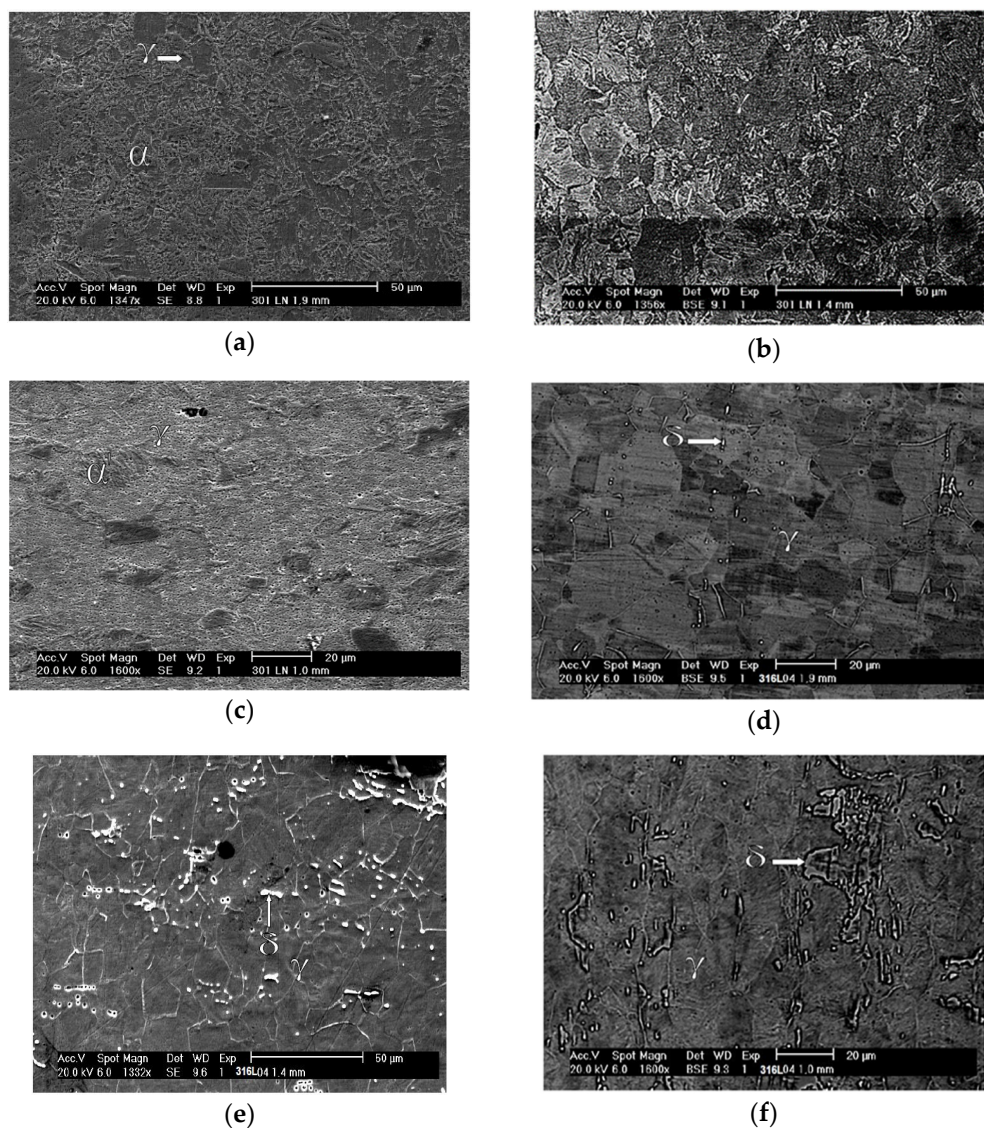
Figure 6. SEM micrographs of the studied samples: A0 with secondary electrons at a magnification of $\times 1347$ (a), A1 with backscattered electrons at a magnification of $\times 1356$ (b), A2 with secondary electrons at a magnification of $\times 1600$ (c), B0 with backscattered electrons at a magnification of $\times 1600$ (d), B1 with secondary electrons at a magnification of $\times 1332$, and (e) B2 with backscattered electrons at a magnification of $\times 1600$ (f).

The morphology of the α' phase of the A0 sample can be seen in detail in Figure 6a. This phase is in the form of interconnected plates and needles, interspersed with the γ phase, and has a smooth appearance. Above the γ phase is the α' phase, which confirms that it is martensite. This transformation implies shearing that causes superficial alleviation [46]. Figure 6b shows fragmentation of the interconnected plate network of the A1 sample, where the γ regions are better distributed and more visible. The porous aspect of the γ phase suggests an increase in deformation that increases the concentration of dislocations and causes pitting corrosion due to a successful chemical attack. In Figure 6c, which is of the A2 sample, it is difficult to distinguish the γ phase, and only a few more fragmented α' plates still stand out from the background full of pits. Figure 6d allows one to reiterate the statement about the initial state of the normalized structure for austenitic grains of the 316L steel. The ferrite (δ) phase has a certain dispersion and, a priori, is oriented according to the direction of the original lamination of the sheet.

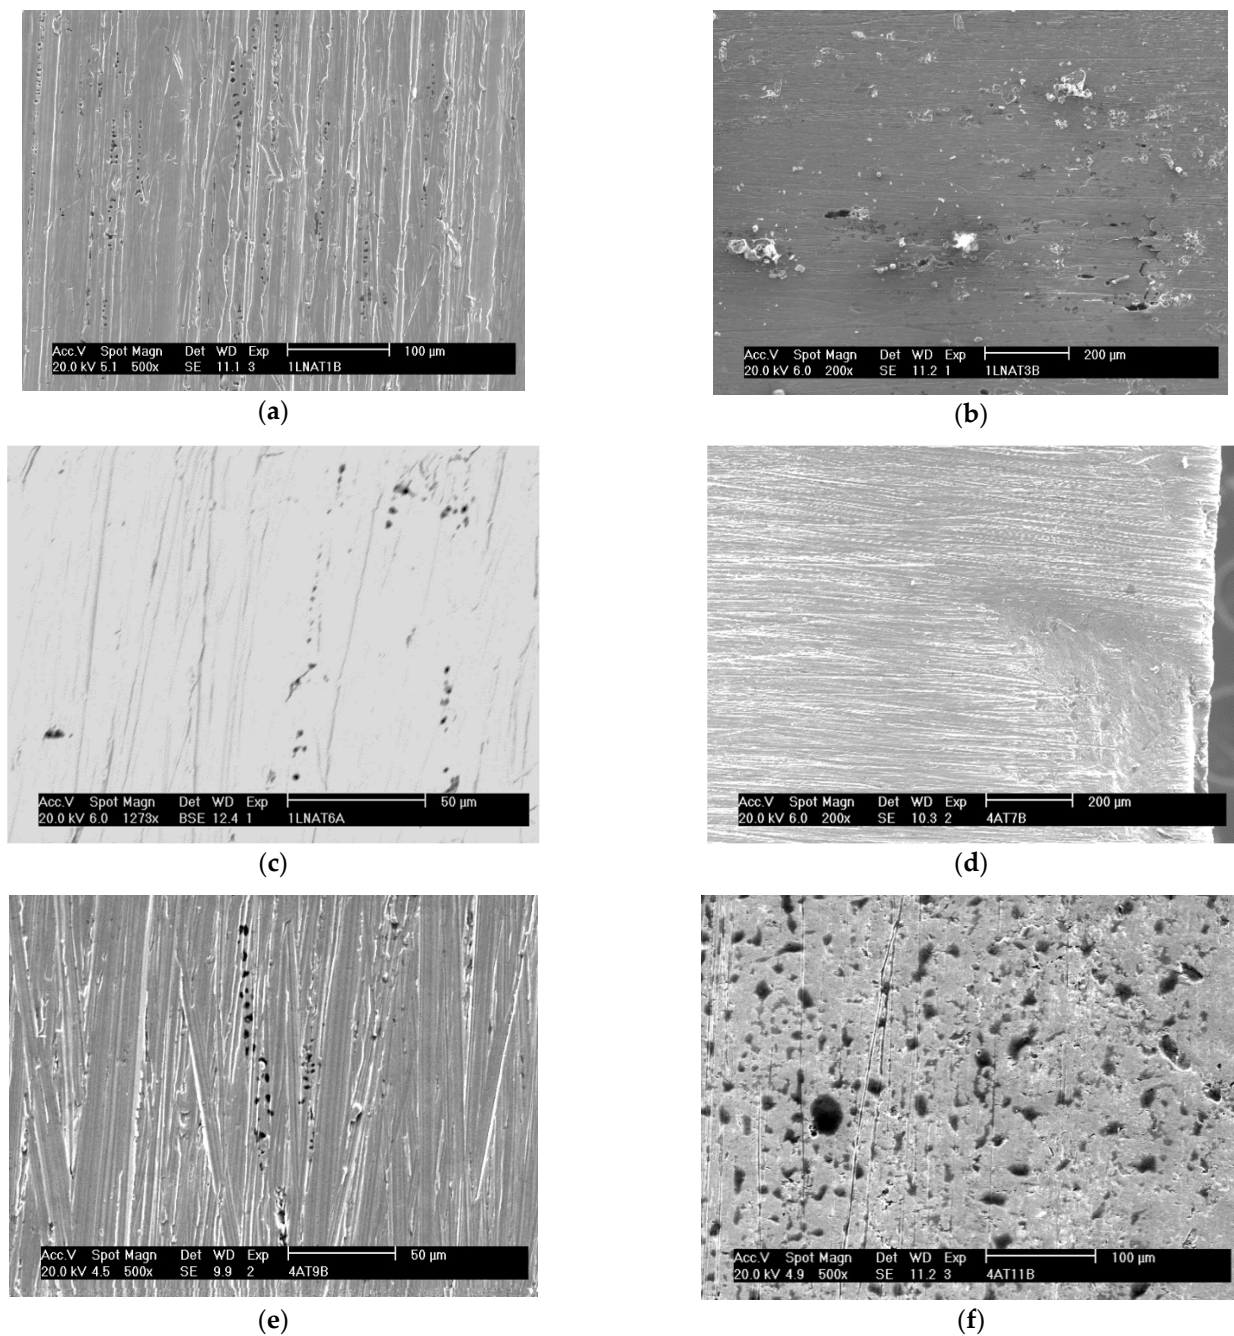
Figure 7. Appearance of the pits obtained by SEM after the corrosion test for the samples: A0 with secondary electrons at a magnification of $\times 500$ (a), A1 with secondary electrons at a magnification of $\times 200$ (b), A2 with backscattered electrons at a magnification of $\times 1273$ (c), B0 with secondary electrons at a magnification of $\times 200$ (d), B1 with secondary electrons at a magnification of $\times 500$ (e), and B2 with secondary electrons at a magnification of $\times 500$ (f).

Figure 7 shows the appearance of the pits obtained by SEM after each sample under study was submitted to the corrosion test. The proportionality between the amount of pitting corrosion and the deformation suffered by both steels can be seen in this figure, and one can conclude that the greater the deformation, the greater the number of pits.

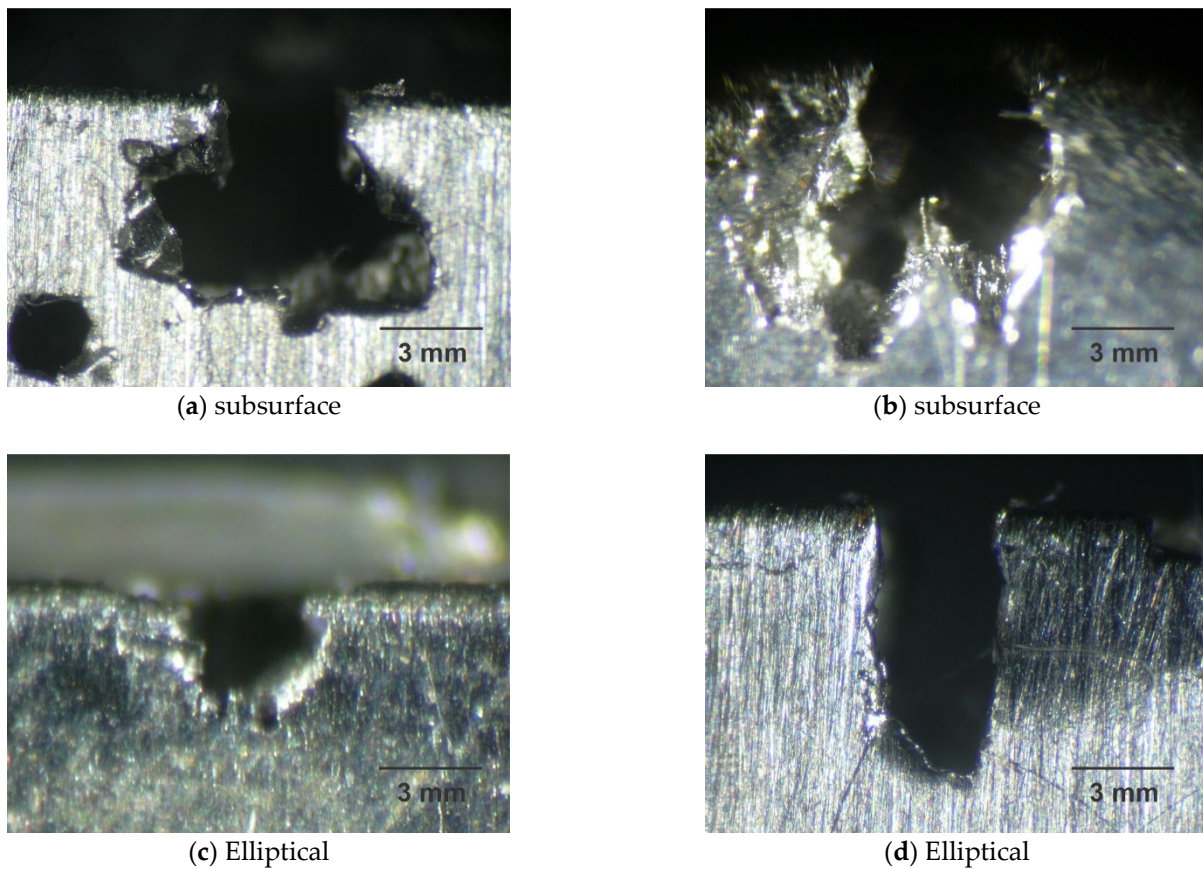
Figure 8. Shape of pit by micrographs obtained by optical microscopy for the samples A0 (a), A1 (b), B0 (c), and B1 (d), with magnification of $\times 25$ after corrosion test.

Figure 8 shows various cavity shapes after pitting corrosion, which are disc, conical, or hemispherical shapes for many steels and their alloys, according to Roberge [47].

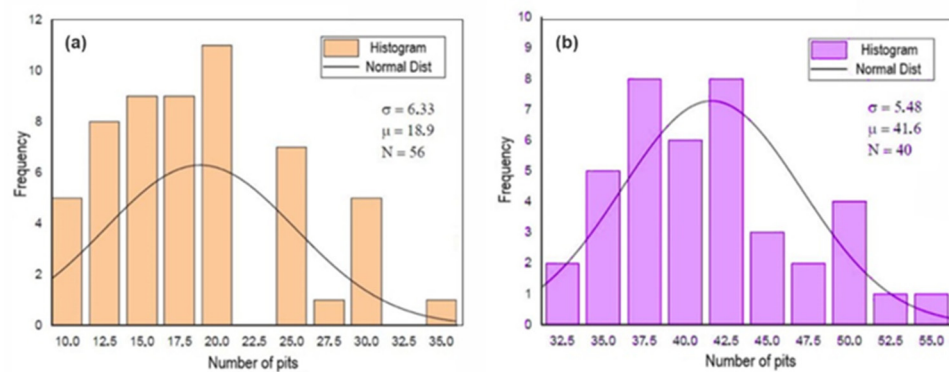
Figure 9. Histogram of the number of pits per analyzed area after the corrosion test for the A0 (a) and B0 (b) samples.

Figures 9–11 show the histograms of the number of pits per observed areas for all studied samples. In these figures, N represents the number of areas evaluated per sample, σ is the standard deviation and μ is the mean. These figures show that the distribution of the number of pits per area in the A0 and A1 samples is close to a normal distribution. However, for the A2 sample, there is a trend towards uniformity. For the 301LN steel, there is an apparent presence of martensite with the occurrence of the texture due to the cold deformation and the fact that pitting corrosion depends on local conditions for its formation; these features caused this normal distribution.

In Figure 9, the initial B0 sample is the one that presents the best performance, in terms of pitting corrosion, due to the fact that the smallest number of defects means that the formation of pits is restricted to the statistical distribution of the pit-generating factors [48].

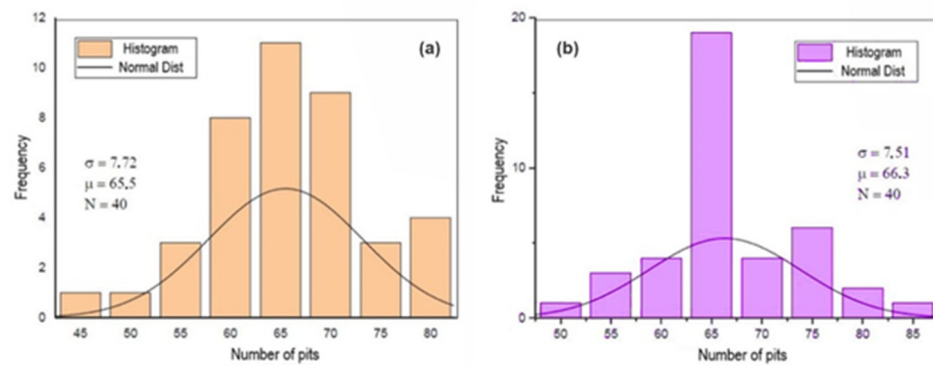
Figure 10. Histogram of the number of pits per analyzed area after the corrosion test for the A1 (a) and B1 (b) samples.

The increase in the level of deformation in the B0 sample changed the pitting corrosion performance and caused the occurrence of regions with a higher concentration of dislocations, dislocations stacking failure, and forests of dislocations [49,50]. There is a greater probability that the nucleation and growth of pits occurred in these regions, which shifts the statistical trend towards a non-Gaussian distribution, as shown in Figures 10 and 11.

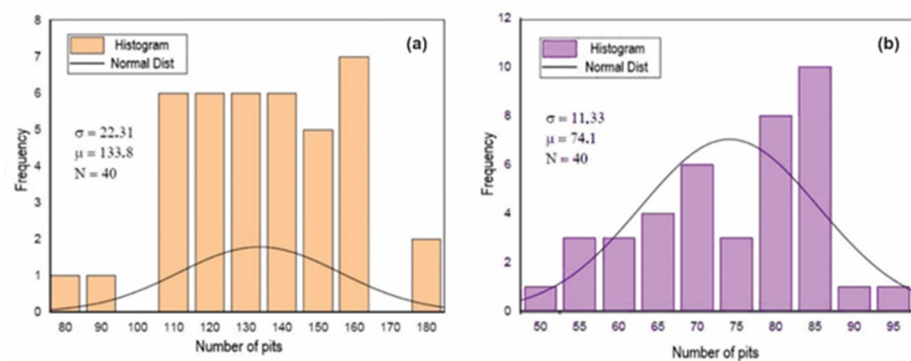
Figure 11. Histogram of the number of pits per analyzed area after the corrosion test for the A2 (a) and B2 (b) samples.

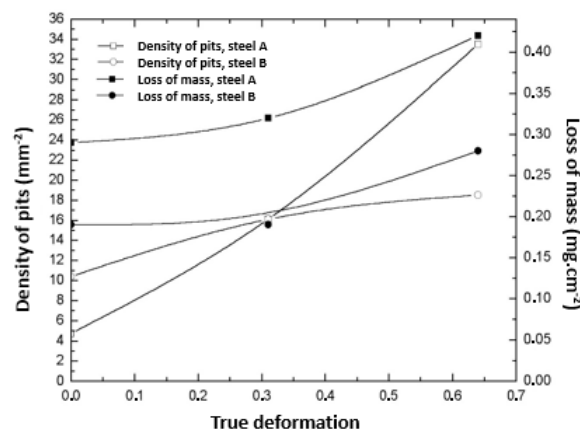
Figure 12. Relationship between the pit density, loss of mass, and deformation for all studied samples.

There is a similarity in the trends of the pit density and mass loss. For both steels, an increase in deformation caused the introduction of defects in the material, which are preferred regions for the occurrence of pitting [51]. The increase in the percentage of pits with the deformation corresponded to an increase in mass loss, as can be seen in Figure 12.
