Preserving Medieval Farm Mounds in a Large Stormwater Retention Area

MICHEL VORENHOUT

The Netherlands has denoted large areas as stormwater retention areas. These areas function as temporary storage locations for stormwater when rivers cannot cope with the amount of water. A large area, the Onlanden — 2,500 hectares — was developed as such a storage area between 2008 and 2013. This peat area contains up to 300 medieval housing areas. These ‘peatmounds’, named after the current visible small mound, were explicitly mentioned as a preservation goal in the project. The preservation of the peatmounds during and after the project has been guaranteed by a combination of protective measures, research, and monitoring actions. At first a risk evaluation was performed, followed by a monitoring project focusing on the preservation of the organic part of the mounds. This evaluation showed that the rewetting of the mounds might improve the overall preservation. A total of fifteen monitoring stations were a-selectively distributed over the total area, covering the four main types of land use. The measured parameters at these stations focus on the desiccation/rewetting effects. The second threat

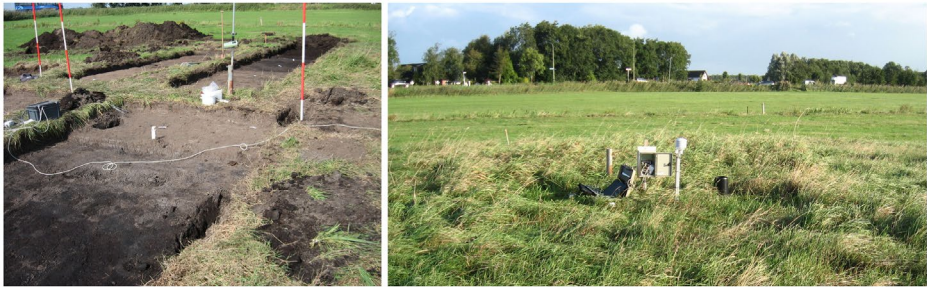
FIGURE 2 Excavation of mound 5 (left) and the monitoring equipped used (right).

Then, the risks were appointed to each peatmound, creating a background database with local risks and threats. The peatmounds were ranked according to their location in the three general groundwater levels: (1) high water/wet conditions, (2) alternating near archaeological level, and (3) less dry/similar level (Table 2). The third criterion was the archaeological information value, as often used in Dutch archaeological valuations by archaeologists (Table 3). As an extra step, a test monitoring setup was installed in peatmound 5, which was excavated in September 2009 (Figure 2).

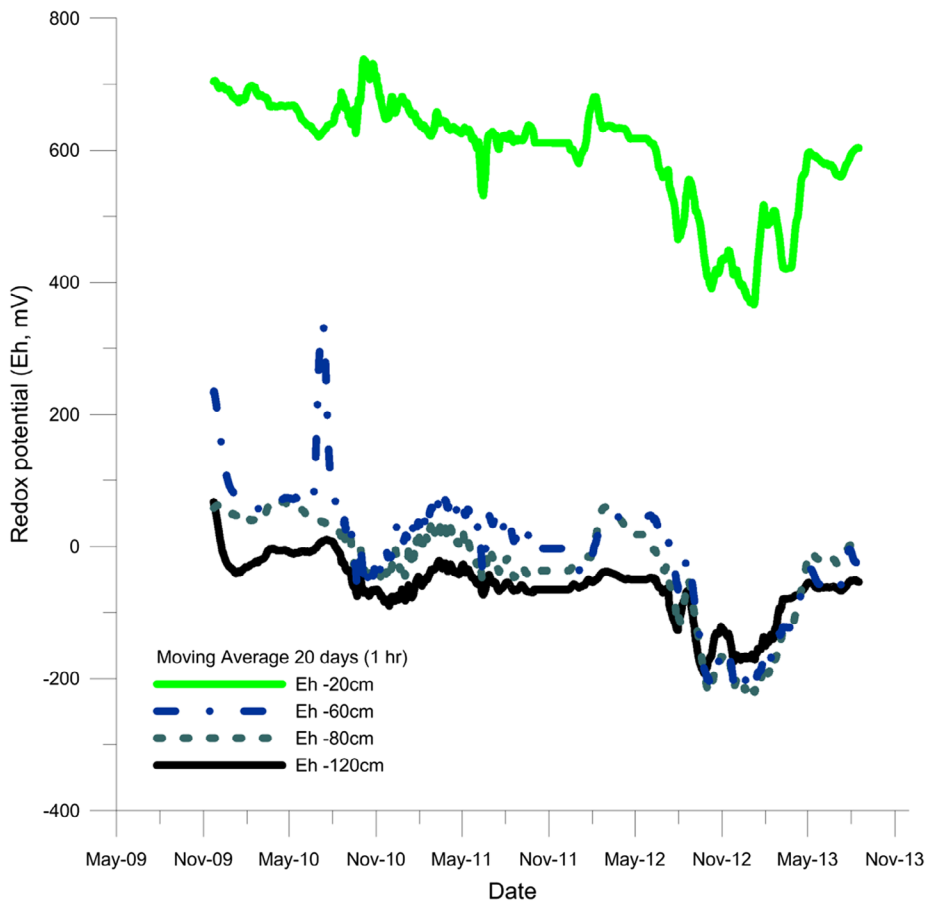
FIGURE 3 Redox potential (Eh) throughout several years in peatmound 84-54.

Looking at one peatmound in particular, 84-54 in the Western National listed Monument, a small but clear effect of the rewetting can be seen. The redox potential in the peatmound, shown in Figure 3, decreased at all measured depths during the first wet winter of 2012-13, and came back to a lower level in summer 2013 than in the other summers. The level at -60 cm is also less variable. The Eh at all but -20 cm from surface are at reduced levels (<0 mV).

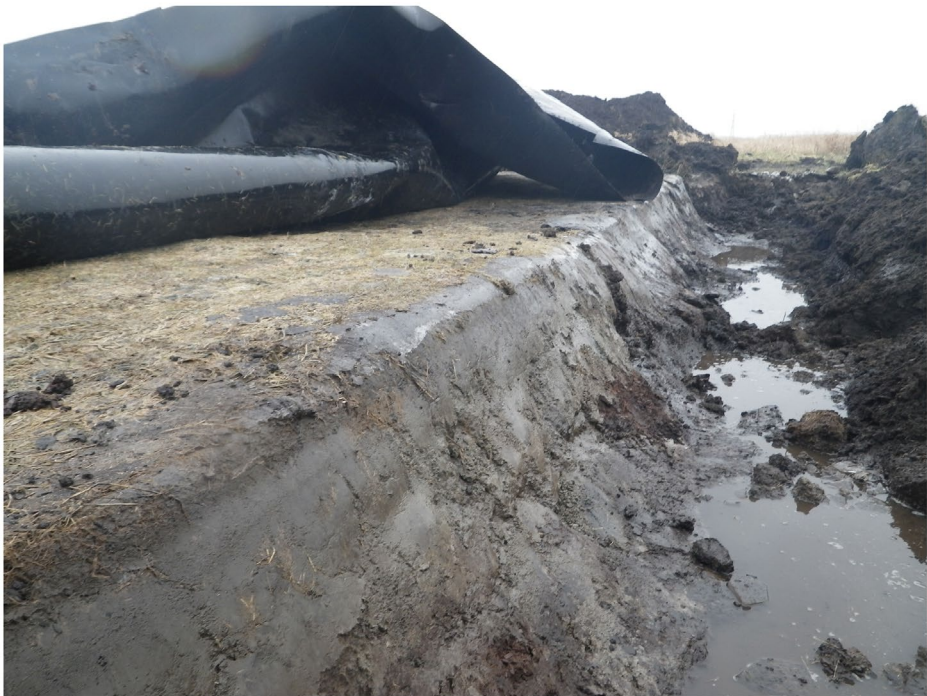
FIGURE 4 Compressed soil after removal of plastic cover and earthen load in February 2011.

One of the threats to the archaeological value in the peatmounds that was perceived to be of high risk was the future deep rooting of plant species such as common reed (*Phragmites* spp.). These wetland species are known for their high density of roots. As the groundwater table will rise, the peatmounds will act as higher and drier areas, favouring the growth of these species, and thus increasing the risk of root ingrowth. One solution that was proposed was the use of a thick membrane (high density polyethylene, HDPE) to cover the complete mound. This membrane is a 2 mm thick industrial plastic, used in managing waste dumps (Müller, 2007). These covers are guaranteed to be root resistant for fifty years by the supplier, but only if they are protected from UV light/sunlight and larger temperature fluctuations. Therefore, a cover layer of soil on top of this plastic is required. The additional pressure caused by this soil column can however cause a sinking of the farm mound into the soft peat soil below. The risks coming from this protective measure were discussed, and an experimental setup was designed to study the effects for a year. An area of 18 × 18 m was covered in the winter of 2010; the experiment lasted till February 2011 (Figure 4). Redox potential, temperature, and pressure were measured

under the cover, and absolute levelling of the plastic cover was performed using settlement plates (See <http://www.dot.state.mn.us/materials/manuals/geotechnical/Appendix%20G%20Installing%20and%20use%20of%20Settlement%20Plates.pdf>). Results (Houthuesen, 2011; Vorenhout, 2008a) showed a steady and reduced soil environment under the cover (Figure 5). Settling was measured, but analysis indicated that only local compression in a vertical direction occurred. The settling was evenly distributed in the horizontal plane (details and discussion in Houthuesen, 2011). Therefore the deformation of the archaeology would be rather minimal: the readability of the profile will still be sufficient as all layers will still be present. The translocation of larger artefacts from one stratum to another will however occur. Items such as bricks will be compressed less than the softer soil surrounding them, and thus be moved upwards. This problem is however a limited problem, as most artefacts found in the test pits were relatively small (data in Nikolay, *in prep.*).

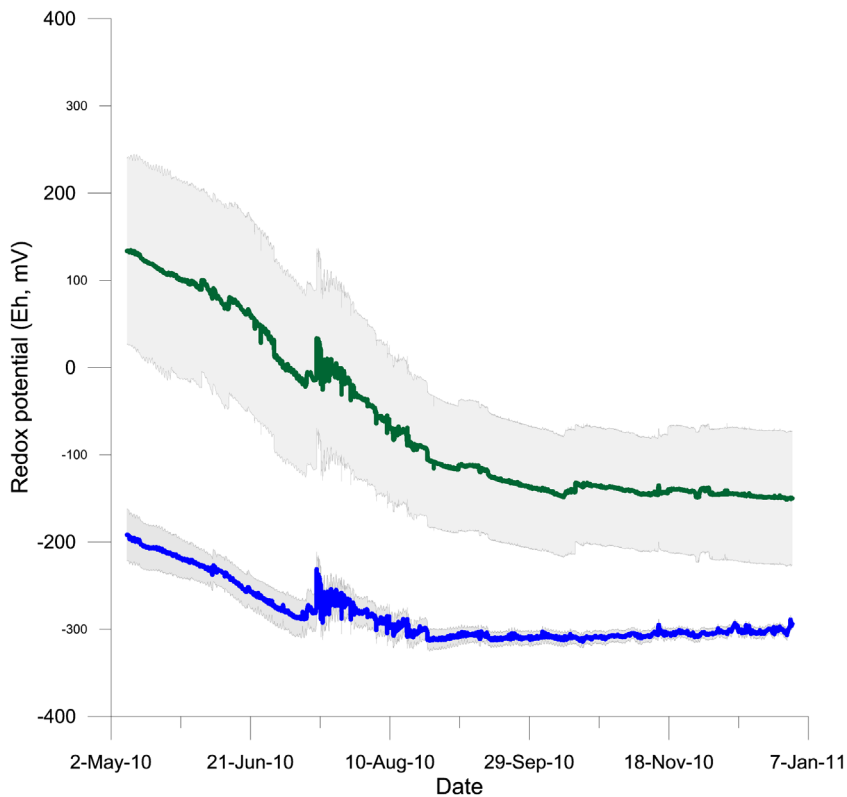
FIGURE 5 Average redox potential ($n = 12$) measured at 5 cm (top, green) and 12 cm (lower line, blue) below surface, with standard deviation in time.

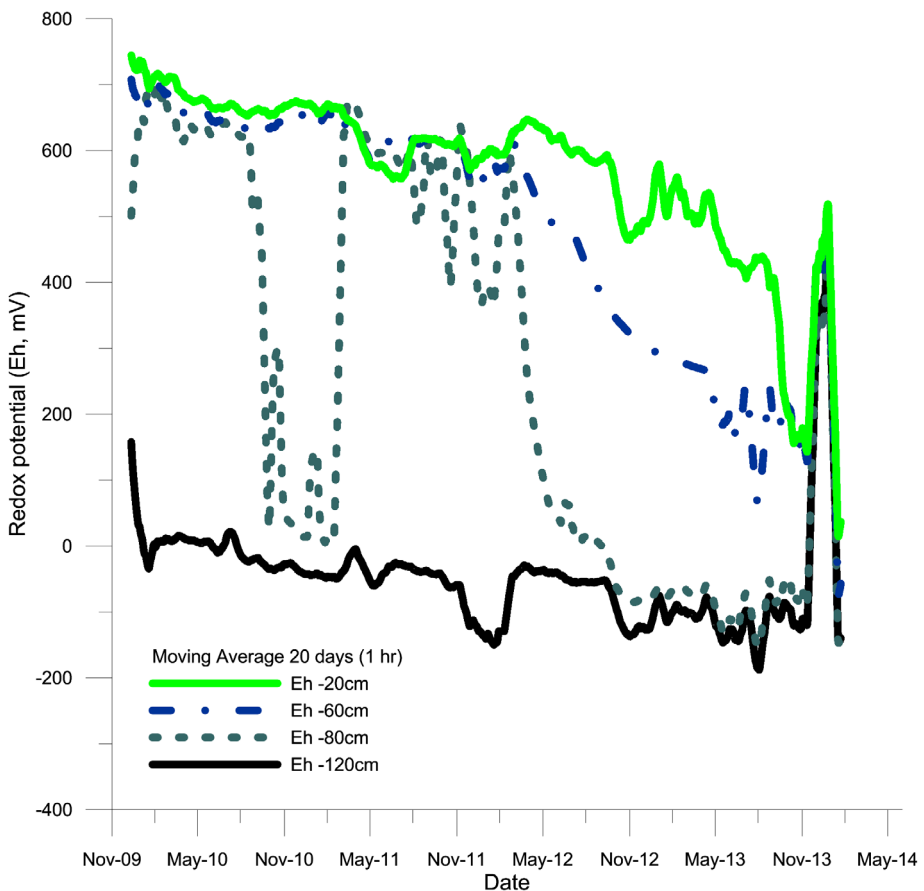
FIGURE 6 Redox potential in a peatmound 19. This mound was covered with plastic and earthen load in 2012.

Given the cost of this cover method, only a selection of eight peatmounds could be covered (Houthuesen, 2013). An additional advantage to the selection was that there was no single method of mitigation chosen, spreading the risk on the long term. The effects on redox potential in peatmound 19 (covered in spring 2012) are similar to the effects in the experimental setup: decreased Eh in time starting after coverage, and somewhat reduced variability of Eh (Figure 6). The spike at December 2013 is probably caused by temporary reference probe failure.
