# Durability of Concrete Protected by an Acrylic Painting

**ABSTRACT:** The fast degradation of concrete is a problem that occurs in some structures. In order to have less degradation, the use of protection systems could be recommended. Acrylic paintings have properties that make possible its use as a protection material of concrete. In our study, one concrete that could be classified as a C33/43, was protected with two coats of an acrylic painting. The durability of the protected concrete was studied. Tests made were: capillarity absorption, oxygen permeability, sulphates attack and freeze-thaw. The results show in general, that the degradation of the protected concrete is lower than the degradation of non protected concrete. For the absorption of water by capillarity the non protected specimens absorbed about three times more water than the protected specimens. The oxygen permeability of the protected specimens was about half of that of the non protected specimens. The results of the tests did not show any increase on the resistance of the concrete to the sulphate attack by the use of an acrylic painting. The non protected specimens presented degradation on the freeze-thaw tests

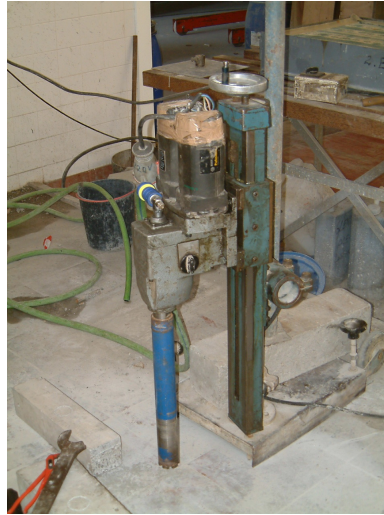
Figure 1 Drilling machine.

capillarity. For the freeze-thaw attack and for the sulphates attack cubic specimens of 100x100x100 mm, were made. For the oxygen permeability a slab with 400x800x50 mm, was made. After, the specimens for this test were cut with a drilling machine (Figure 1). These specimens were a diameter of 50 mm and an height of 40 mm.

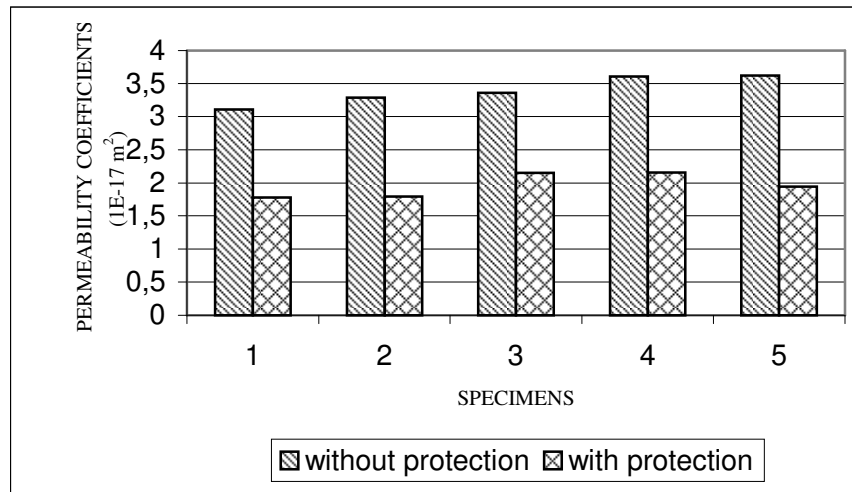
Figure 6 Oxygen permeability coefficients for the specimens without and with protection.

Figure 6 presents the oxygen permeability coefficients of the specimens without and with acrylic painting. For the concrete without protection the average of oxygen permeability

coefficient was  $3,395 \times 10^{-17} \text{ m}^2$ . With the protection the same coefficient decreased to  $1,963 \times 10^{-17} \text{ m}^2$ . The protection of a concrete with an acrylic painting decreased the oxygen permeability of this concrete of about 42 %.

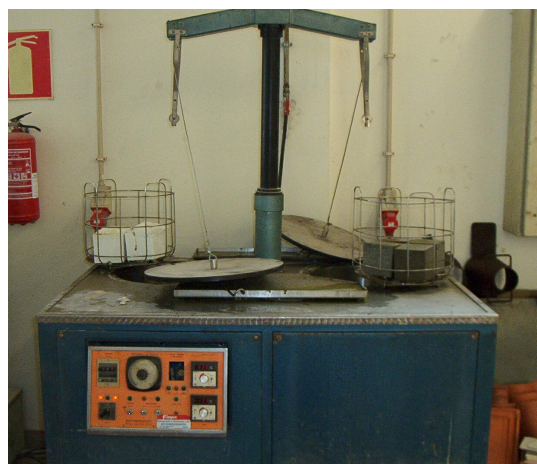
Figure 8 Apparatus for the freeze-thaw tests.

The freeze-thaw tests were made following the ASTM standard [11] with some adaptations. The tests consists on submit eight specimens (four without protection and four with protection with acrylic painting) to two hours cycles with positive temperature inside water (20°C) on the first hour and negative temperature (-17.7°C) on the second hour. Figure 7 represents the schema of the freeze-thaw cycles. The specimens were placed on the freeze-thaw apparatus (Figures 8 and 9). Every 72 hours the specimens were removed to the apparatus and were weight and observed. A total of 300 cycles were made.

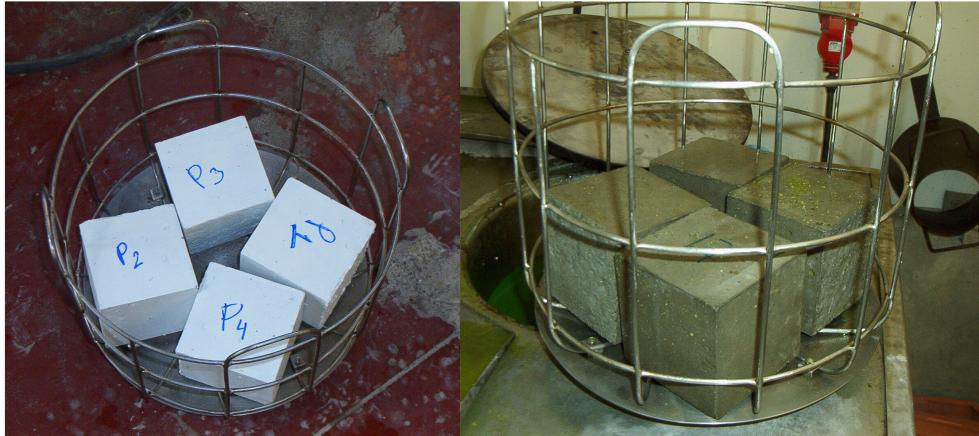
Figure 9 Specimens on the apparatus before the test.
