STRUCTURAL FAULTS + REPAIR – 2006

11th International Conference and Exhibition

RADAR INVESTIGATION ON CIVIL STRUCTURES USING 3D DATA RECONSTRUCTION AND TRANSMISSION TOMOGRAPHY

Lukasz Topczewski, Francisco Fernandes, Paulo J.S. Cruz, Paulo B. Lourenço, Luís F. Ramos
University of Minho
Department of Civil Engineering
4800-058 Guimarães
Portugal
lukasz@civil.uminho.pt

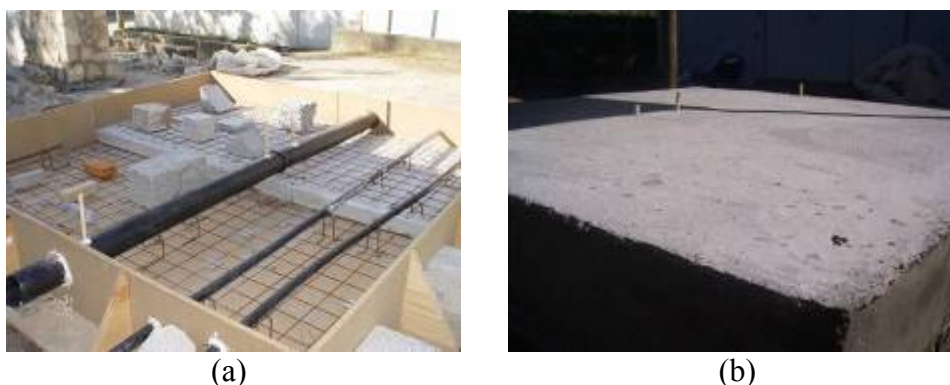
Fig. 1 General view of the concrete specimen. (a) Overview of the features and objects placed inside the specimen and (b) final view of the slab

A concrete specimen has been specially designed and built for this testing campaign in April 2004 aims to simulate a small part of a typical concrete bridge deck. It is a square with dimensions of 250×250 cm and a thickness of 32 cm. The elements that were placed inside were chosen among typical elements used in the construction of structural elements in reinforced and pre-stressed concrete bridge decks. A number of typical defects and anomalies that may occur deriving from errors during the construction were put in the specimen as well. A general view of the features inside the slab before being filled with concrete is illustrated in Fig. 1a, while a general view of the final specimen is illustrated in Fig. 1b.

Inside the slab were placed three tendon ducts in PVC, one with 110 mm and the other two with 35 mm of diameter. The larger tendon duct is generally used for the introduction of post-tensioning cables, while the two smaller tendon ducts are simulating simple mono-cables, one in straight line and the other with a curved path. The objective is to detect all tubes by radar and to verify if all tubes are correctly detected,

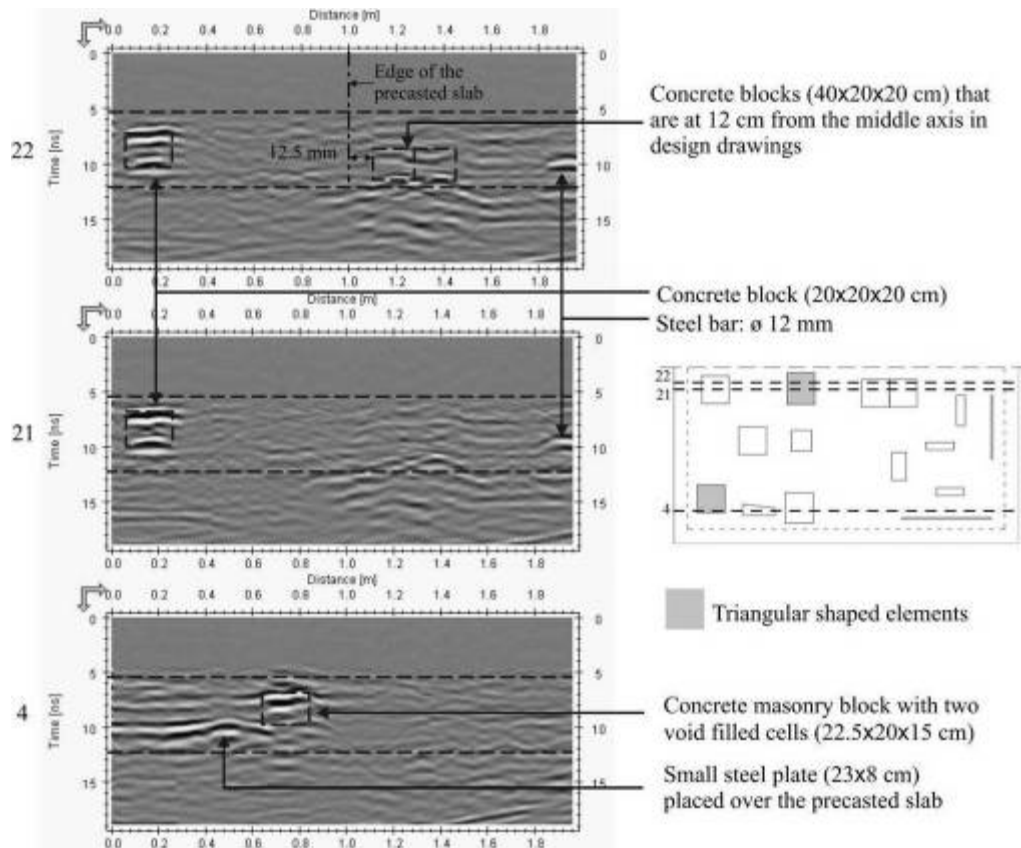
Fig. 5 2D profiles of the 22nd, 21st and 4th acquisition lines, respectively, from top to bottom.

In Fig. 5 are shown additional profiles from where it is clear that poorly vibrated concrete and voided elements were successfully detected, as well as the metallic bar. From the radargrams below, the length of the concrete elements were acquired with rather satisfactory accuracy (the dashed boxes correspond to the dimensions of those elements). The height computed with the velocity of 9.2 cm/ns resulted in lower values than the real ones, which seem to suggest that the velocity within these concrete elements is slightly higher than in the rest of the whole specimen (radiowaves in porous concrete have a higher velocity than in full concrete). The position of objects is also rather accurate according to the location of two concrete blocks in the 22nd profile, relatively to the center axis. The radargram reported 12.5 cm, while it was located at 12 cm (relatively to design plans). However, one element in each of the profiles from lines 4 and 22 was not detected. It must be noted that these elements have a triangular shape (see Fig. 1a) and that the incident waves in such surfaces are scattered in a direction far from the receiver position. Thus, they are very difficult to detect.

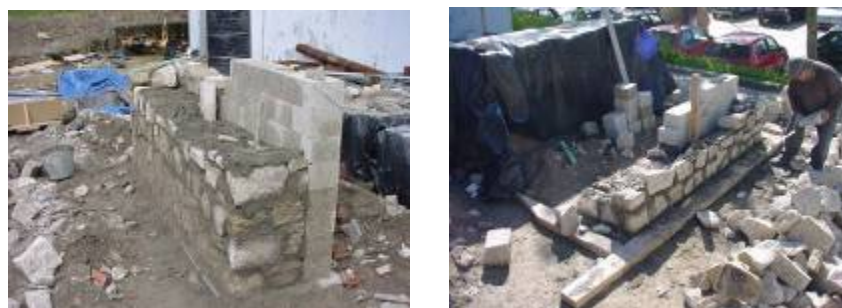
Fig. 11 View of the embedded objects. (a) Polystyrene prism. (b) Wood beam.

Moreover, for *Wall 1*, the infill was constituted by rock and brick fragments, sand, pebbles and clay, in order to simulate an inhomogeneous infill material of low strength. In *Wall 2*, the infill is made of gravel, with 2-3 cm of diameter and almost no cohesion. The objects embedded in the walls have the following dimensions: high density polystyrene prism: 9.5×8×40 cm (Fig. 11c), wood beam: 6.5×6.5×100 cm (Fig. 11b). The objectives of the present investigation were to distinguish the different layers and to detect the wood and polystyrene elements placed inside the walls.

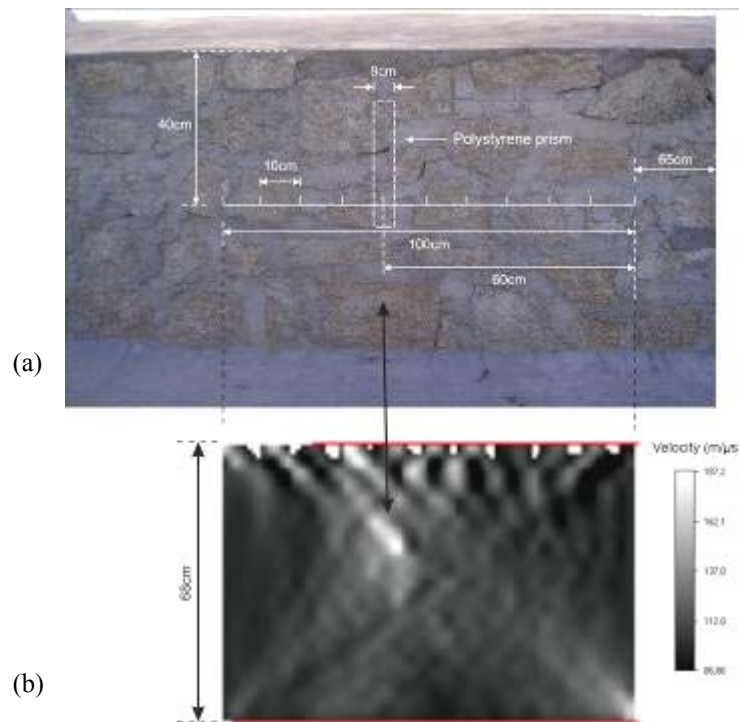
Fig. 14 Tomography in *Wall 1*. (a) Position of the fixed stations for the transmitter antenna and relative position of the polystyrene prism in the grid of measurements. (b) Velocity tomogram.

The final velocity tomogram obtained from the investigation in *Wall 1* is illustrated in Fig. 14. It shows that the major part of the tomogram exhibits an average velocity smaller than 12 cm/ns. The borders of the tomogram are characterized by a substantial number of artefacts and other side effects, which were not taken into consideration. A small area exhibiting a very high velocity, around 18 cm/ns, is located in the centre of the tomogram. Its position corresponds to the position of the polystyrene prism. From the tomogram can be perceived that the speed of propagation of radiowaves within polystyrene is close to the velocity in air (which is why this material is often used for air substitution when simulating air voids inside structures). The area with high velocity radiowaves correspond to an area 19 % smaller than the area of the polystyrene prism.

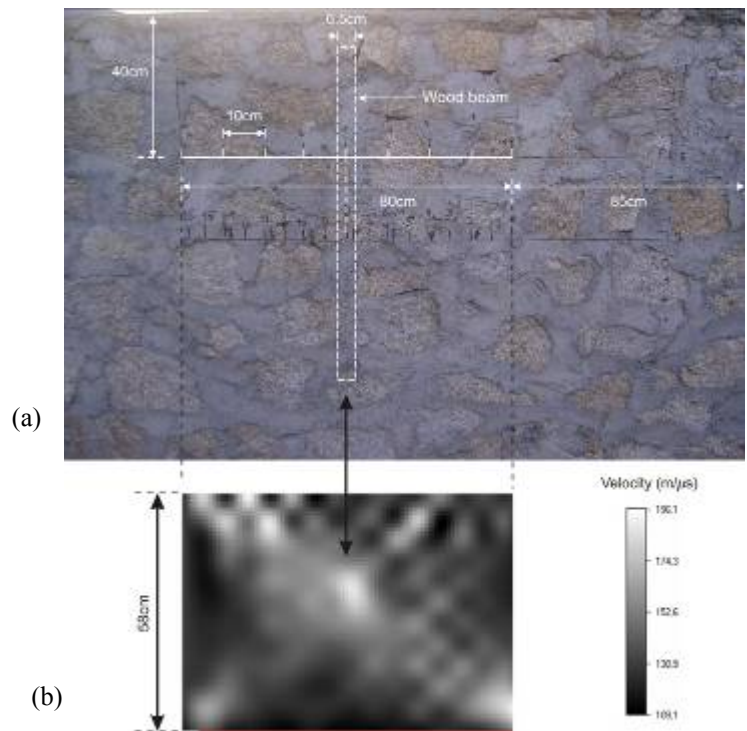
Fig. 15 Tomography in *Wall 2*. (a) Position of the fixed stations for the transmitter antenna and relative position of the polystyrene prism in the grid of measurements. (b) Velocity tomogram.

With respect to *Wall 2* (with the wood beam), the section of interest was located 30 cm below the top of the wall and consisted in an area of $80 \times 58 \text{ cm}^2$ illustrated in Fig. 15. The transmitter was sequentially fixed in nine stations separated by 10 cm, while the receiver was performing nine continuous profiles in the opposite side of the wall. The final velocity tomogram obtained from the investigation in *Wall 2* is illustrated in Fig. 15. The major part of the tomogram exhibits an average velocity around 14 cm/ns. The area that was interpreted as being from the wood beam correspond well to its geometrical location and exhibits a very high velocity, around 19 cm/ns, slightly higher than in polystyrene, which reveals that the radiowave velocity is similar in both materials. However, the borders and interior of the tomogram are characterized by a substantial number of artefacts and other side effects that affect quite severely the quality of the data. In this case, the resolution of the tomogram is much limited due to the reconstruction algorithms used by the software. This problem has already been described by other authors (Valle et al, 1999).

The area of the wood beam cross-section was estimated from both tomograms but results were rather distinct. While in the first case (Fig. 15) the area in the tomogram was 17 % larger than the real area of the
