# Improving the seismic resistance of masonry buildings: Concepts for cultural heritage and recent developments in structural analysis

Paulo B. Lourenço, Daniel V. Oliveira

#### 4 APPLICATION TO MONASTERY OF JERÓNIMOS, LISBON

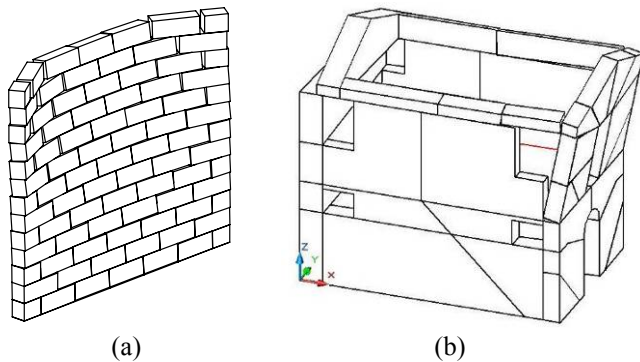
Figure 3. Results for rigid block limit analysis: (a) panel subjected to out-of-plane failure and (b) simplified analysis of a complete building with macro-blocks

results of modeling a shear wall with an initial vertical pre-compression pressure. Figure 3 illustrates results using advanced solution procedures for non-linear optimization problems, with a limit analysis constitutive model that incorporates non-associated flow at the joints and a novel formulation for torsion, Orduña and Lourenço (2005).

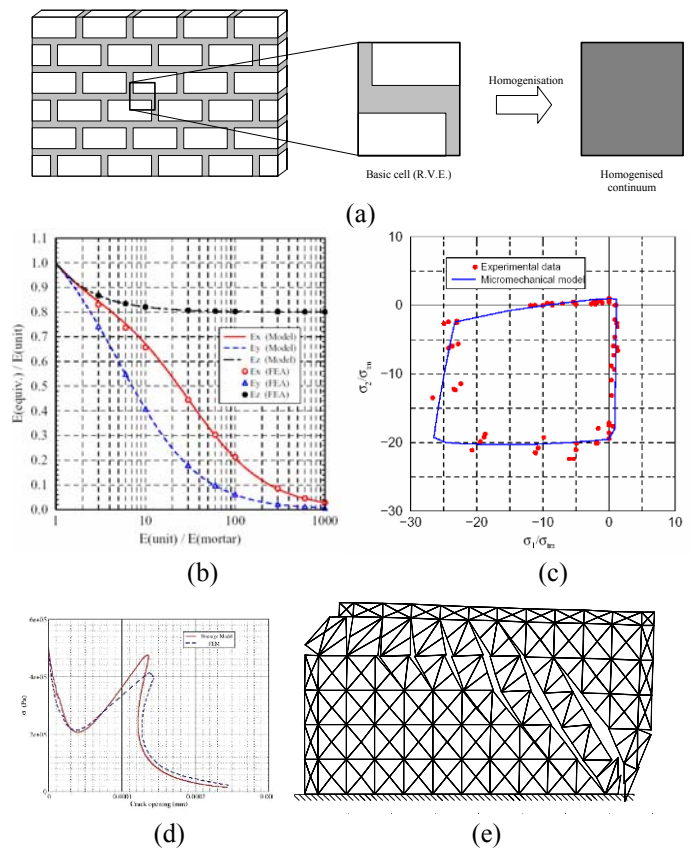
Figure 5. Results for homogenization (macro) analysis: (a) basic cell and process; (b) Young's modulus; (c) failure surface; (d) constitutive behavior in tension; (e) results of shear wall using limit analysis finite elements.

Another approach that is receiving much attention from researchers is the homogenization theory, in which the macro constitutive behavior of masonry is obtained from a mathematical process involving the geometry and the constitutive behavior of the masonry components. Figure 5 illustrates typical results obtained for homogenized failure surfaces and homogenized constitutive behavior, see Zucchini and Lourenço (2002), Zucchini and Lourenço (2004) and Milani et al. (2006).

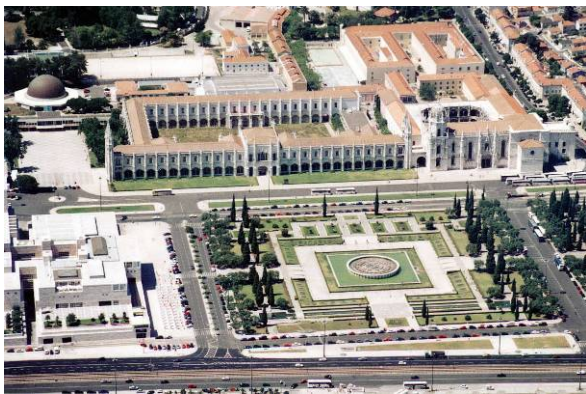
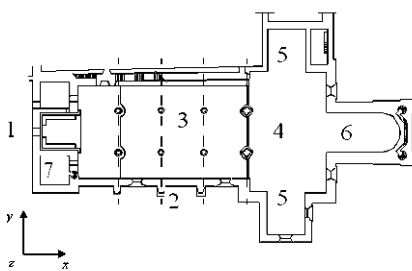
Figure 6. Monastery of Jerónimos: (a) general view; (b) plan (1-axial doorway, 2-lateral doorway, 3-nave, 4-transept, 5-side chapels, 6-chancel; 7-South bell-tower); (c) half of transversal cross-section

Monastery of Jerónimos is, probably, the crown asset of Portuguese architectural heritage dating from the 16<sup>th</sup> century. The monumental compound has considerable dimensions in plan, more than  $300 \times 50 \text{ m}^2$ , and an average height of 20 m (50 m in the towers). The monastery evolves around two courts and is located in the right shore of Tagus river, in Lisbon. The construction started in 1502 and ended in 1604. Its original plan is now missing. It was built in limestone that has been removed mainly from its implantation place. One court is composed by the Church and the cloister of the monastery. The Church has considerable dimensions, namely a length of 70 m, a width of 23 m (main nave) and 40 m (transept) and a height of 24 m. The plan includes a single bell tower (South side), a single nave, a transept, the chancel and two lateral chapels, see Figure 6.

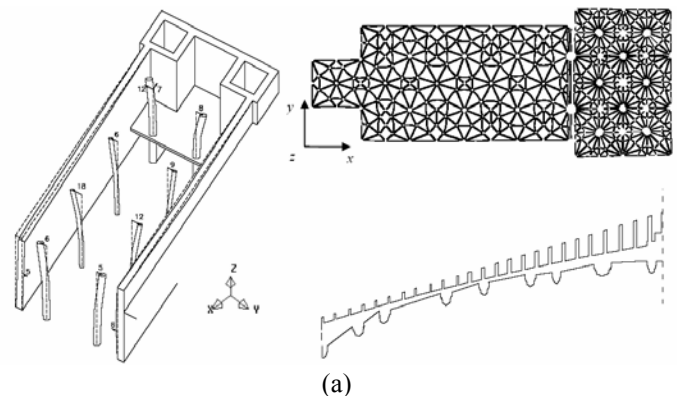
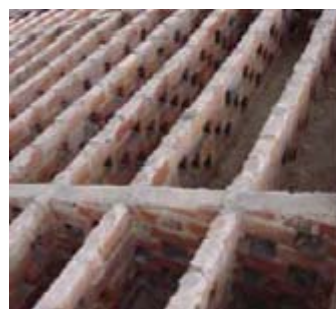
Figure 7. Geometry and survey of the nave: (a) survey of the columns and external walls, together with vault plan and transversal cross-section; (b) removal of the roof and existing brick wall system to support the tiles, together with GPR inspection of the columns

The analysis of previous existing works allows concluding that the geometrical survey of the main nave demonstrates a vertical non-alignment for all

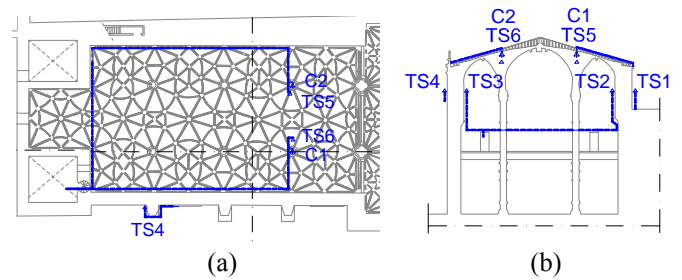
Figure 8. Static monitoring system: (a) vault plan; (b) nave cross-section

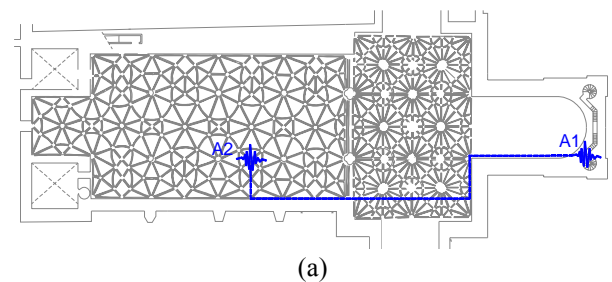
Figure 9. Dynamic monitoring system: (a) location of the accelerometers (A1 on the base and A2 on the top of the vault nave); (b) sensor A2 directly on the vault extrados; (c) strong motion recorder (analyzer)

lyzer) connected each one to one triaxial accelerometer. Two points were selected to install the accelerometer sensors as it can be seen in Figure 9. The two recorders are connected by an enhanced interconnection network, which allows a common trigger and time programmed records.

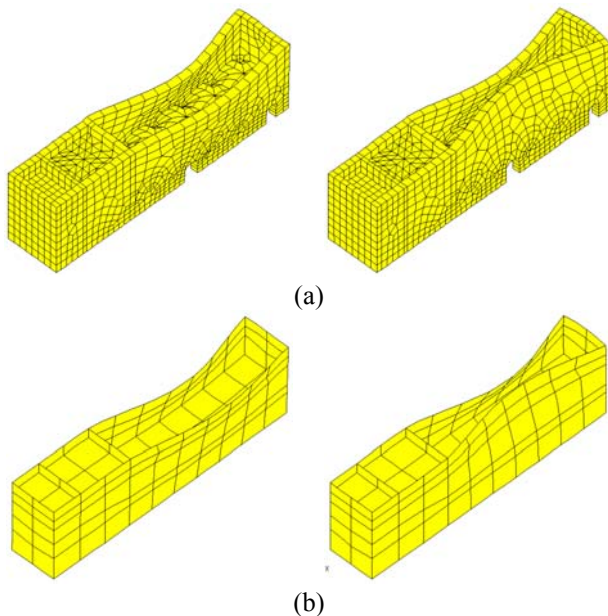
Figure 11. Shape of the first two global vibration modes: (a) refined model; (b) simplified model

A modal analysis of the structure has been carried out and reasonable agreement is found between the refined and the simplified refined model, see Figure 11 and Table 4. Nevertheless it is stressed that the simplified model exhibits a significantly large number of local modes due to the vertical modes associated with the flat slabs. Local modes affect mostly the element selected and hardly the entire structure. It seems that it is possible to conclude that the corrected simplified model allows an adequate representation of the dynamic behavior of the construction. Note that free vibration of the flat slabs was precluded in the analysis.

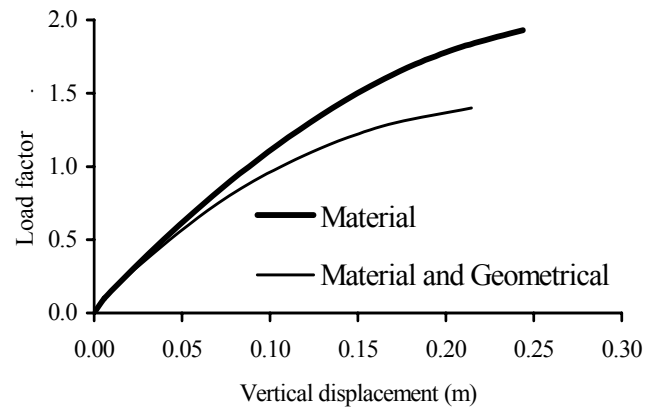
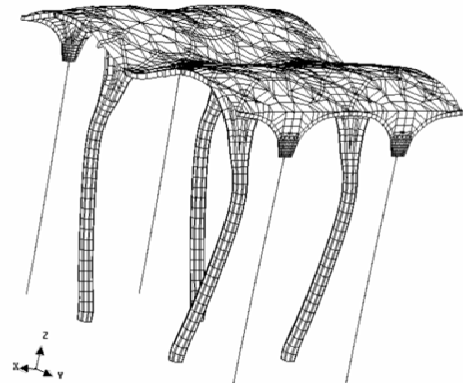
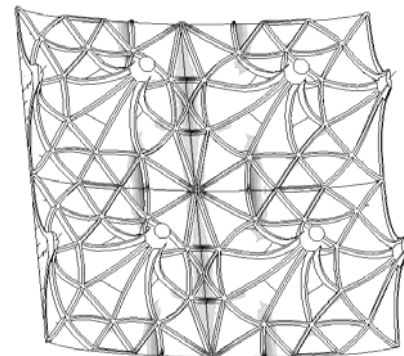
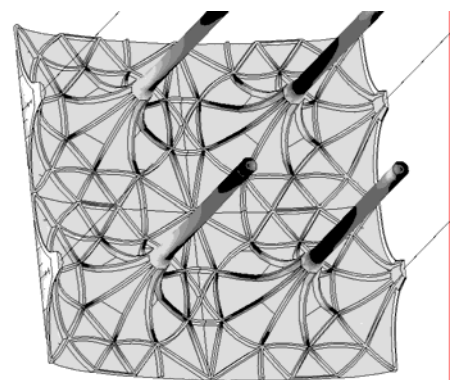
Figure 14. Results of nave analysis: (a) load-displacement diagram, (b) incremental deformed mesh at failure, (c) maximum principal strains (equivalent to cracks) and (d) minimum principal stress (compression)

The results are shown in Figure 14, in terms of load-displacement diagrams, deformed mesh, maximum principal strain (equivalent to tensile damage) and minimum principal stresses (compression). Further discussion on the results can be found in Lourenço and Krakowiak (2003). Figure 14a illustrates the load-displacement diagrams for the vault key and top of the column. Here, the load factor represents the ratio between the self-weight of the

structure and the applied load. It is possible to observe that the response of the structure is severely nonlinear from the beginning of loading, for the nave, and from a load factor of 1.5, for the column. The behavior of the nave is justified by the rather high tensile stresses found in the ribs, using a linear elastic model. The collapse of the columns is due to the normal and flexural action. The ultimate load factor is 2.0, which is low for this type of structures. Adding geometrical non-linear behavior in the analysis, it can be observed that this reduces the ultimate load factor to a value of 1.4, which is rather low. Nevertheless, if the compressive strength assumes the experimental value of  $10 \text{ N/mm}^2$ , the value of the ultimate load factor increases over two folds, see Lourenço and Krakowiak (2003).

The deformed mesh at failure, see Figure 14b, indicates that the structural behavior is similar to a two-dimensional frame, with a collapse mechanism of five hinges (four hinges at the top and base of the columns and one at the key of the vault). Nevertheless, there is some vault effect with slightly larger displacements at the central octagon, formed between the four capitals. The stresses are bound in tension and compression, meaning that cracking and crushing occurs. Figure 14c illustrates the maximum principal strains, which are related to cracking of the structure. The pairs of transverse ribs that connect the columns (in the central part of the structure) exhibit significant cracking, as well as the infill in the same area. Additional cracking, less exuberant and more diffused, appears in the central octagon defined by the capitals of the four columns. Such cracking occurs at the key of the octagon and in the longitudinal ribs, which confirms the larger displacements of the vault and the bi-directional behavior of the vault. Finally, Figure 14d illustrates the minimum principal stresses at failure. It can be observed that very high compressive stresses are found in the capital ribs, particularly in the transversal area that connects a pair of columns. The columns exhibit also very high compressive stresses, which lead to the collapse mechanism described before.

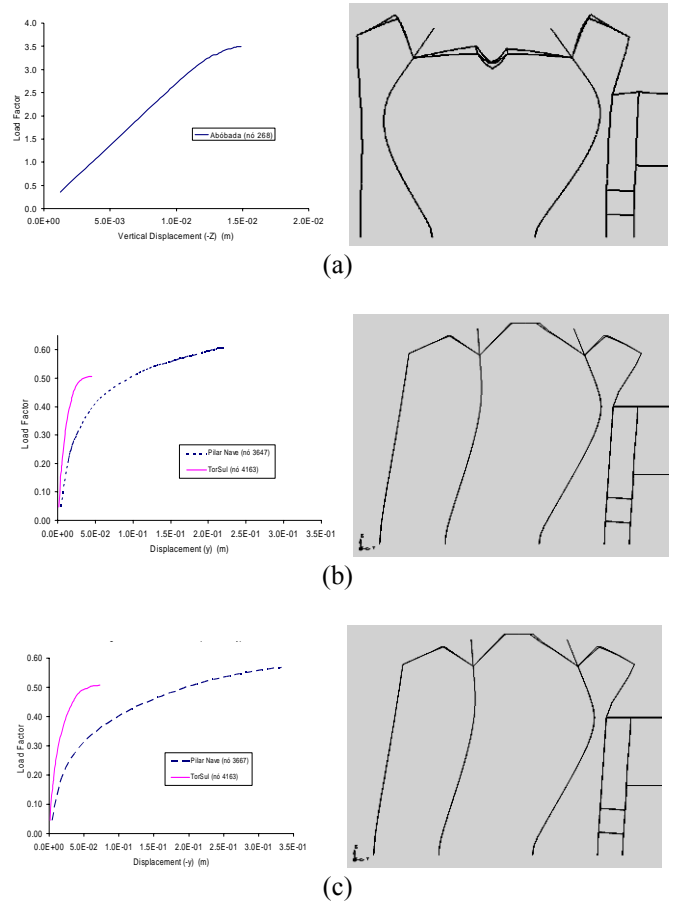
Figure 17. Results of non-linear static analysis in terms of load-displacement diagrams and transversal cross view of the nave at collapse: (a) Vertical direction (z), with  $\lambda_{ult} = 3.50$ ; (b) Horizontal direction (+y), with  $\lambda_{ult} = 0.60$  (0.50 for the bell-tower); (c) Horizontal direction (-y), with  $\lambda_{ult} = 0.55$  (0.50 for the bell-tower). The collapse load factor  $\lambda$  equals the applied load / self-weight.

direction of the nave controls the behaviour of the structure. Therefore, it was decided to perform non-linear static analyses for both vertical and horizontal (y) directions under an increasing gravity load factor until the development of collapse mechanisms. Collapse load factors and respective mechanisms patterns are briefly presented in Figure 17. These results show the need for a carefully numerical analysis against earthquakes, and the lack of a symmetric response.

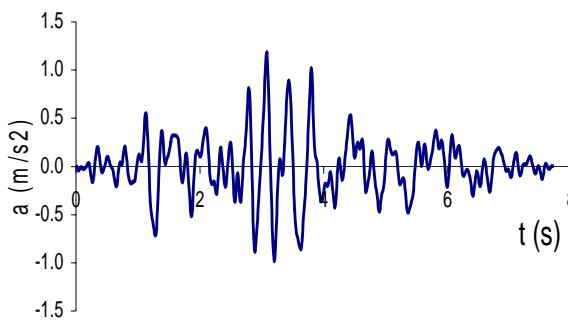
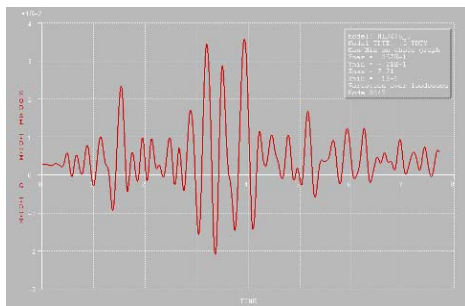
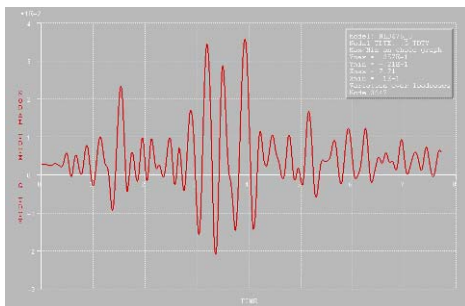
Figure 18. Seismic action and response time histories (475\_M74\_3): (a) synthetic accelerogram for 475 years return period; (b) vertical North column reaction; (c) transversal displacements (y) on the column

Following the methodology presented above, non-linear dynamic analyses were performed for the transversal (y) direction using the HHT time integration method with steps of 0.01 seconds. A damping coefficient of 2% was adopted for the computation of the Rayleigh matrix. Only results from the first hazard scenario are available at this stage (475 yrp). The numerical results obtained for this scenario, see Figure 18, show that:

- Maxima “drift” values are below 0.3% and are observed in the columns;
- The global average shear base ratio in Y direction is about 0.10 (with 0.08 for the minimum and 0.13 for the maximum);

- The maximum variation of the vertical reactions of the columns with regard to self-weight is 65%;
- The compressive stress in columns is within the elastic domain;
- The maximum compressive stress in the North and South walls (about  $7.0 \text{ N/mm}^2$ ) is nearly 10 times greater than the stress caused by self-weight;
- The vaults are subjected to important compressive stresses due to the earthquake;
- The collapse of the South belfry tower by overturning is nearly to happen;
- After the earthquake, the remaining global stiffness of the structure is about 60% of the original value.
