Application of radar techniques to the verification of design plans and the detection of defects in concrete bridges

Non-destructive tests (NDT) are an essential tool used in special inspections to gather detailed information about the condition of a bridge. The inspection of bridge decks is a critical task, and, currently, can be successfully carried out using a wide range of NDT techniques. Nevertheless, some of these techniques are excessively expensive and time consuming. One of these techniques, the ground penetrating radar (GPR), has been used for some decades in the non-destructive inspection and diagnosis of concrete bridges. GPR is useful to find general information about the true position of reinforcement and tendon ducts, and check the quality of the construction and materials. A significant number of reinforced and prestressed concrete bridges are deteriorating at a rapid rate and need to be repaired and strengthened. During these rehabilitation processes, designers are often faced with a lack of original design plans and unawareness of the real position of reinforcement and tendon ducts. In this paper, three case studies of the use of GPR techniques for the inspection

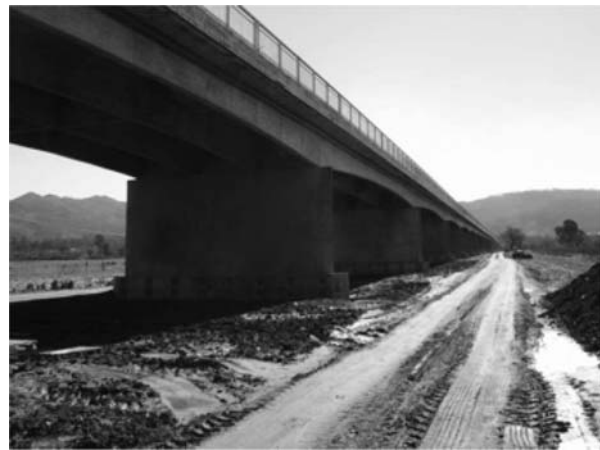
Figure 4. Lanheses Bridge.

The Lanheses Bridge is illustrated in Figure 4. It is a cantilever bridge with a total length of 1218 m between abutments and the width of the bridge deck is 11.5 m. The superstructure, in reinforced and pre-stressed concrete, consists of four longitudinal beams with variable inertia, connected superiorly by the deck's slab and transversally by beams located over the columns and at thirds of the spans. The bridge presents, along its length, typical spans of 30.0 m, with the exception of the approach spans, which have a length of 24.0 m.

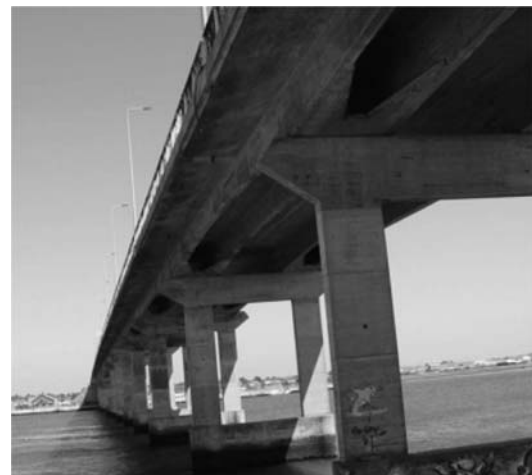
Figure 5. Barra Bridge.

The Barra Bridge, which crosses the delta of the Vouga River ('Ria de Aveiro'), in Ílhavo, was also designed by Edgar Cardoso in 1972 and was built in 1978. Currently, this bridge suffers from significant deterioration caused by contact with seawater, an aggressive environment and nearly 30 years of service-life. Figure 5 illustrates a general view of the structure. The total length of the bridge is about 620 m between the abutments, and the width of the bridge deck is 15.9 m. The bridge deck is composed of reinforced concrete that is supported by four longitudinal beams of variable inertia and box-girders over the bridge

supports. These beams are prestressed longitudinally, are connected at the top face by the deck slab, and are connected transversally by reinforced concrete beams located over the support columns. The distance between columns is 32.0 m, with the exception of the approach spans, which have a length of 25.0 m. The columns, in reinforced concrete, possess a large slenderness and a rectangular cross-section. They are connected through transversal beams at the top and at the base, in the foundations. The transversal beams are connected to the longitudinal beams by neoprene supports. Finally, the abutments are walls in harmonic and extend for 20.9 m.

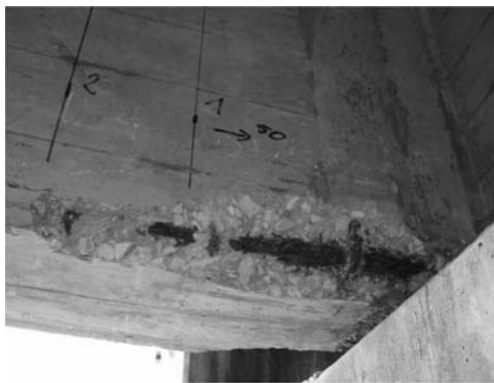
Figure 6. Example of: (a) corrosion of the reinforcement in the Barra Bridge, and (b) window opened in a longitudinal beam for the detection of tendon ducts in the Lanheses Bridge.
