# EN-CORE/fib Round Robin Testing Initiative

## Round Robin Tests 1.2

### *Tensile tests on bars/strip for NSM*

Report N.º 10-DEC/E-23

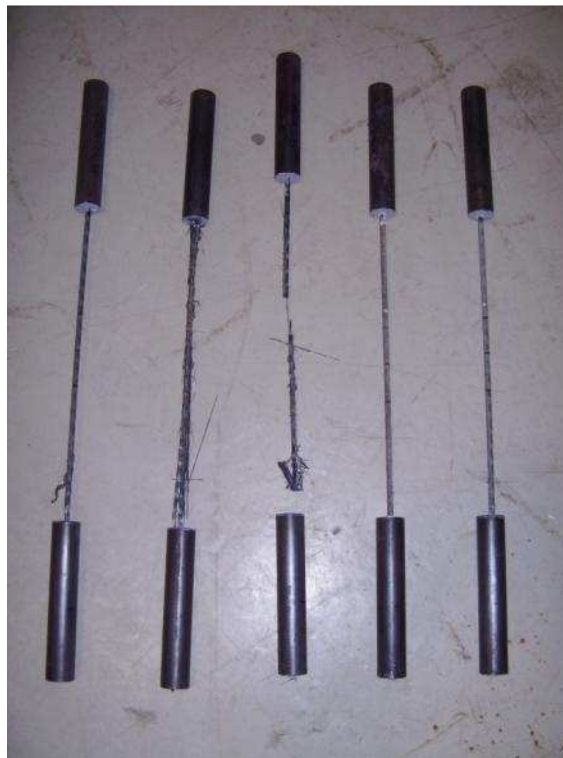
**Figure 4.1.1** – Tested specimens

Anchorage: Failure of the FRP close to the anchorage  
 Debonding: Debonding of the FRP inside the adhesive

**Description of failure mode:** Since in general a significant slip of the bar inside the anchorage system was verified, a longer anchorage length seems recommended for future tests.

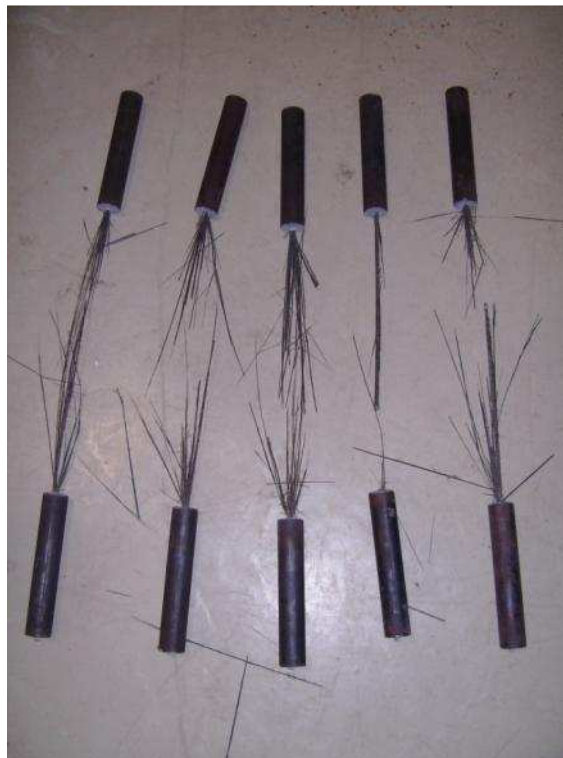
**Figure 4.2.1** – Tested specimens

LS: longitudinal splitting and fibre fracture

**Description of failure mode:** Explosive.

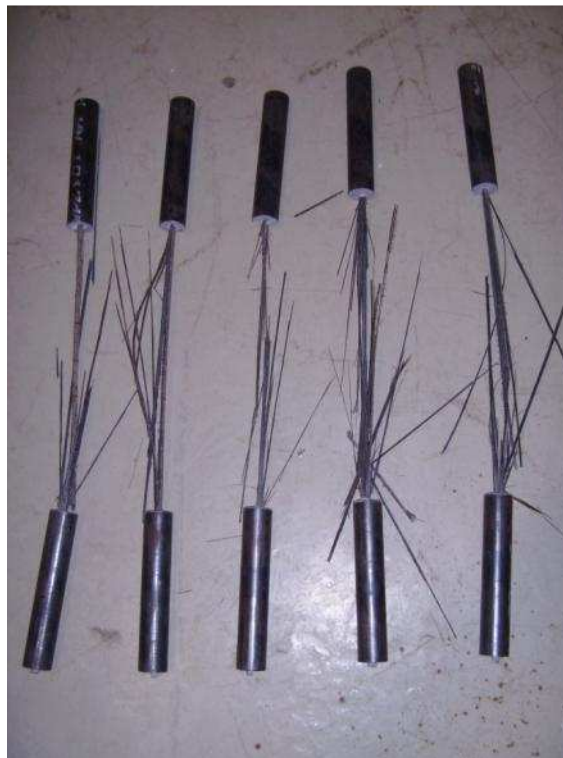
**Figure 4.3.1** – Tested specimens

LS: longitudinal splitting and fibre fracture

**Description of failure mode:** Explosive, although less than the corresponding bars of lower diameter.

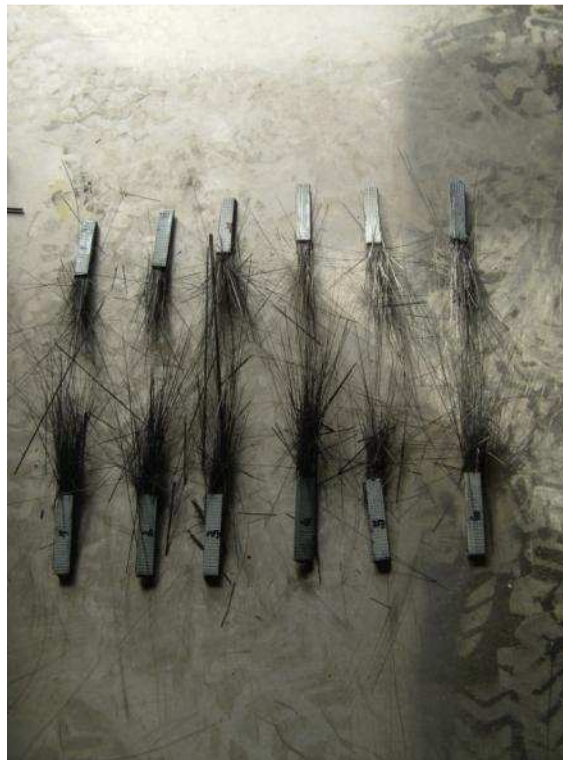
**Figure 4.4.1** – Tested specimens

LS: longitudinal splitting and fibre fracture

**Description of failure mode:** Noisy, but not so pronounced as occurred in the other FRP bars.

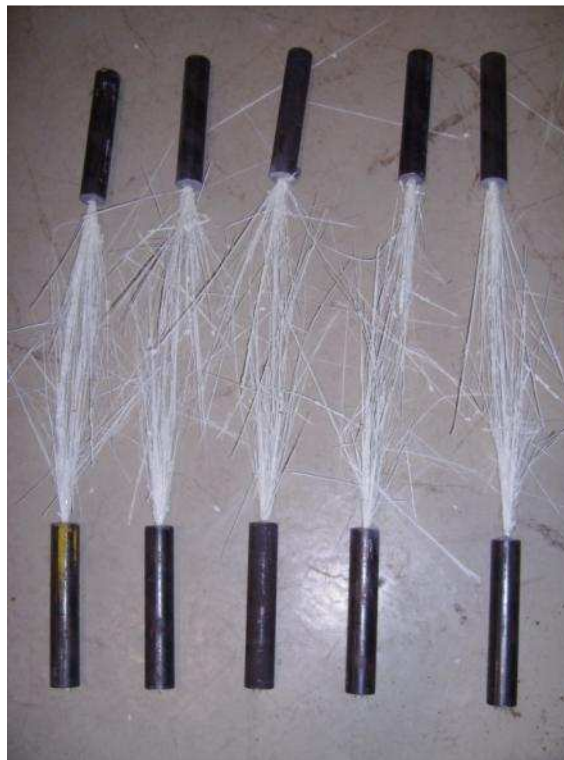
**Figure 4.5.1** – Tested specimens

LS: longitudinal splitting and fibre fracture

**Description of failure mode:** Explosive followed by small fibres all around.

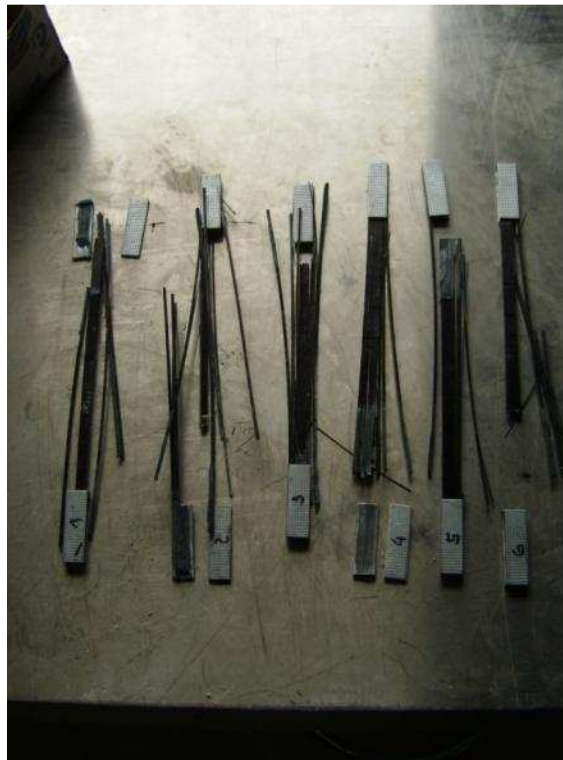
**Figure 4.6.1** – Tested specimens

LS: longitudinal splitting and fibre fracture

**Description of failure mode:** Not much explosive, and not too messy. However, the type of failure occurred did not correspond exactly to the one expected. The fibres split longitudinally but fractured too close to the end tabs.

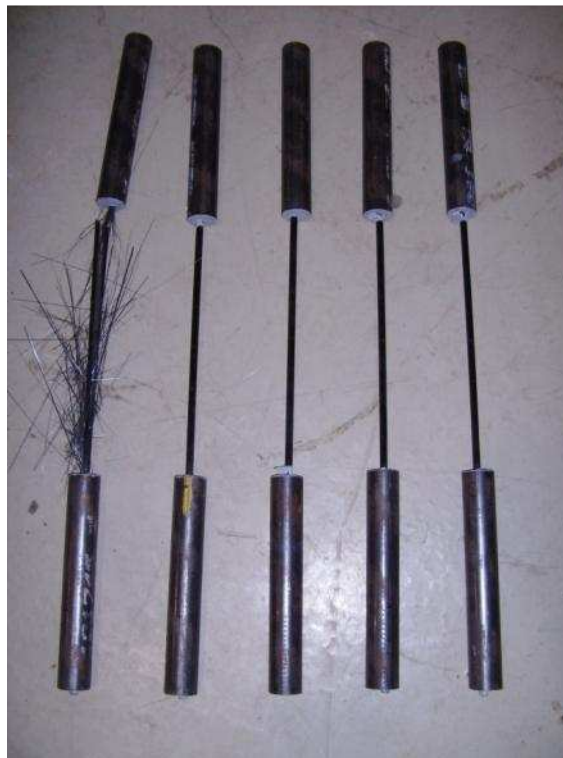
**Figure 4.7.1** – Tested specimens

LS: longitudinal splitting and fibre fracture

PO: Pull-out bars

**Description of failure mode:** The first specimen only failed because it was accidentally pre-compressed. In all other cases, the anchorage length was insufficient. In most of the specimens the bar was debonded from the adhesive.

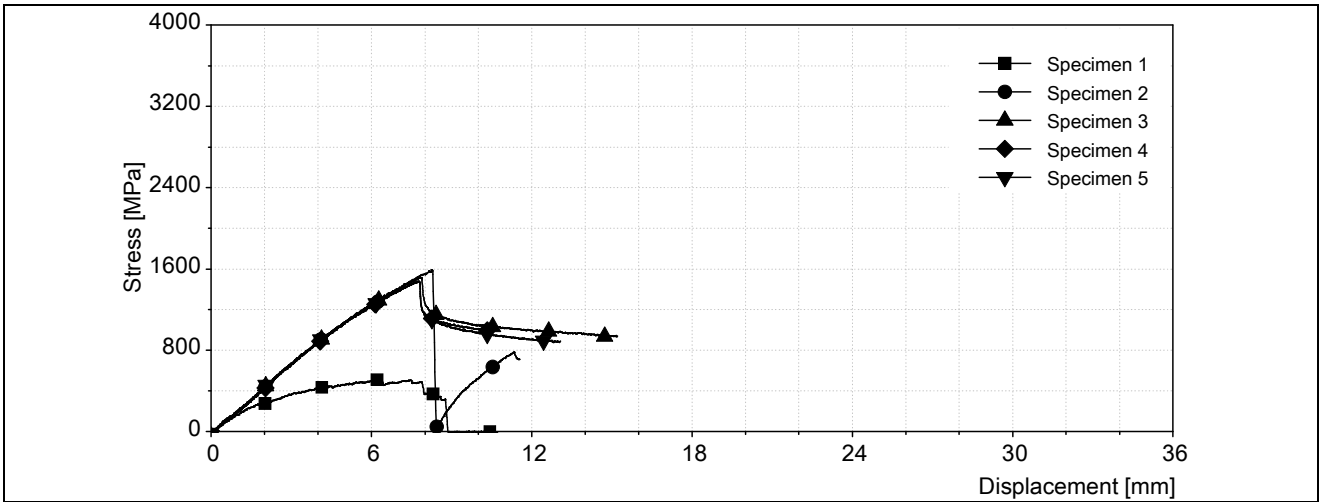
Figure 4.7.2

Stress vs displacement

Stress vs Strain

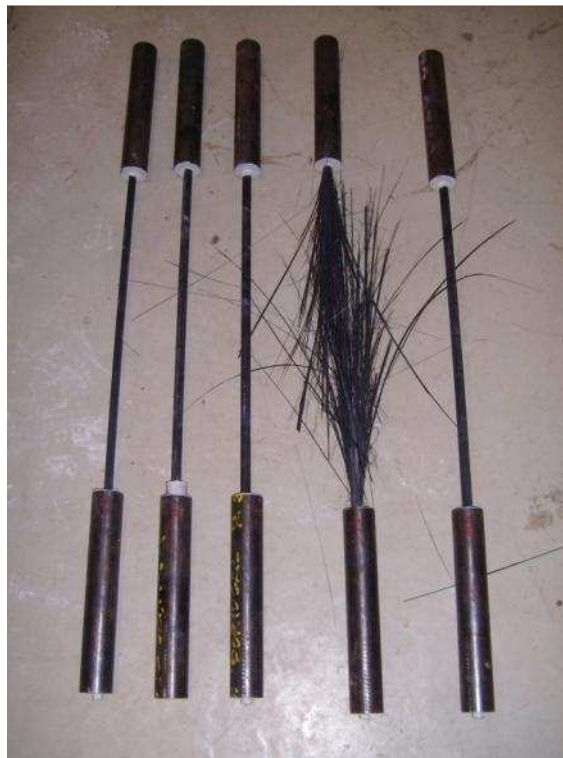
**Figure 4.8.1** – Tested specimens

PO: Pull-out bars

**Description of failure mode:** Only one specimen has ruptured. In spite of using an anchorage length of 250 mm in these specimens (the maximum in all test program), the other four did not fail. It seems that with a little higher anchorage length the rupture of these bars can be attained.
