strengthening

J.M. Branco

ISISE, University of Minho, Portugal

ABSTRACT: This paper aims to present an overview on the Portuguese traditional timber structures pointing out the current approach on their refurbishment. The results of an extensive survey intending to assess geometries, materials, and on site pathologies are presented. The most common traditional timber structures are analyzed, the degradation processes are reported and the main strengthening needs are discussed.

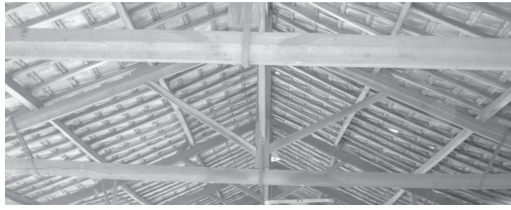
Figure 1. Incorrect truss configuration for the roof span.

Improper maintenance of the structure and faulty design or construction are the main causes of safety reduction of Portuguese timber trusses. Problems associated with moisture contents, especially near the supports, are usually present. The faulty design is frequently consequence of a wrong selection of the truss configuration for the roof span (Fig. 1) and due to eccentricities in the purlins.

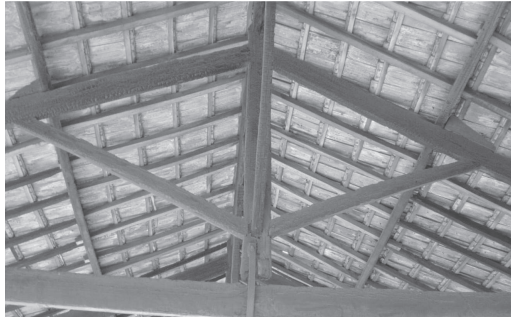
Figure 2. Wrong positioning of the purlins with eccentricity relatively to the truss joint.

In fact, although, a strong emphasis is traditionally placed on the need to limit bending moments in the truss elements, eccentricities in the purlins are common (Fig. 2).

1. The application of concentrated loads out of the joints, for example originated by a wrong positioning of the purlins, can compromise the structural global safety;
