SMALL HARBOURS RISKS: LOWERING FOR FISHERY AND INCREASING EROSION. THE CASE OF PORTINHO DA AGUDA (NW PORTUGAL)

Abstract

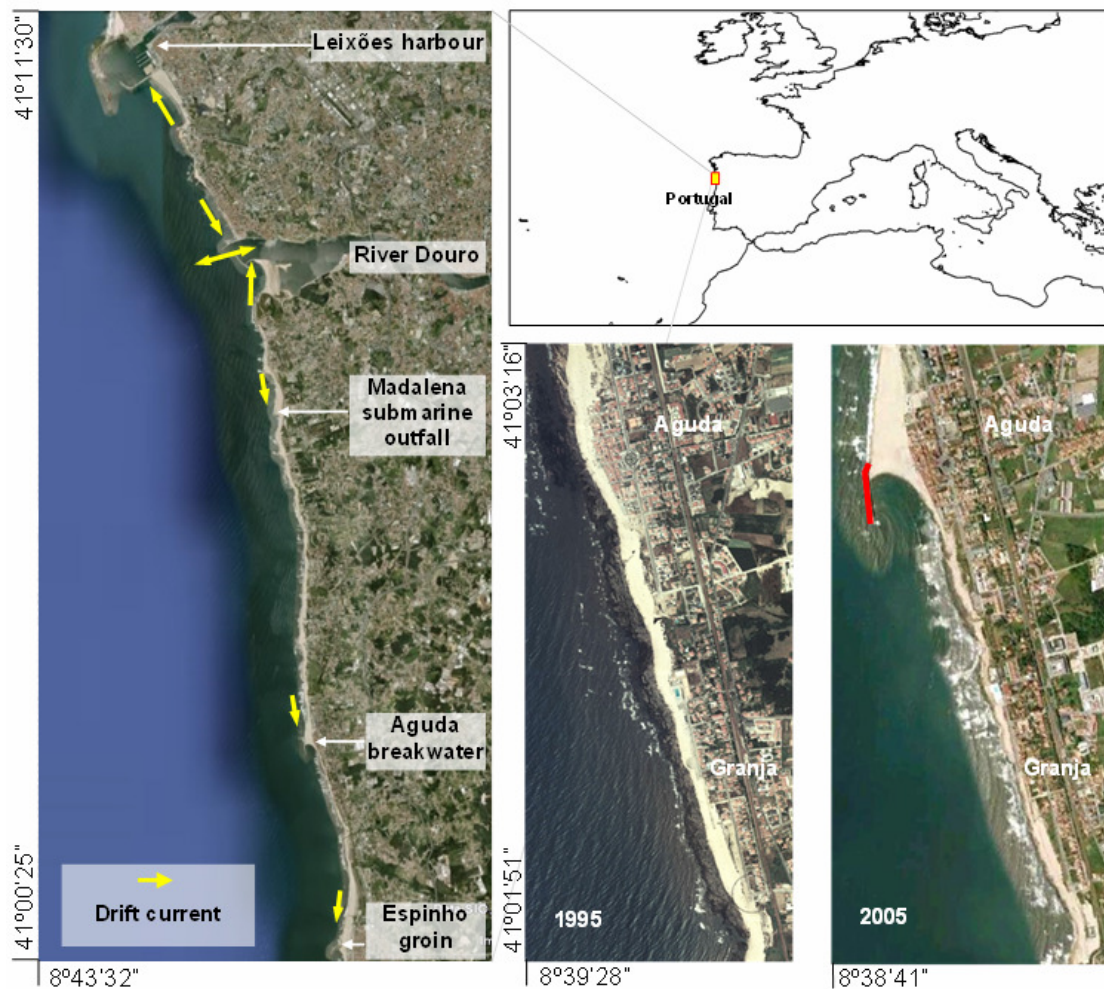
Fig. 1. Location of the Aguda and Granja beaches in northern Portugal, and aerial images of the coastal stretch before (1995) and after breakwater construction (2005). Images represent about 1 km \times 2.6 km ground surface. The detached breakwater is drawn in red.

The Portinho da Aguda was built between October 2001 and July 2002, at Aguda village. This coastal stretch presents a rocky platform (Fig. 1 – 1995 aerial image) that protected the coastal border against the direct wave impact, on an area where the erosion impact knowledge is old.

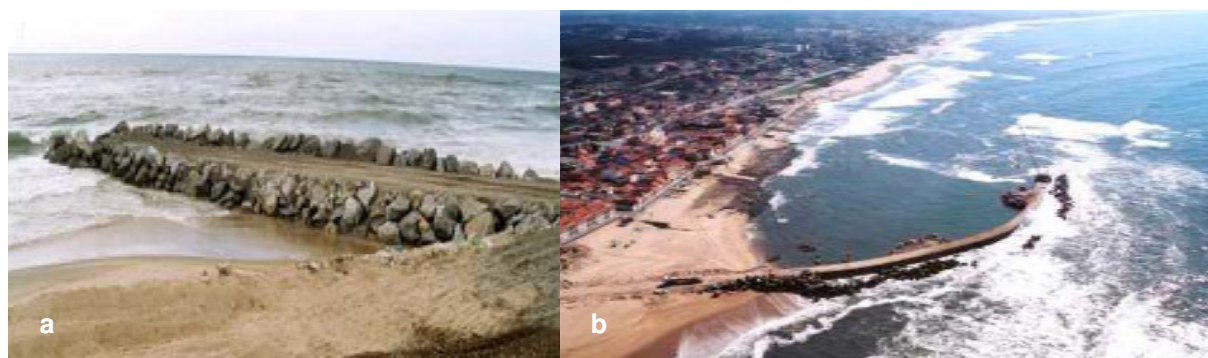
Fig. 2. Construction of the Aguda breakwater: a) access groin; b) final works (adapted from INAG, 2010)

The harbour was created building a detached curved breakwater, anchored in rocky outcrops. A temporary groin, starting on the beach, was made to allow the access and transport of material for the breakwater construction (Fig. 2).

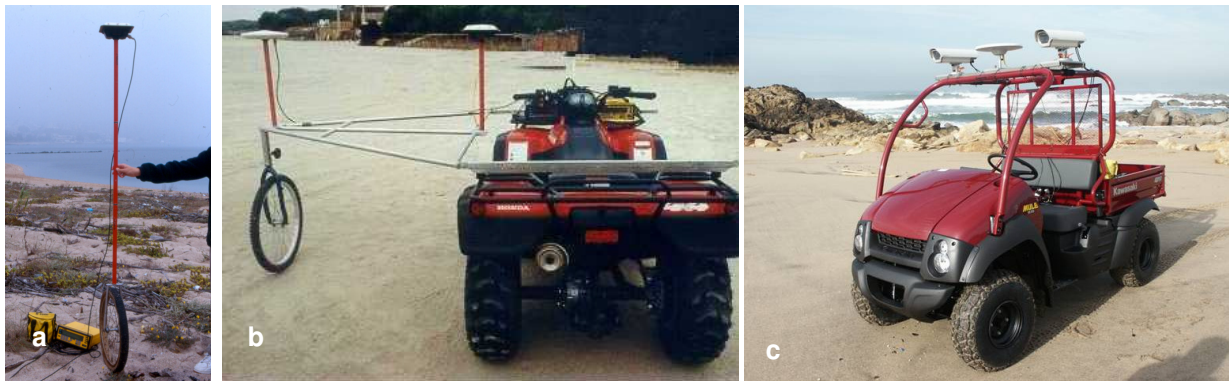
Fig. 3. Mobile mapping gear: a) single-antenna equipment; b) vehicle equipped with two antennas on an articulate arm, c) four-wheel vehicle with two antennas and videogrammetric equipment.

Land-based measurements were taken contouring the low-tide water line and the dunes, and on a grid of longitudinal and horizontal profiles. Although always based on kinematic DGPS, different survey methodologies were used. First campaigns (2001-2003) were done with on-foot equipment (Fig. 3, a), which was later replaced by a two antenna DGPS system mounted on a motor-quad (Fig. 3, b) and finally (in 2009) by a videogrammetric mobile mapping system (MMS) (Fig. 3, c). Details about the methodologies used can be found in Baptista *et al.* (2008a,b) and Madeira (2007). The 3D positioning precision of the kinematic DGPS processing technique is better than 5 cm. Concerning the MMS system, special care has to be given to the determination of the inclination of the cameras baseline as the final accuracy of the coordinates is very sensitive to the error in roll (Bastos *et al.*, 2009). DTM models with heights above chart datum (the mean sea level is 2 m below CD) on a regular 1×1 m grid were computed through Triangulation with Linear Interpolation (TLN) using Surfer 8 software.

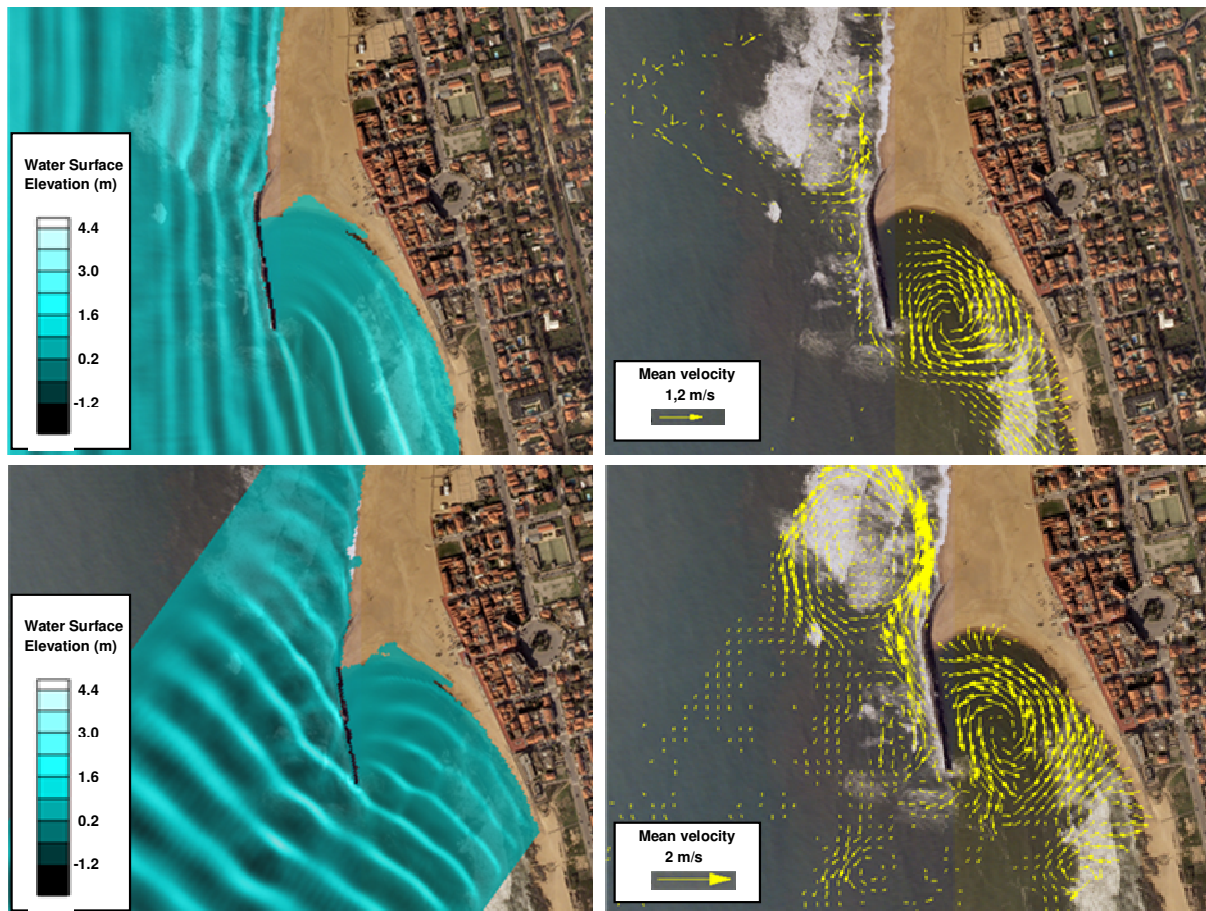
Fig. 6 Wave transformation in the Aguda breakwater vicinity for irregular waves coming from west (upper pictures) and for irregular waves coming from southwest (lower pictures).

The breakwater construction had a significant impact in the local wave dynamics as can be seen in Fig.6. The most frequent wave directions are from W (60% of the buoy records in the period of May 2001 to September 2009) followed by NW (34% of the buoy records) and SW (5% of the buoy records). For the most frequent wave directions, diffraction tends to interrupt the previously installed North-South coastal drift tendency in this coastal segment. During storms from S and SW this coastal defense structure is inefficient and can be significantly affected by sediment depositions inside the artificial bay, forcing the execution of dredging works.

For the most frequent local wave dynamics (waves from NW and W) the coastal defense structure reveals to be efficient protecting the fishery boats navigation. However, the inversion of the local sedimentary drift suggested by the obtained model results and the monitored sediment deficits verified at the South segment reveals that this structure presents maintenance costs (associated with beach nourishment at South and dredging inside the protected bay) that were not predicted before its construction. Its evaluation should be done in the future and alternatives to the present structure configuration should be evaluated in order to obtain a better performance. Design of such structures must consider the particular behavior characteristics of this coastal segment that is mainly formed of pocket beaches constituted by sands confined between the urban area and the rocky platform.
