THE PERFORMANCE OF ULTRA-HARD  
CUTTING TOOL MATERIALS IN MACHINING  
AEROSPACE ALLOY TA48

being a thesis submitted for degree of  
DOCTOR OF PHILOSOPHY

in the University of Hull

January 1991

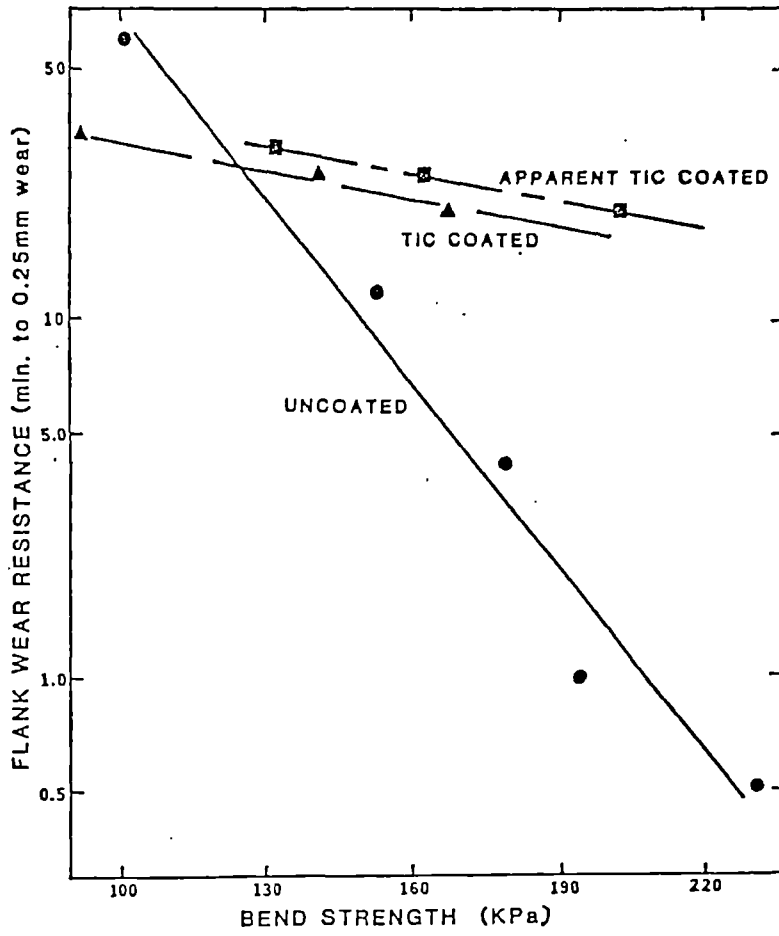
Fig 2.16 a) Flank wear resistance versus bend strength  
 b) Cutting speed versus tool life (110).

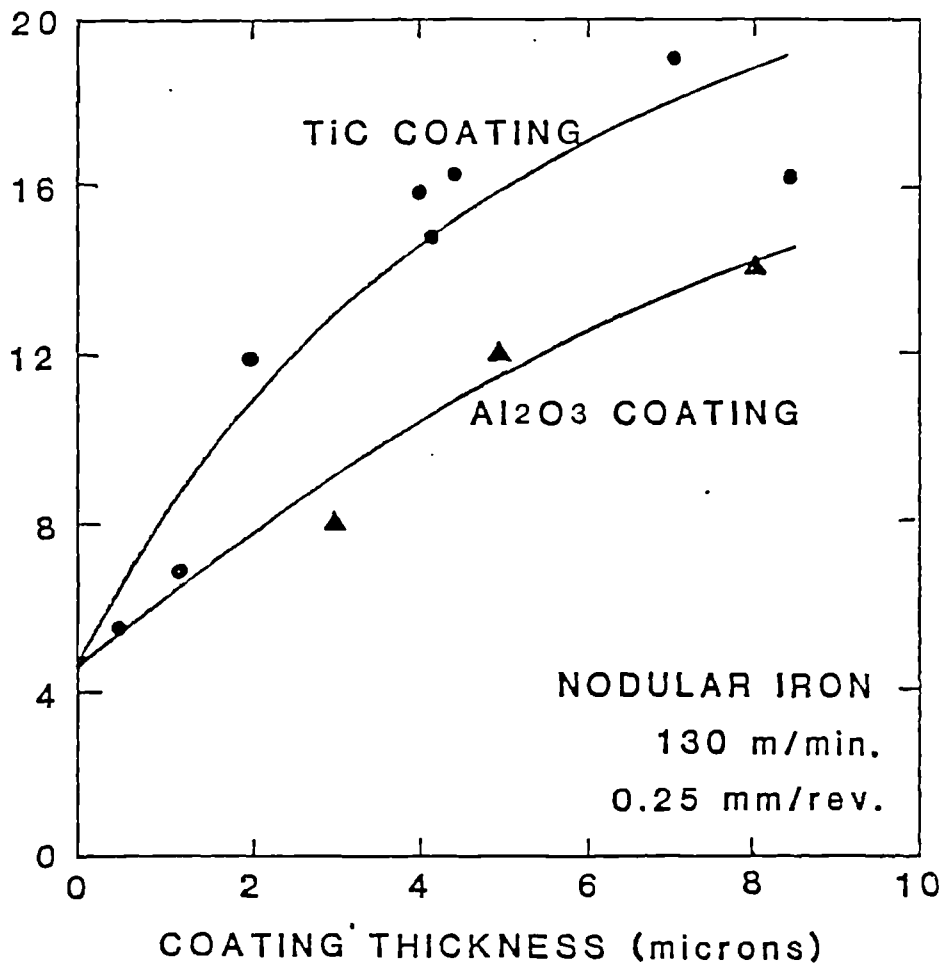
Fig 2.19 Time to 0.25 mm flank wear as a function of coating thickness for TiC and  $Al_2O_3$  coating (110).

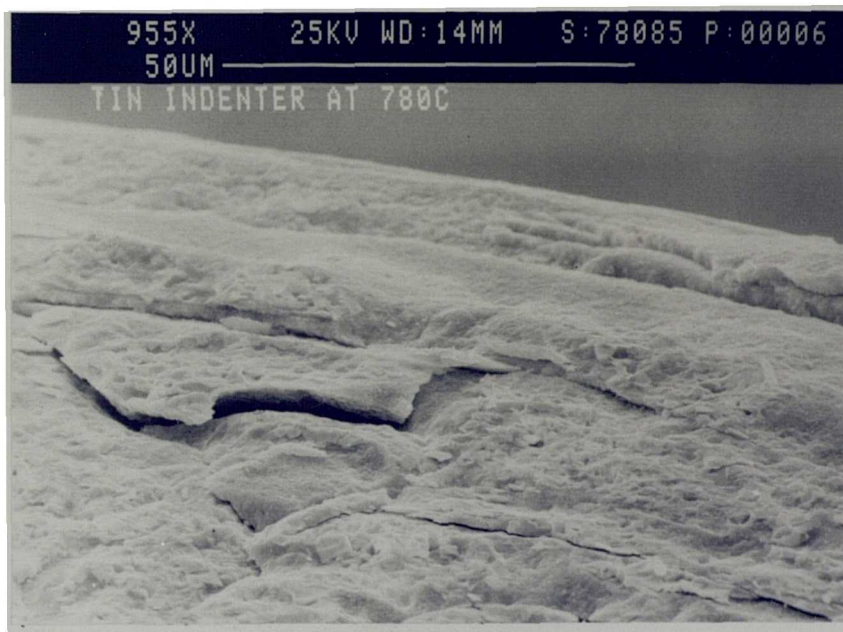
**Fig 4.14** Titanium alloy indenter with strongly-adherent carbide (KC850) after fracture within bulk tool material.

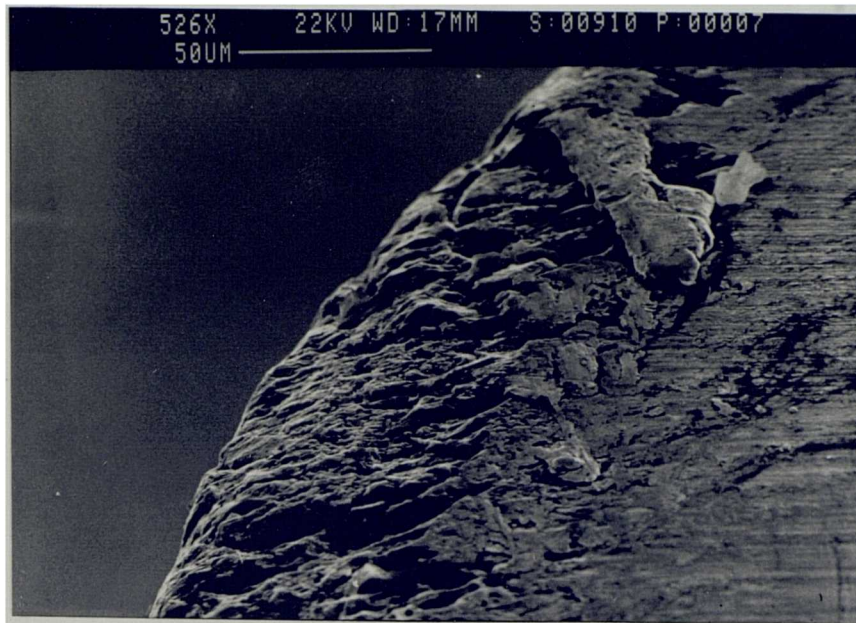
**Fig 4.58** Plucking about to take place on the rake face of carbide coated tool.

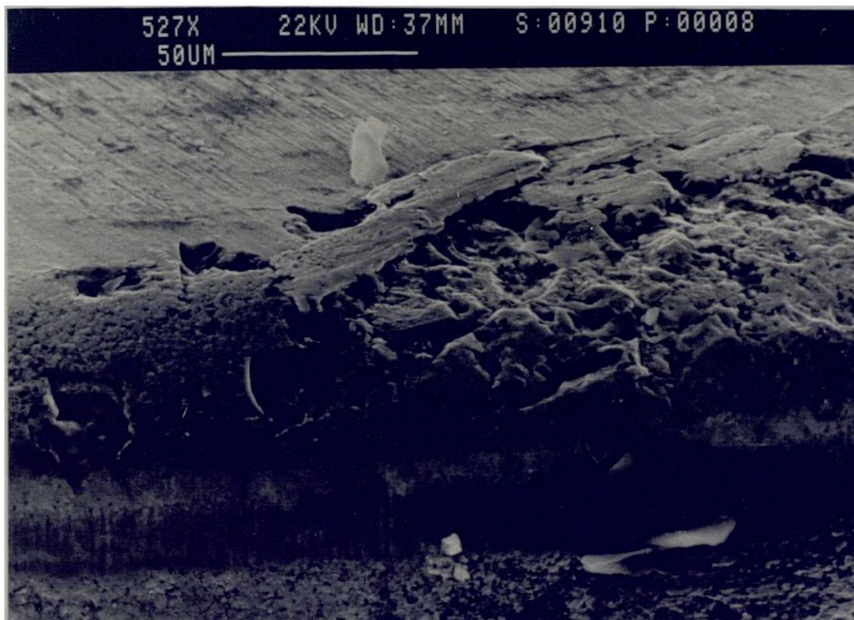
**Fig 4.63** Smoothly worn flank face with plucking at the rake face.

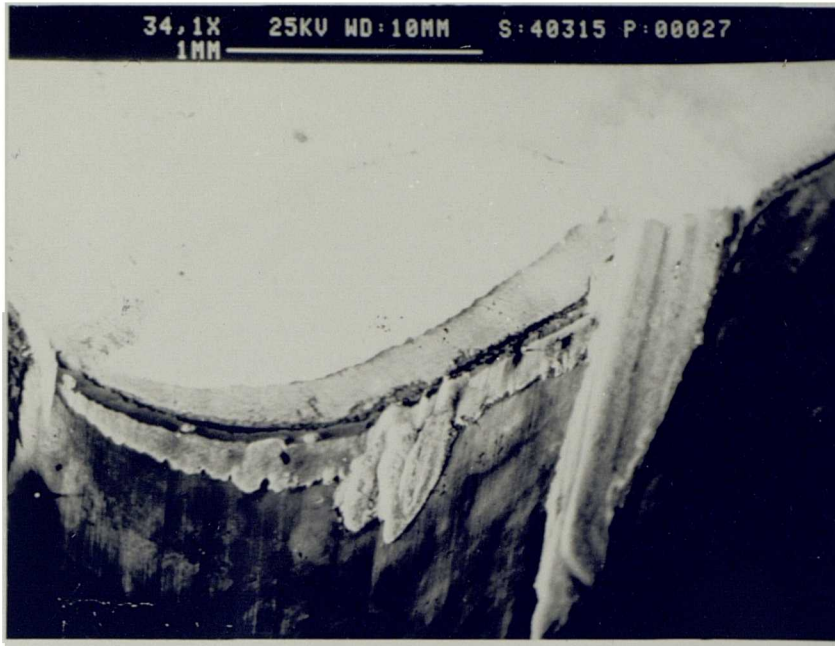
**Fig 4.81** Development of notches at the both extremities of the depth of cut on the flank face.

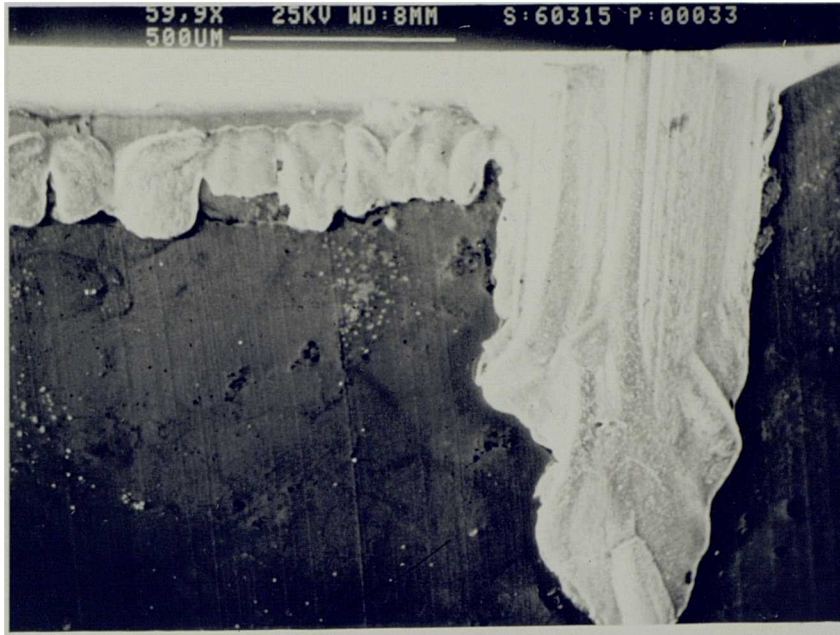
**Fig 4.88b** Formation of large size notch wear at the flank face.

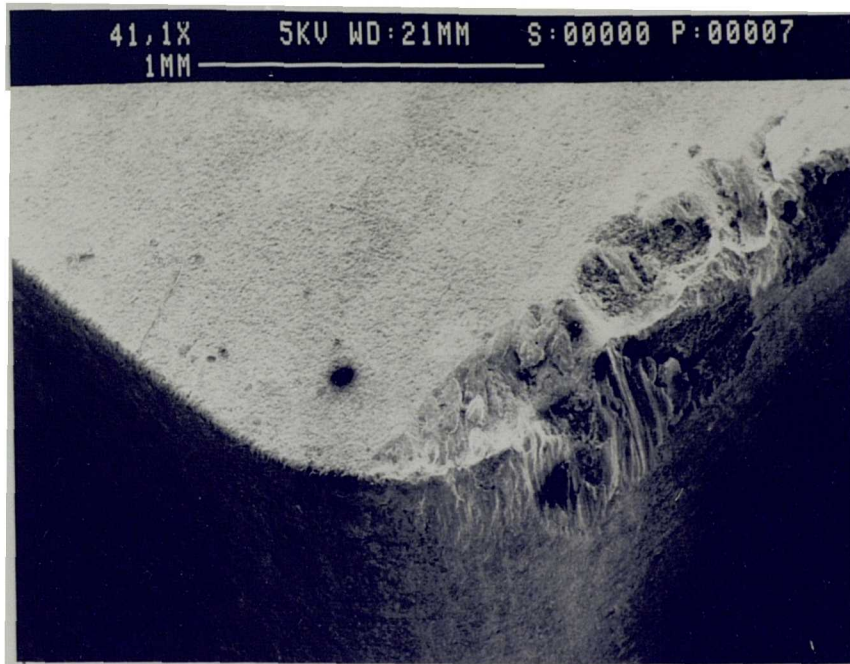
**Fig 4.91** Chipping at the cutting edge of cubic boron nitride insert.

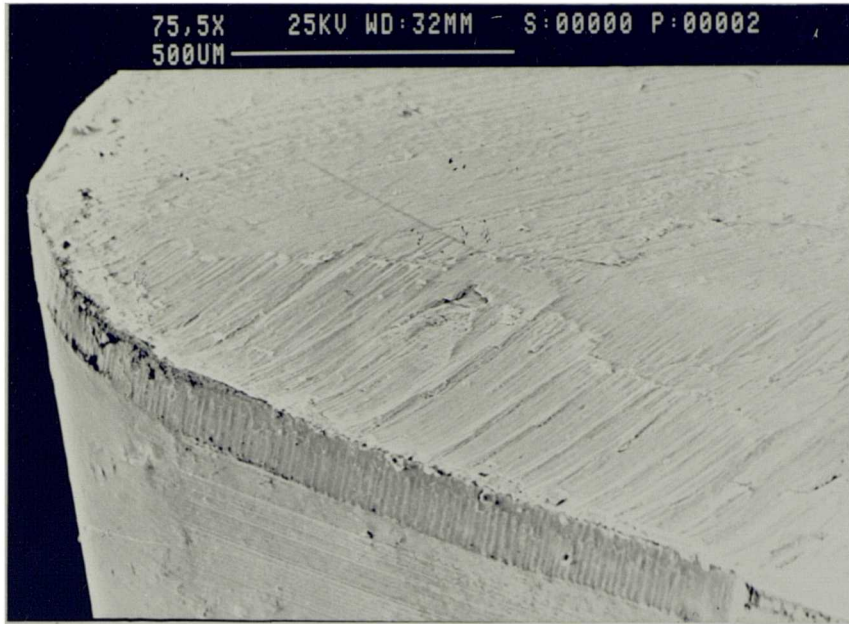
**Fig 4.106** Worn surface of flank & rake faces of cubic boron nitride tool.

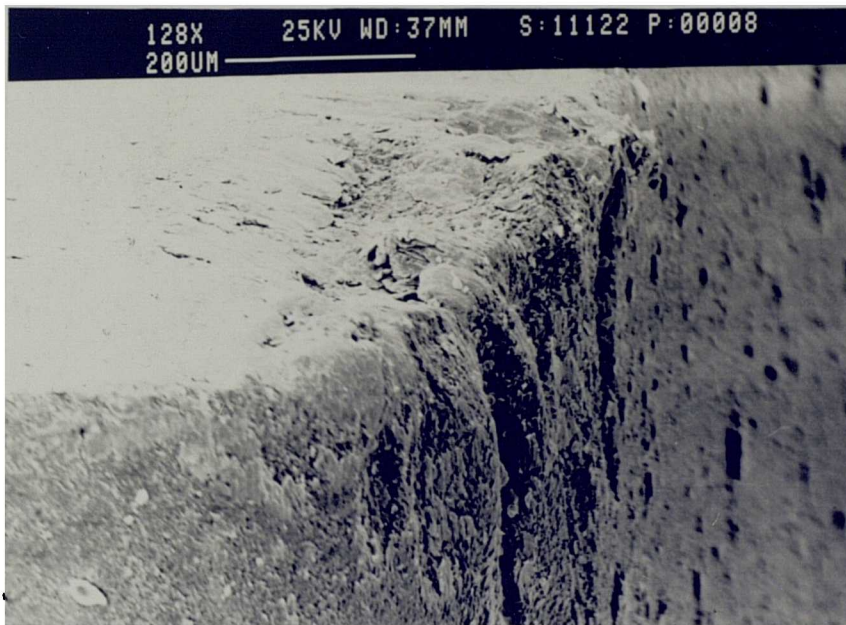
**Fig 4.11** Wear grooves formed around the cutting edge of modified tool wear.

A wear groove formed around the cutting edge after 12 minutes is shown in Figure 4.111. It seems that this wear notch was caused by fracture. Although the surface of the wear had formed at a relatively large flank land, the nose radius was

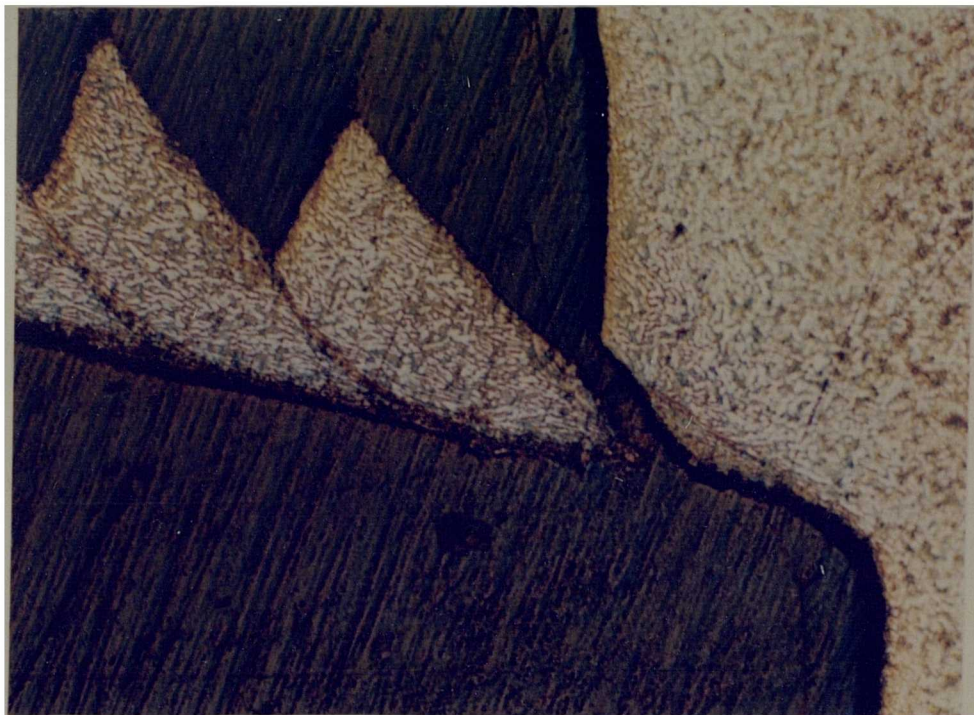
**Fig 4.148b** Close-up view of (a) (200X).
