## OPERATIVE CONDITIONS EVALUATION FOR EFFICIENT BUILDING RETROFIT – CASE STUDY

### Abstract:

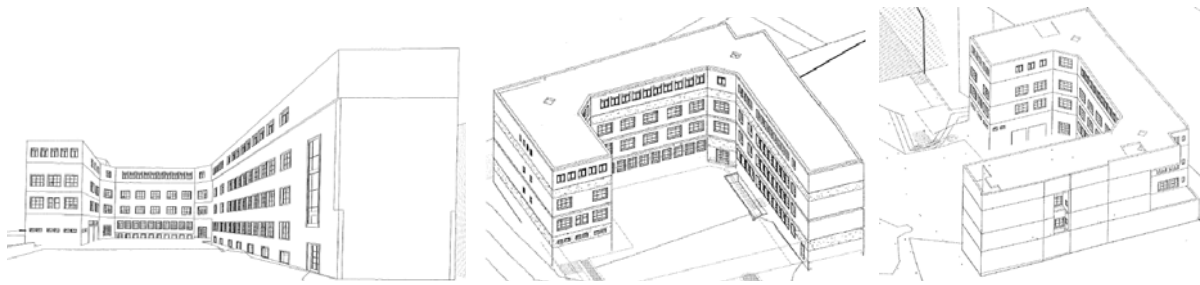
The building under analysis is located in an urban area, in the city centre of Porto in the North-West of Portugal. The building, represented in Figures 1, 2 and 3, has 5 floors (the ground floor is partially underground), 3.3 m of floor to ceiling height and 2713 m<sup>2</sup> of useful area. The building was built in the 1970's and suffered some minor changes in the 1990's.

Figure 1. Views of the building (general perspective, SW and SE perspective)

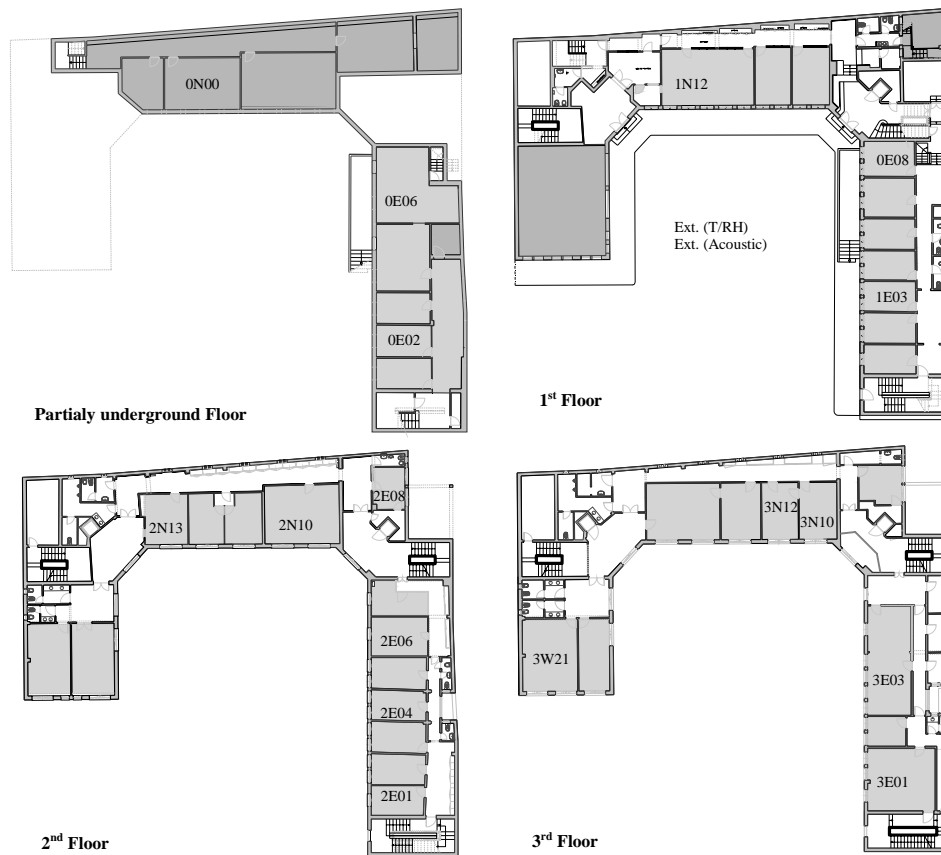
Figure 4 shows the rooms where the measurement campaign was performed.

Figure 4. Measured rooms (first number represents the number of the floor, the letter represents the orientation of the room and the last two numbers represent the room number)

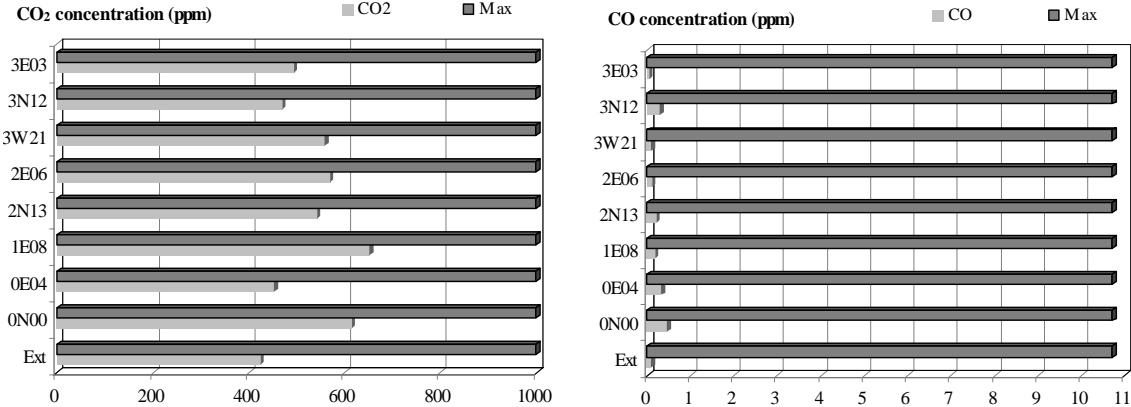
Figure 10 shows the results of the carbon dioxide and monoxide (CO<sub>2</sub> and CO) measurements for the different studied office rooms of the building.

Figure 10. CO<sub>2</sub> and CO concentration and maximum reference values

The measurements show that the concentrations of CO<sub>2</sub> and CO are considerably lower than the limits due to the fact that the occupants open the windows and the outdoor concentration is also low.

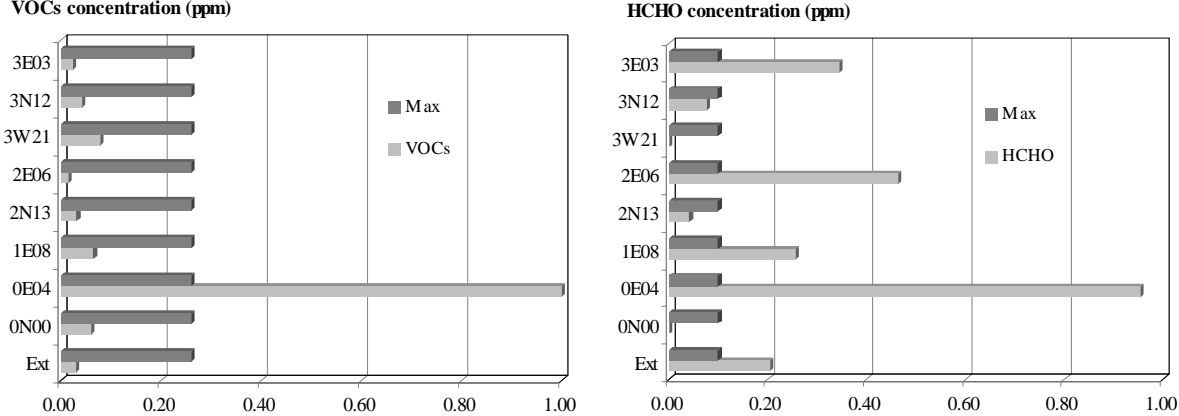
Figure 11 shows the results of the volatile organic compounds (VOCs) and formaldehyde (HCHO) measurements for the different office rooms of the building that were studied.

Figure 11. VOCs and HCHO concentration and maximum reference values

Regarding VOCs, the measurements showed a high concentration (almost 5 times higher) in the room 0E04 – the laboratory – where several reagents are used. A high concentration of HCHO (about 8 times higher than the maximum value allowed) was also measured in the exterior and in this same room 0E04 - the laboratory. A high concentration of HCHO was also measured in the offices located above the laboratory, offices 1E08, 2E06 and 3E03.

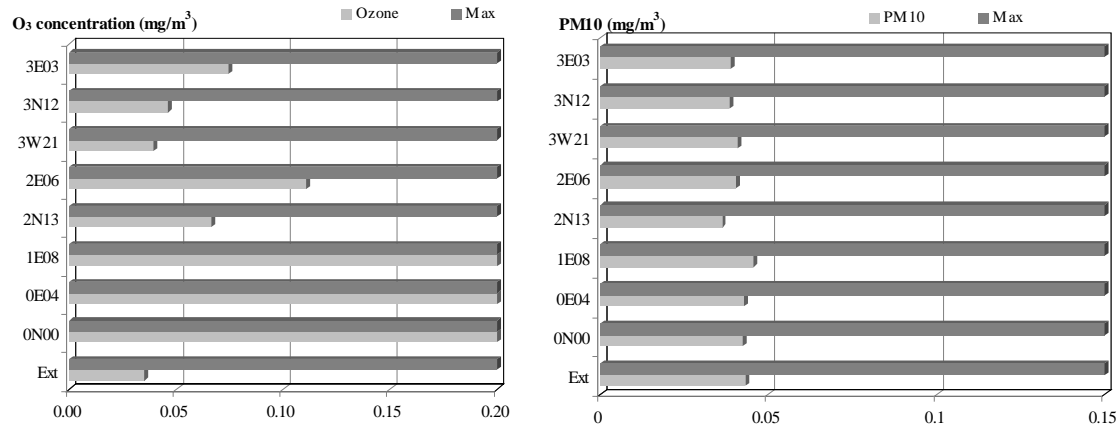
Figure 12 shows the results of the ozone (O<sub>3</sub>) and suspended particles (PM<sub>10</sub>) measurements for the different office rooms of the building that were studied.

Figure 12. O<sub>3</sub> and PM<sub>10</sub> concentration and maximum reference values

The high ozone concentrations are probably due to the outdoor concentration (intense traffic) and the presence of laser photocopiers in some offices and then the air movement between spaces transfer the contaminant between rooms.

As the printers and copiers are the potential cause of noise and high  $\text{O}_3$  concentration the placement of these equipments in specific areas, with an adequate ACH and envelope, will be beneficial both for acoustic comfort and for IAQ.

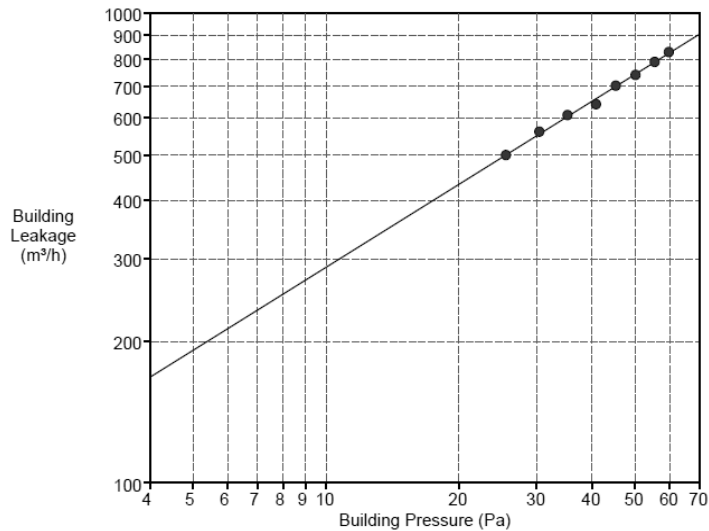
Figure 13. Air flow rate of the room 1E08

The measured air change rate is quite high and will result in substantial heat losses in winter and heat gains in summer.

Besides the installation of more airtight window frames and doors it is necessary to install mechanical ventilation systems with heat recovery units to ensure an adequate air change rate of the building to reduce the uncontrolled infiltrations through the envelope that lead to high energy losses through ventilation and to guarantee the indoor air quality.

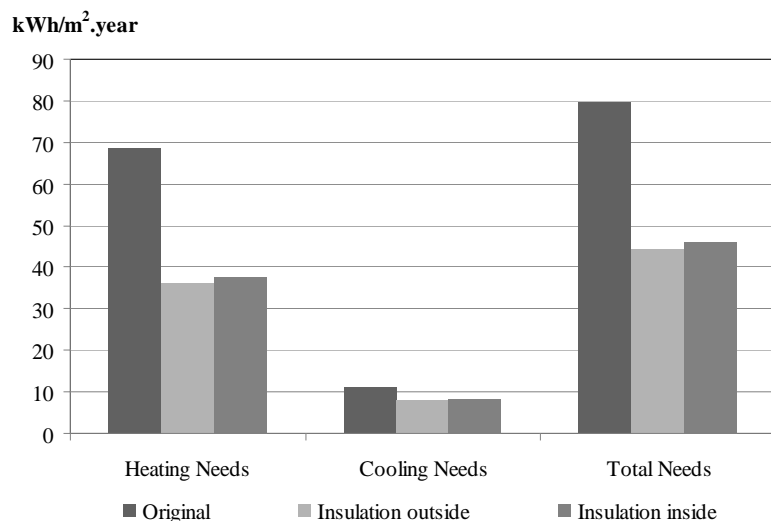
Applying the dynamic simulation code, it was possible to obtain the energy needs, final energy for the original office building and for both retrofit options, as shown in Figures 14, 15 and 16.

Figure 14. Heating and cooling needs for the original building and retrofit alternatives

With the retrofit of the building envelope the heating needs will be reduced in 45% and the cooling needs in more than 25%. The annual energy needs reduction is more than 40%.

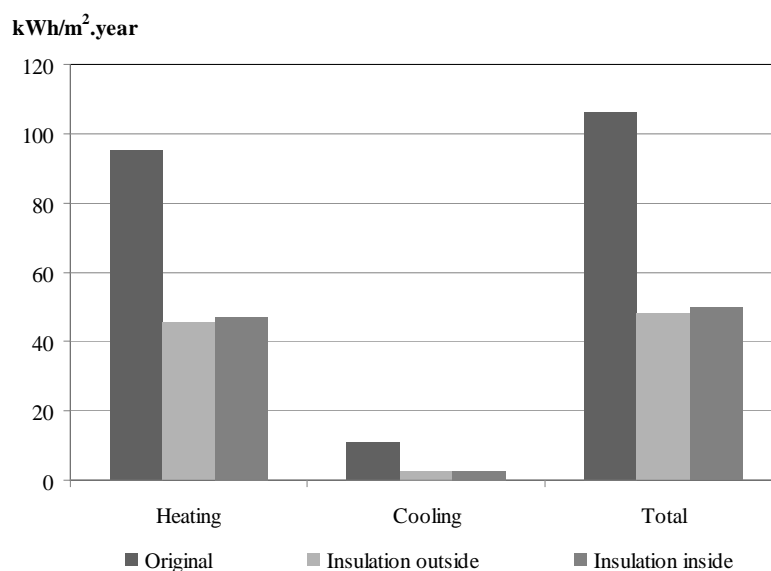
Figure 15. Heating and cooling consumption for the original building and retrofit alternatives

With the installation of a pellets boiler (efficiency of 60%) and of a chiller (COP of 3) in addition to the improvement of the envelope, the required heating and cooling final energy consumption is reduced in more than 20%.

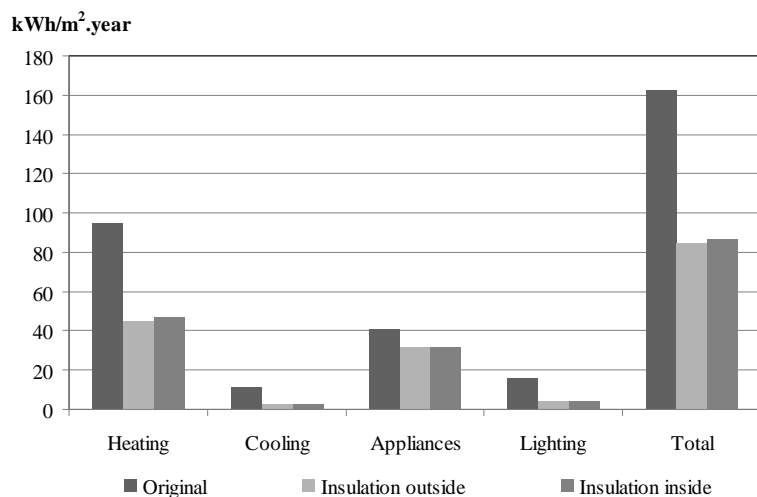
With the retrofit of the building envelope, the heating system, appliances, and light bulbs replacement and the installation of a cooling system, the final energy consumption can be reduced in about 47%.

Figure 16. Total final energy for the original building and retrofit alternatives

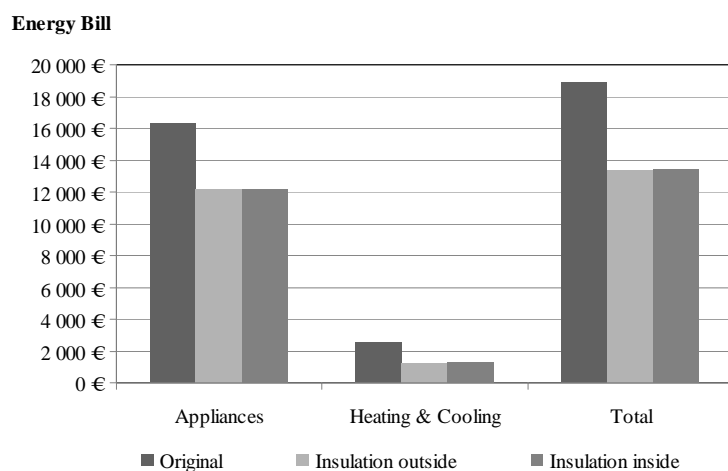
The annual energy bill of the building (Figure 17) was also calculated for the three situations. The energy bill is the price of energy necessary for heating, cooling, appliances and lighting. The lighting systems and appliances characteristics were identified during the visits to the building. The occupation, lighting systems, appliances and HVAC systems schedules were defined in accordance with the Portuguese thermal code [24].

Figure 17. Annual energy bill for the original building and retrofit alternatives

The reduction of the energy bill with the retrofit of the building envelope and with the replacement of the heating system, appliances and light bulbs and with the installation of a chiller is of about 37%.
