Using simplified indices to forecast the seismic vulnerability of New Zealand unreinforced masonry churches

Jason M. Ingham¹, Paulo B. Lourenço², João Leite³, Saahil Castelino⁴ and Edlyn Colaco⁵

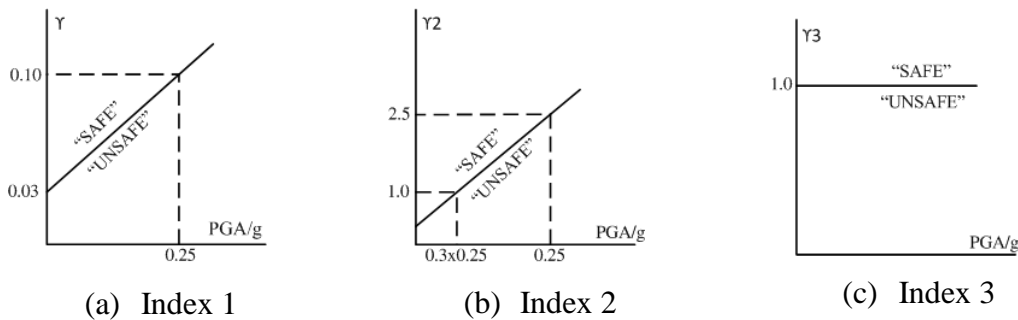
Figure 1. Assumed thresholds for indices 1, 2 and 3 as a function of PGA/g

For indices 1 and 2, the seismicity is taken into account by considering that the threshold value given above is valid for a PGA/g value of 0.25 and assuming a linear variation with PGA/g, as illustrated in Figure 1. Conversely, Index 3 should be constant in different seismic zones, as the effect of seismicity is incorporated. This index format is close to the traditional safety approach adopted for structural design, with a threshold value equal to 1 (see Figure 1).

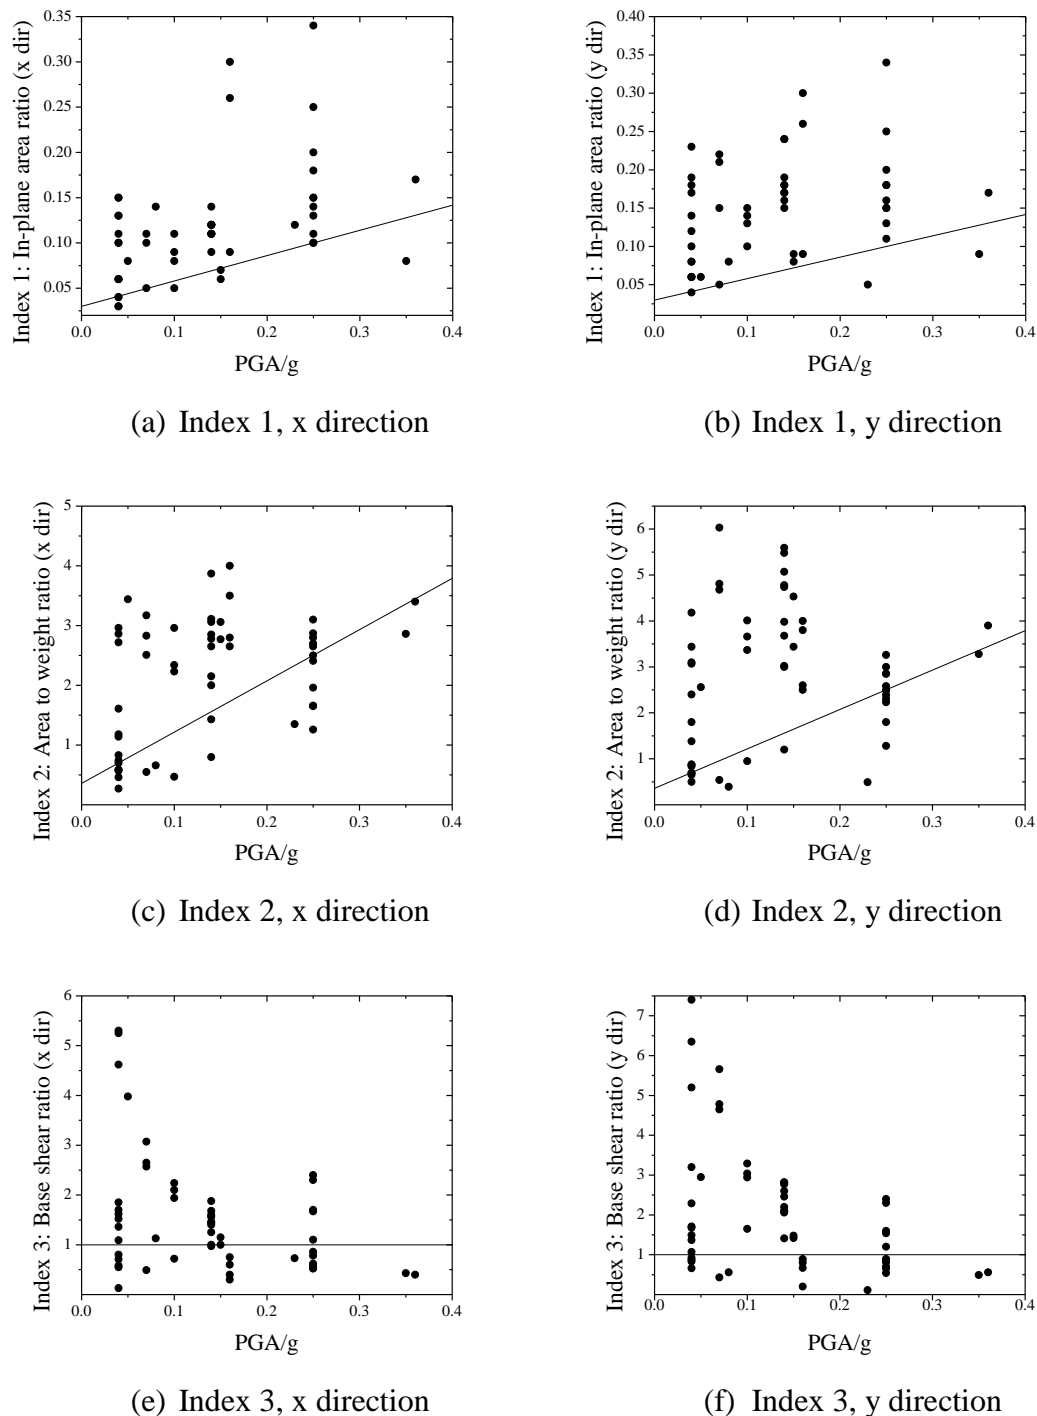
Figure 2. Relationship between in-plane indices and PGA/g for 44 European URM churches

From Figure 2 it is found that Index 1 average values are lower (less safe) in the transversal (x) direction of the church nave, which is expected due to church geometry, although Italian indices were found to be similar in both directions. Index 1 data do not exhibit a clear variation with seismicity, even if the Index value tends to grow roughly with increasing seismicity. It was found that 25% of the churches violated the proposed threshold in the x direction and that 9% violated the threshold in the y direction. This finding suggests that the cases that may merit further investigation are those churches demonstrating deficient earthquake resistance along the transversal direction of the church nave.

Index 2, although being inversely proportional to building height, presents a situation similar to Index 1. Again, the calculated values shown in Figure 2 do not exhibit a visible trend with respect to seismicity, although there is a tendency associated with an increase in Index 2 with increasing PGA. On average, Index 2 data present lower values in the x direction, again justified by typical church geometry. Consequently, this index is violated by 39% and 30% of the churches in x and y directions, respectively. This index is mainly violated by Spanish churches.

Index 3 data show an alarming decreasing variation with the PGA parameter. For moderate and high seismicity areas (PGA greater than 0.15g), Index 3 is violated by the majority of churches, in both directions. For low seismicity areas, Index 3 is also not entirely fulfilled. Individually, 41% and 32% of the churches in the x and y directions respectively violate the Index 3 threshold, which denotes a deficient earthquake resistance along both the transversal and longitudinal directions. This index is mainly violated by Italian churches.

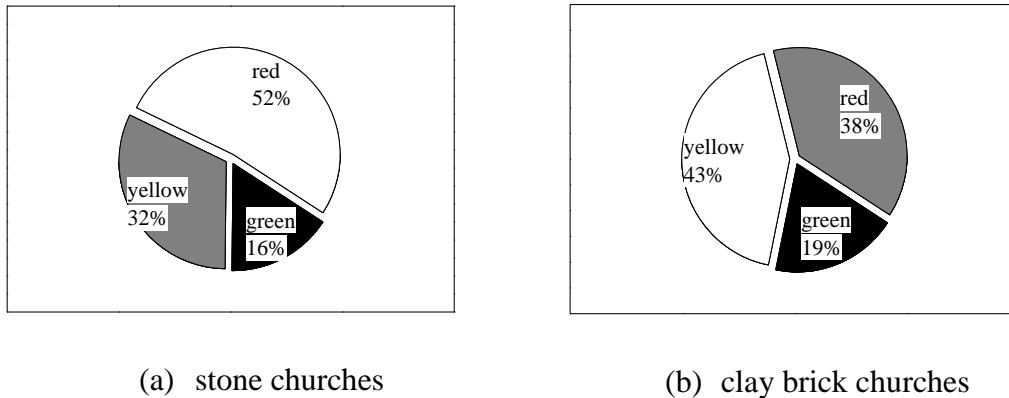
Figure 3. Placard classification for assessed URM churches following the Canterbury earthquakes

A comprehensive statistical analysis of the performance of churches in the Canterbury earthquakes is reported by Leite et al. (2012), including the in situ damage observed, the structural assessment classification assigned by the local authorities and a comparison with the structural classification used in Italy, where a specific survey form for churches is used. For stone URM churches, more than half of the churches (52%) were assigned a red placard and only 16% of the churches had a green placard assigned (see Figure 3(a)). Figure 3(b) shows that a red placard was assigned to 38% of the clay brick URM churches, while a yellow placard was assigned to 42% of those churches. The percentage of red placards assigned for the clay brick typology was smaller than the percentage assigned for the stone churches, but the sum of the red and yellow placards was similar for both masonry typologies and exceeded 80%.

From Figure 7 it may be established that all URM churches in Wellington failed Index 1, for both loading directions. This outcome is largely a result of the high PGA for the region. For Index 2 82% (9 of 11) of Wellington URM churches failed in the x (transversal) direction and 45% (5 of 11) failed in the y (longitudinal direction). For Index 3 100% and 73% (8 of 11) failed in the x and y directions respectively. From this data it is evident that most Wellington URM churches can be expected to perform poorly in a design level earthquake. Recognising that Wellington is a region of high seismicity, this finding is in general agreement with the damage reported to Christchurch URM churches as shown in Figure 3.

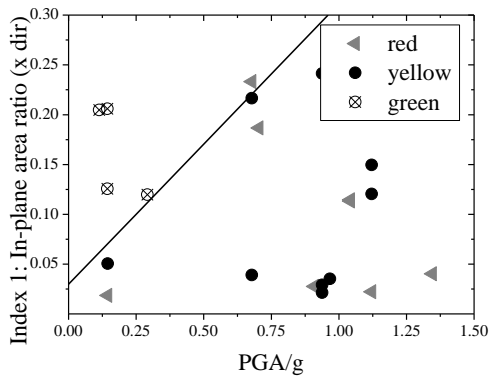
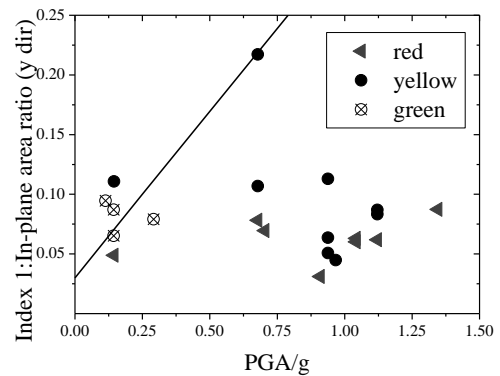
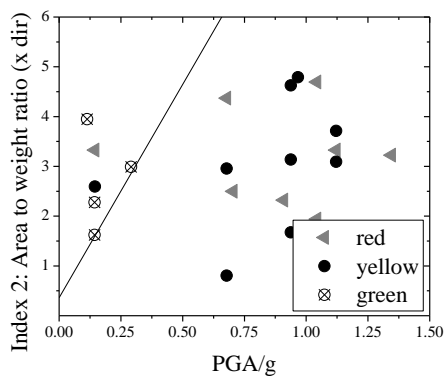
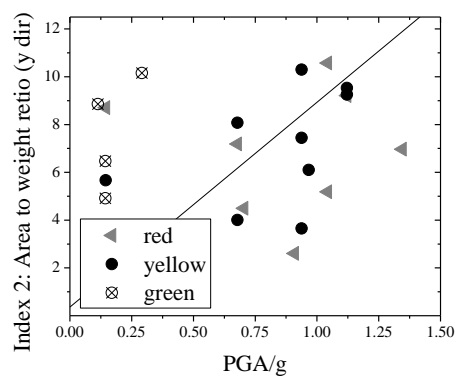
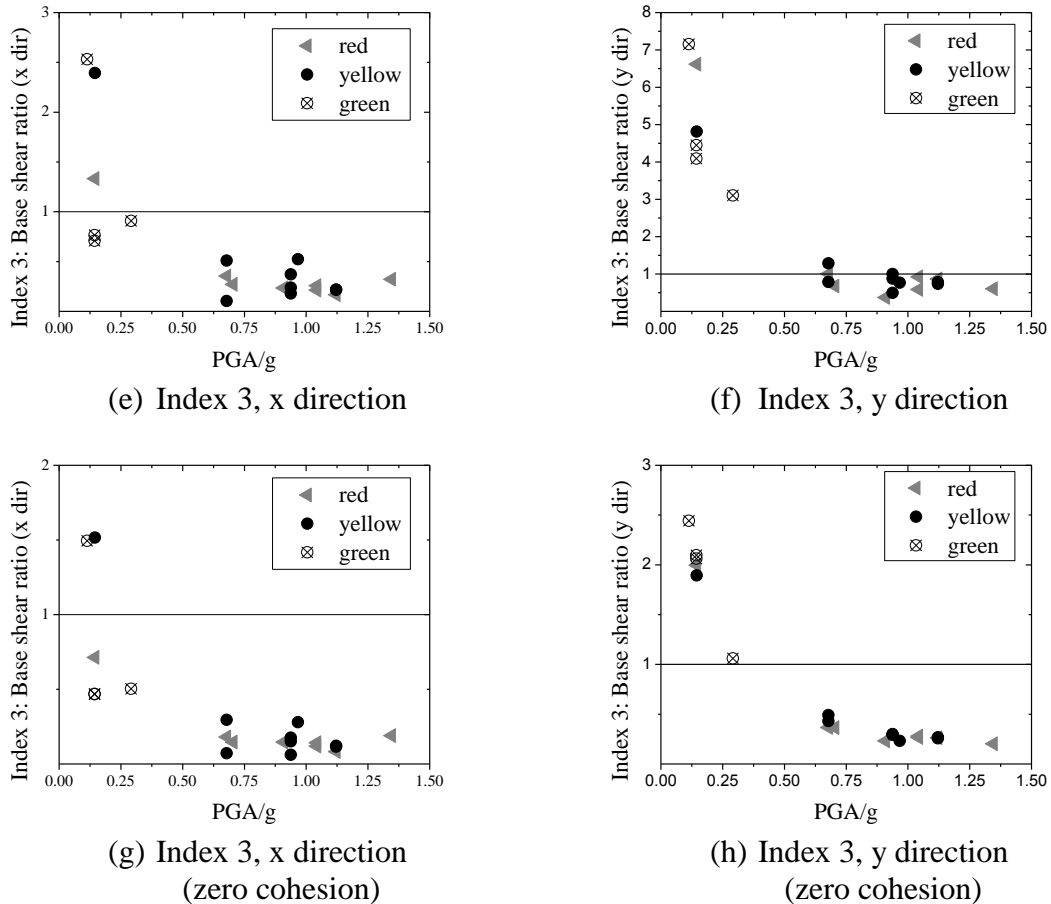
(a) Index 1, x direction

(b) Index 1, y direction

(c) Index 2, x direction

(d) Index 2, y direction

Figure 4. Indices for clay brick URM churches in the Canterbury earthquakes

The indices related to the above mentioned simplified method of analysis were computed for all the stone and clay brick URM churches that were surveyed following the Canterbury earthquakes. Figure 4 presents the scatter plots of each index and the horizontal PGA of the 22 February 2011 event interpolated at each site for clay brick URM churches, as well as the proposed thresholds from Figure 1. The threshold for Index 1 is excellent, with all the green tagged churches falling above or near the line and one yellow and one red church incorrectly identified. The yellow tagged church had only minor cracking with the exception of a large shear crack on one longitudinal wall of the main nave. The red tagged church was also a particular case, as it had pinnacles overhanging from the transversal walls. The thresholds for Index 2 and Index 3 also have acceptable results. The x (transverse) direction provides better results for all three indices, and this is the critical direction. Index 3 exhibits the worse correlation if cohesion is taken into consideration, with better results obtained for zero cohesion.

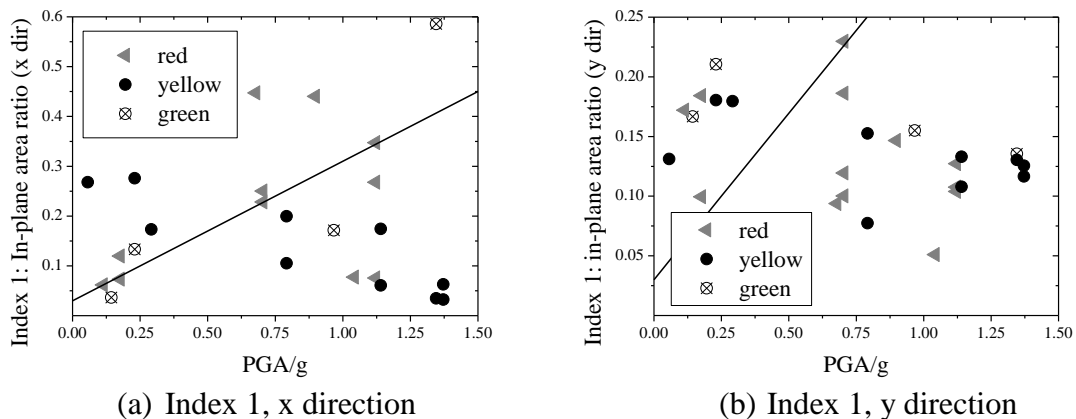
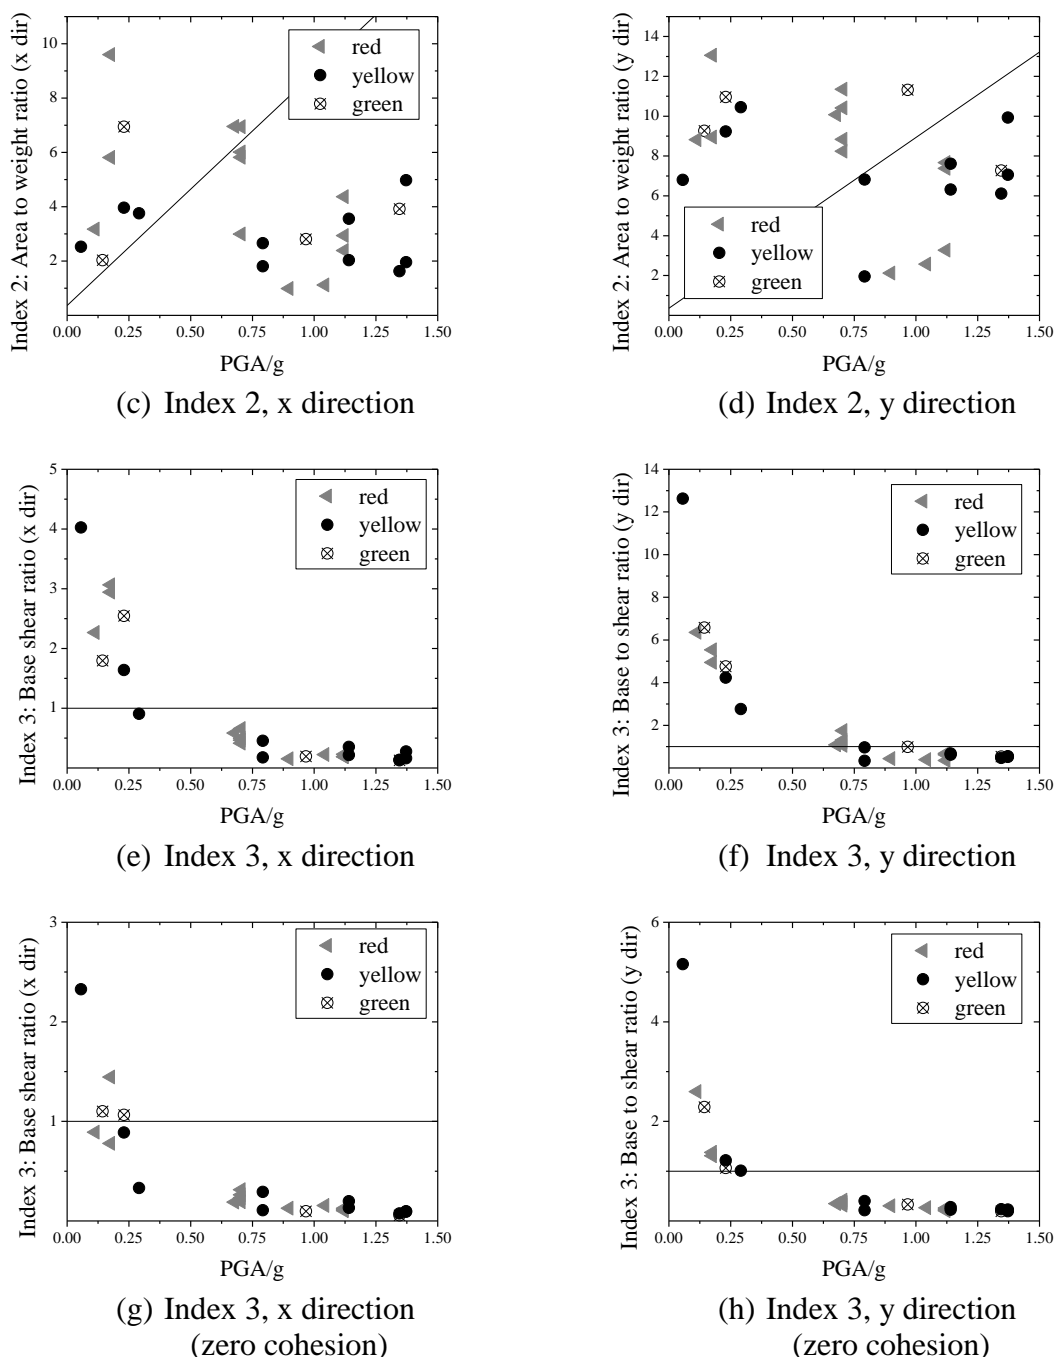
Figure 5. Indices for stone URM churches in the Canterbury earthquakes

The thresholds for the stone URM churches are not as good as those for the clay brick URM churches (see Figure 5). For all indices in both directions, there are green tagged churches that lie under the threshold, and red tagged churches that lie above the threshold. The lack of homogeneity of the stone URM churches justifies the lack of agreement with the thresholds, as the seismic behavior of these churches is rather different. Monumental good quality stone URM churches can present a seismic behavior similar to clay brick URM churches, while weak rubble stone URM masonry lacks interlocking and disaggregates, even for low PGA values, suggesting that it could be helpful to consider sub-sets of typologies for this class of church. Also, the data merits revisiting to establish if any of the stone URM churches had received prior seismic improvements. As for the clay brick URM churches, there is a better agreement with the threshold of Index 3 if cohesion is not taken into consideration.

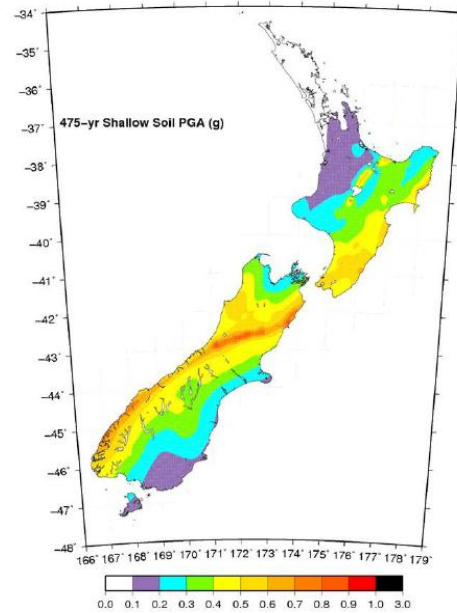
Figure 6. PGA/g values for a 500 year return period earthquake (from Stirling et al. (2012))

development of the city was somewhat comparable to that of Christchurch, with an expectation that the stock of URM churches in Dunedin was analogous to that of Christchurch. 29 URM churches were inspected in Dunedin. Christophersen et al. (2011) report that for a 500 year return period, the 2010 New Zealand National Seismic Hazard Model (2010 NSHM) results in values of PGA/g of 0.540 for Wellington and of 0.192 for Dunedin. The PGA data is also shown in Figure 6.

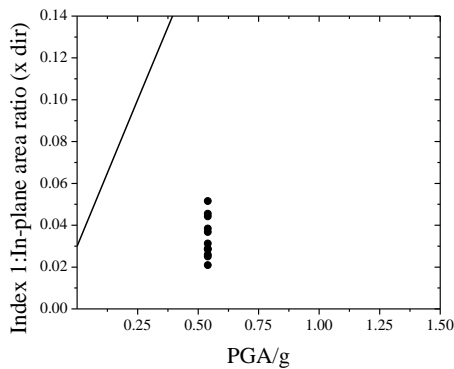
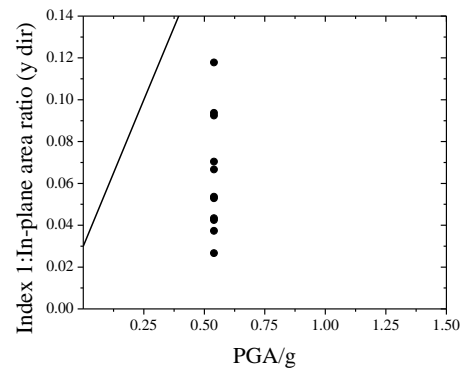
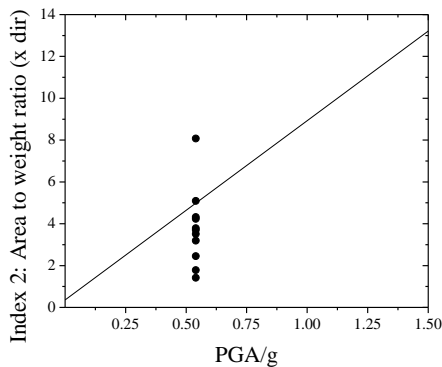
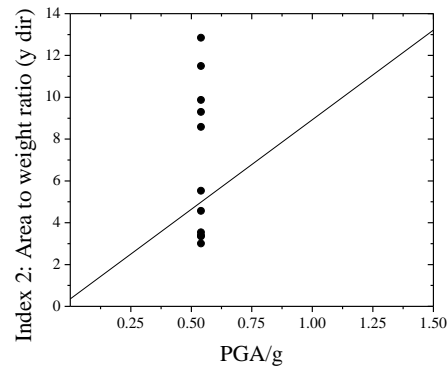
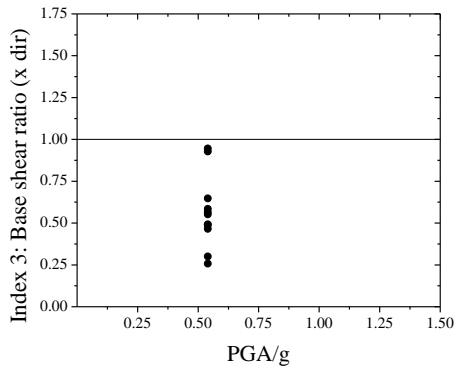
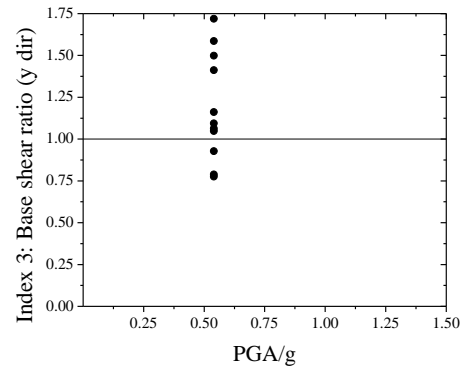
(a) Index 1, x direction

(b) Index 1, y direction

(c) Index 2, x direction

(d) Index 2, y direction

(e) Index 3, x direction

(f) Index 3, y direction

Figure 7. Indices for URM churches in Wellington

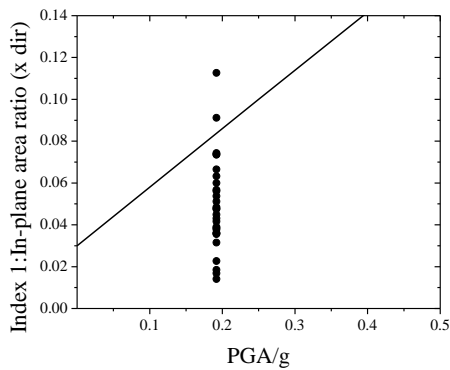
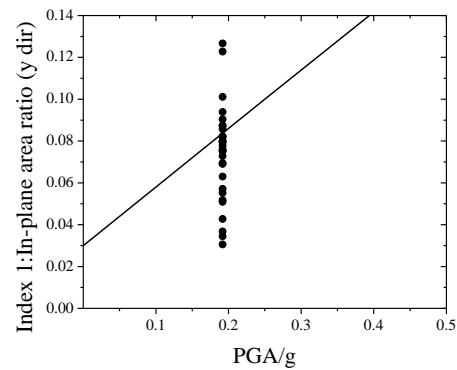
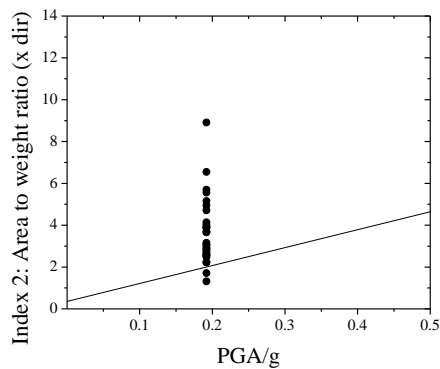
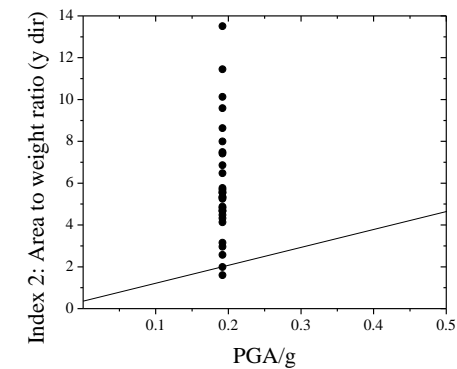
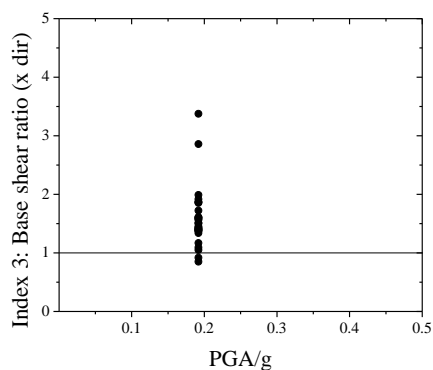
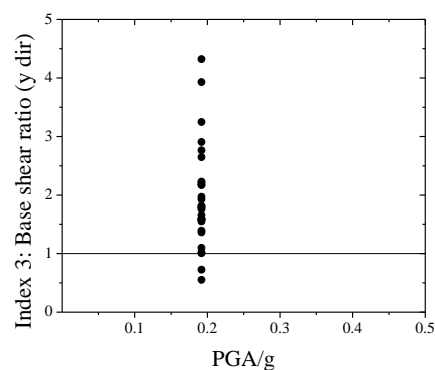
(a) Index 1, x direction

(b) Index 1, y direction

(c) Index 2, x direction

(d) Index 2, y direction

(e) Index 3, x direction

(f) Index 3, y direction

Figure 8. Indices for URM churches in Dunedin

From Figure 8 it is evident that 93% (27 of 29) of Dunedin URM churches fail Index 1 in the x direction and 72% (21 of 29) fail Index 1 in the y direction. However, this finding is in contrast with Index 2 where only 7% (2 of 29) fail in each of the two directions. For Index 3 only 7% (2 of 29) of Dunedin URM churches fail for each orientation. Overall the results from the Dunedin study are an excellent endorsement of the simplified index method, as the procedure has resulted in the identification of a small subset of URM churches that specifically merit priority attention for seismic improvement in a region that by New Zealand standards is of moderate/low seismicity. Images of the three churches that were identified using the simplified index method as most seismically vulnerable are shown in Figure 9.

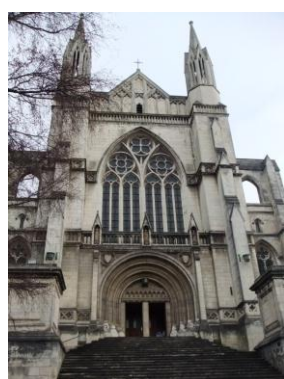
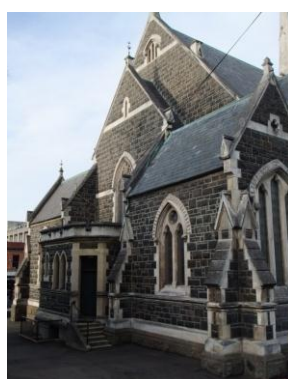
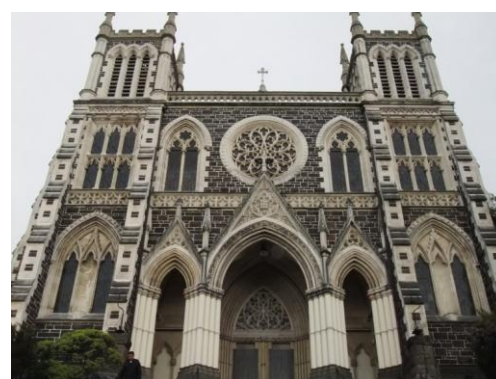
(a) St Paul's Cathedral

(b) Knox Church

(c) St Joseph's Basilica

Figure 9. Three Dunedin URM churches that score poorly on all indices
