# Assessment of the Seismic Behaviour of Unreinforced Traditional Half-timbered Walls

**E. Poletti & G. Vasconcelos**

*ISISE, Department of Civil Engineering, Universidade do Minho, Guimarães, Portugal*

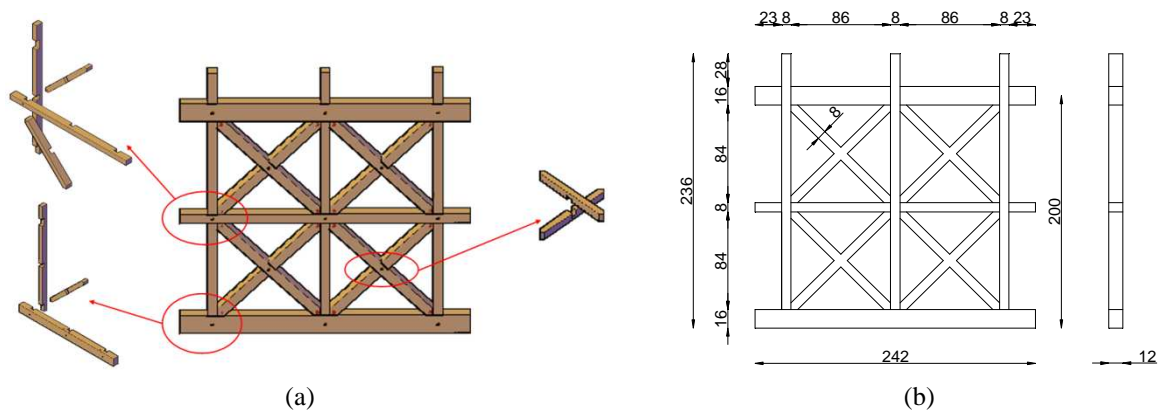
**Figure 2.** Wall specimens: (a) connections used; (b) dimensions of elements in cm

Half-timbered wall specimens were prepared according to dimensions found in existing buildings in Lisbon. All the connections between the vertical posts and the beams are overlapped ones, as well as the connections between the two diagonals of the St. Andrew's crosses, whilst the connections between the diagonal and the main frame are simple contact ones (see Figure 2a).

The walls were built in real scale, with realistic cross sections for all the elements (see Figure 2b). A factor that influences the behaviour of the walls is the connection between the vertical posts and the bottom beam. A variability is met in existing buildings: (1) the post could be considered continuous between one storey and the next, connecting two timber elements with appropriate connections (for example a scarf joint); (2) they could be discontinuous and independent between two contiguous storeys; (3) at times, they could even be in different positions, connected to the base beam of the wall with half-overlapped connections. These variations led to a possible different behaviour of the wall, depending on how “strong” and fixed the base of the wall was. Thus, three configurations for the connections between the base beam and the posts were considered, namely: (1) overlapped connections with a single nail inserted; (2) overlapped connections with multiple nails inserted; (3) steel plates inserted in the connections with bolts and screws.

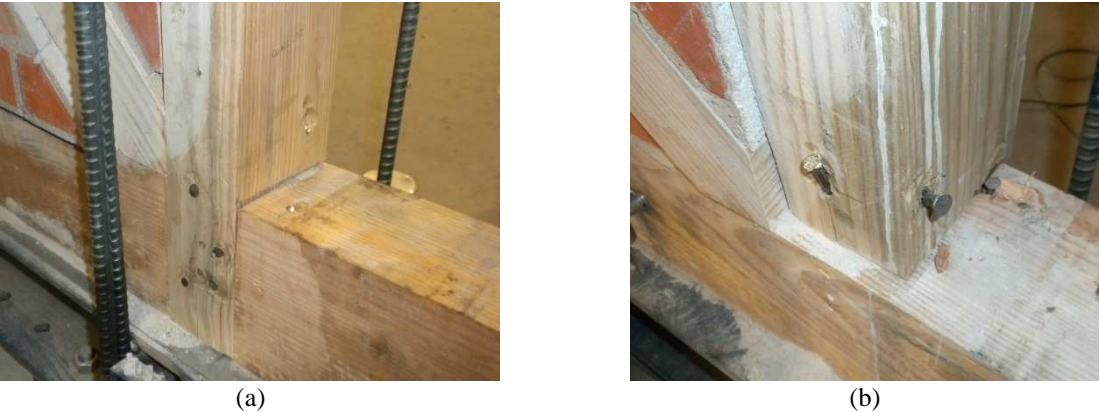
Figure 6. Additional nails inserted at bottom connections

To better understand the influence of the level of continuity in the bottom connections, additional nails were added to the three bottom connections, inserting the nails not only perpendicularly to the cross section, but also transversally (Figure 6a), in order to oppose more resistance to the out-of-plane opening of the connections. The total number of nails in each bottom connection was now 6 nails. Traditionally, a total number of two or three nails could be found in each connection, but considering that the nails used in this study were smaller, a greater number was used. The idea was to avoid the considerable high uplift of the vertical posts.

For this test, nail pull-out was significant and pinching was much more evident than in the previous test. All the nails had the tendency to pull-out (Figure 6b) and the hysteretic loops (Figure 7a) are very flat for low forces, a behaviour which is associated with pinching, i.e. the behaviour associated to the nails which, tearing off the timber, create a free path that gives almost no resistance to the nail.

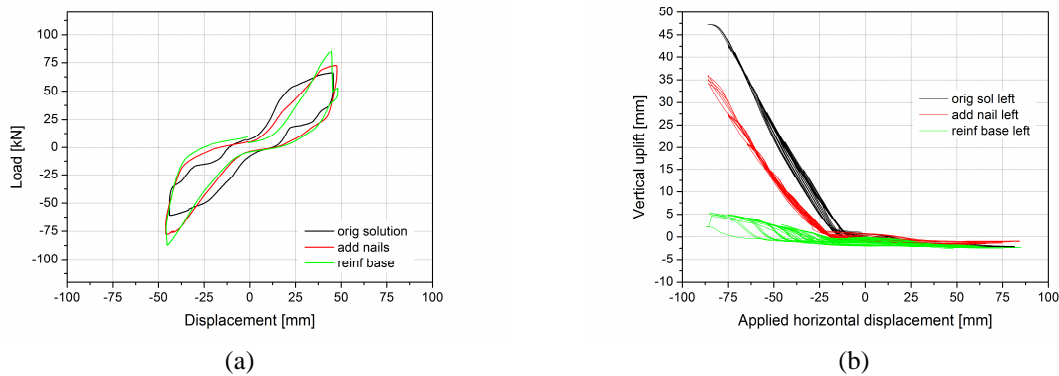
**Figure 10.** Wall behaviour with different bottom connections: (a) typical hysteresis loop; (b) vertical uplift of lateral bottom connection

The different behaviour of the base connections can be understood analysing a typical hysteresis loop for each test. Figure 10a shows the hysteretic loop corresponding to an applied horizontal displacement of 50.61mm, which in all tests coincides with the cycle at which the maximum load was reached. It can be noticed how the loop of the original solution reaches a lower load, but has a comparable stiffness at that cycle as well as a similar dissipated energy, i.e. the energy enclosed in the loop. The solution with additional nails and the one with the steel plates reach a higher load and have a smoother unloading path, since the vertical uplift is lower than that of the original solution (Figure 10b), but the uplift begins for all solution at the same applied displacement. The wall specimens with a more efficient base connection present a higher level of pinching, which tends to reduce the dissipated energy.

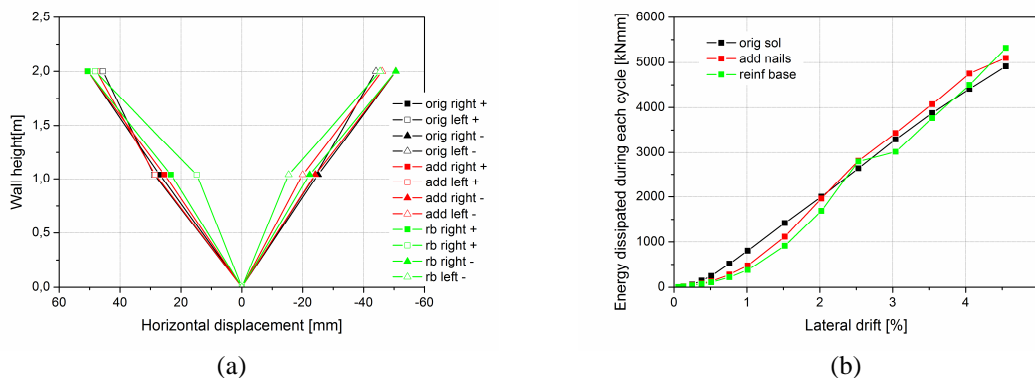
**Figure 11.** Wall behaviour with different bottom connections: (a) lateral deformation of walls; (b) energy dissipated by walls during each cycle

The walls with only nails in the connections present a flexural behaviour. This can be deduced also by the deformation of the wall. Actually, if one considers the horizontal displacement of the wall at different heights (Figure 11a shows the progress at a given top displacement of 50mm), it can be seen how walls subjected to a flexural behaviour exhibit a linear trend of the horizontal displacement with the height of the wall, whilst the wall specimen with the reinforced base exhibits a non-linear progress of the lateral displacement, meaning that the wall is deforming in shear.

Considering the energy dissipated by each wall during the cycles (Figure 11b), the original specimen has almost a linear trend, while the other two configurations have an exponential trend. In terms of values, there are no great differences, but they still point out some characteristics of the walls.

The solution with a reinforced base dissipated less energy for low values of drift, when the behaviour of the wall is still mainly linear for this wall, and then the dissipated energy tends to increase at a higher rate than that of the other solutions, until failure is reached in the wall, so that the energy drops slightly and then it starts increasing again as the wall regains some resistance.

For the wall with additional nails, the same trend is observed; the linear part interests higher values of lateral drift, so at the beginning the wall is dissipating less than the original solution, and then as the behaviour becomes non-linear. This configuration dissipates slightly more energy, since, even though the hysteretic curves have similar strength and stiffness, the loops for the wall with additional nails, for higher displacements, are larger and have a smoother descending branch, since the uplift is lower. Notice that the increase on the fixity degree of the bottom connections influences considerably the unloading branches of the hysteresis diagrams, which is associated to the decrease of the uplift of the post from the bottom beam and to a more reduced detachment of the connection.

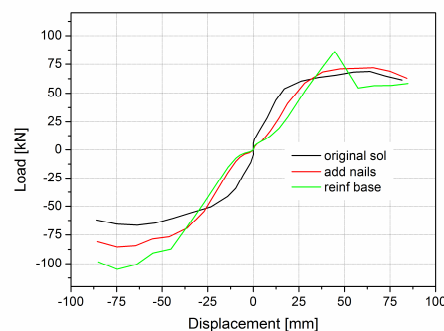
**Figure 12.** Envelope curves of three proposed solutions

In terms of ductility, which can be obtained from the bilinear idealization of the envelope curves of the walls (Figure 12), ductility is higher for the original solution (5.88), while for the wall with additional nails the value of ductility was of 3.13 and for the one with the reinforced base was 2.20. These changes happened because the wall with the original solution presents a higher initial stiffness and lower loads.
