Seismic Response Analysis Of Concrete Block Masonry Buildings: An Experimental Study Using Shaking Table

L. Avila, G. Vasconcelos, P.B. Lourenço, N. Mendes & P. Alves

ISISE, Department of Civil Engineering, University of Minho, Portugal.

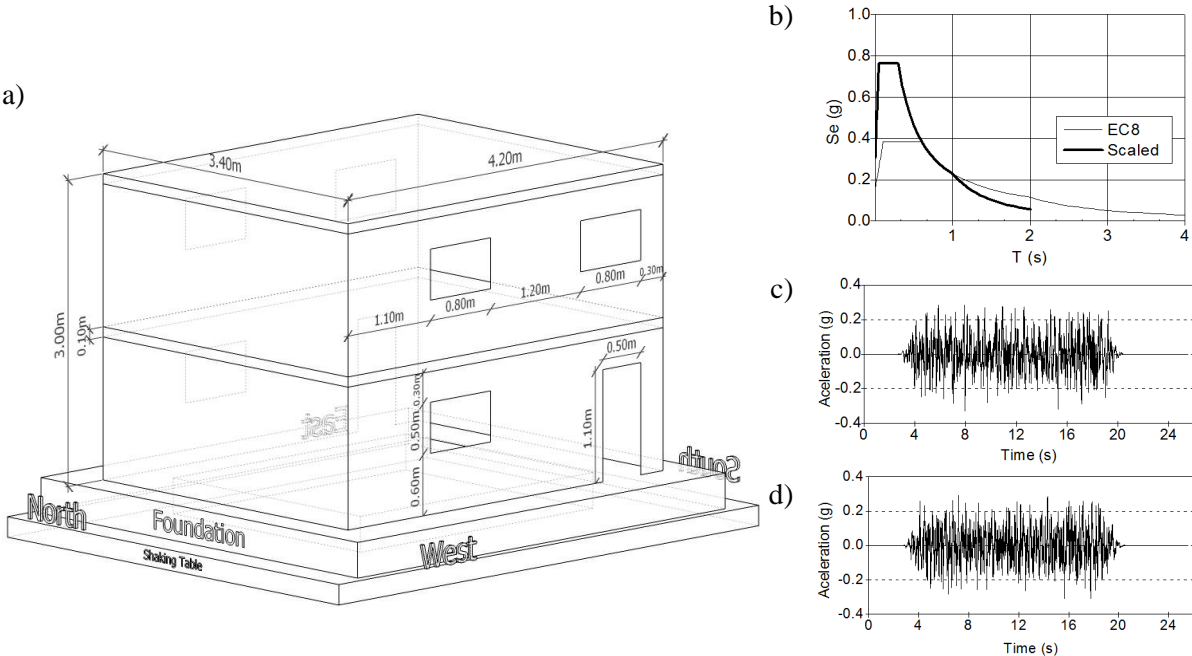
Figure 1. (a) Geometry for RM and UM experimental models; (b) standard and scaled elastic response spectrum; (c) artificial accelerogram North-South direction and (d) artificial accelerogram East-West direction

Cauchy scale law was adopted for the construction of the experimental models and for the input design. Figure 1a shows the final geometry of the scaled masonry buildings. Such a type of scaled models to be tested on a shake table can be used in the case when the stresses induced by the gravity loads are small and negligible with respect to the stresses induced by the seismic forces. This is the case when the lateral load resisting system consists primarily of shear walls.

The tests were developed by imposing simultaneous base excitations, acting along two orthogonal horizontal directions. Two uncorrelated accelerograms based on the type 1 elastic response spectrum for Lisbon zone with ground type A and 5% damping, were implemented, one for each direction respectively. Following the scale law the final response spectrum is show in Figure 1b, and corresponding accelerograms in Figure 1c and 1d. Each building was subjected to a series of dynamic input tests with increasing ground motion, obtained by scaling the accelerograms. The resulting input accelerograms have duration about 17s and spectral acceleration in the plateau region of about 0.75g.

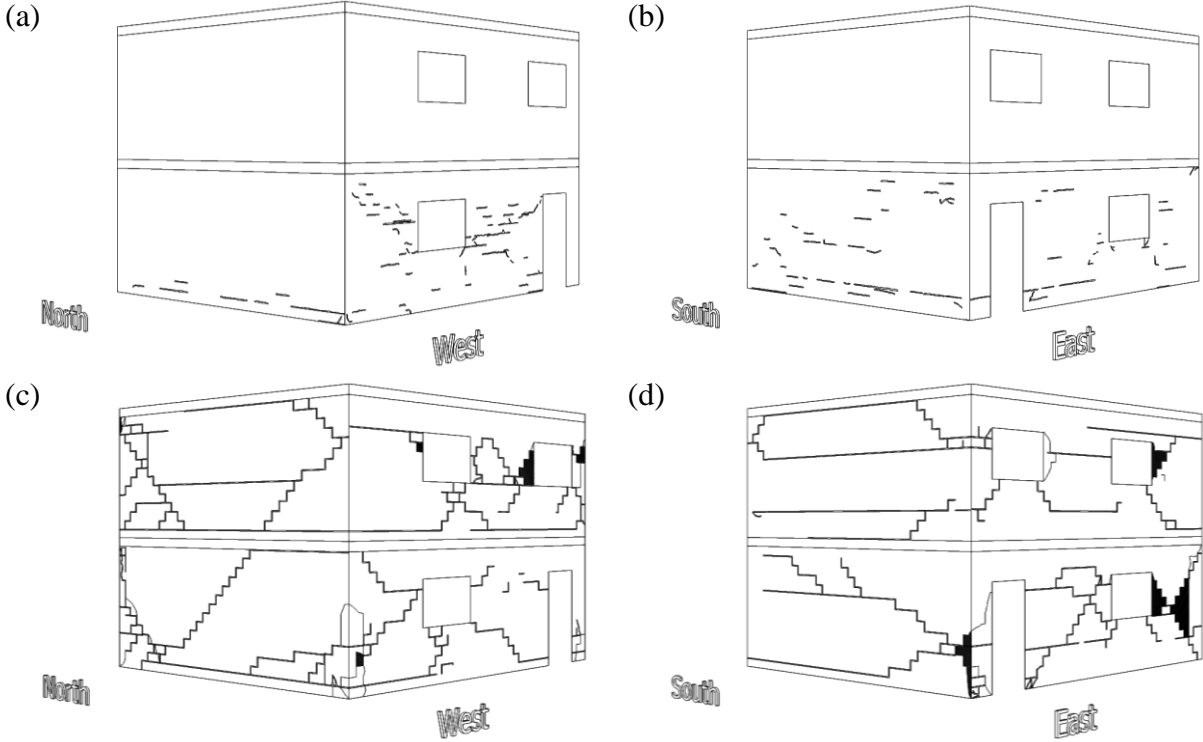
Figure 2. Final damage of: (a, b) RM after 9 test runs; (c, d) UM after 5 test runs

The final damages after an input of 1.61g for RM and 1.33g for UM buildings are presented in Figure 2. It is noted the few damage observed in the RM building after the high strong motion imposed. For this model first cracks appeared after the input test of 100% (0.39g) however it is only until test of 300% (1.33g) that significant quantity of cracks were developed. The model does not present any sign of damage at the second level. The north façade shows only horizontal cracks developed in the mortar joints at the first two rows of units, whereas many smeared horizontal cracks distributed around the

first level wall are found in the south façade, however are also presented similar cracks to the ones observed in the north façade. It was noted that for these two walls 80% of the damaged occurred after the input of 300% (1.33g). In the walls with openings smeared cracks following a diagonal direction within openings are clearly identified. Most of the cracks are horizontal ones at the mortar-unit intersection. It should be mention that the damage in this building started in these walls. This damage is related to the in-plane shear resistant mechanism developed at the first story where stresses are higher due to lateral movements. At the end of the tests maximum crack openings were lower than 1mm.

Major cracks and damages are presented in UM building in which collapse of masonry units were observed at the two levels. For this model significant damage was found at more early stage that the one registered for the reinforced solution. Long horizontal cracks together with stair step ones were found in all walls for the two levels after the input motion of 100% (0.51g). Not small cracks or damage were presented for the test of 50% (0.27g). Most of the stair step cracks started from the windows openings. Subsequence tests developed a mixed in-plane and out-of-plane resisting mechanism of the walls increasing rapidly the initial damages and causes severe horizontal cracks that joined around the whole structure perimeter. This fact develops the separation of the model in well-defined horizontal blocks that promotes sliding resisting mechanisms during shaking tests. Consequently during the final test of 250% (1.33g) several masonry units from two levels started falling out.

As observed the differences in damages between RM and UM models are notorious. The behavior shown for RM building during all the input tests is explained by the contribution of both horizontal and vertical steel reinforcement which increase the connection between structural members. As observed the final condition of this model is very far away from collapse. In the UM building, even the damages were serious, the whole structure did not collapse after and input of 1.33g. The cracking pattern observed for this model differs considerably from the reinforced solution. On it is possible to find clear diagonal cracks that joined with long horizontal ones in both levels. The sliding mechanism generated, increased significantly the displacements of the structure, but at the end of the tests it remains standing. It should be stressed that from the recent past earthquakes, in which masonry

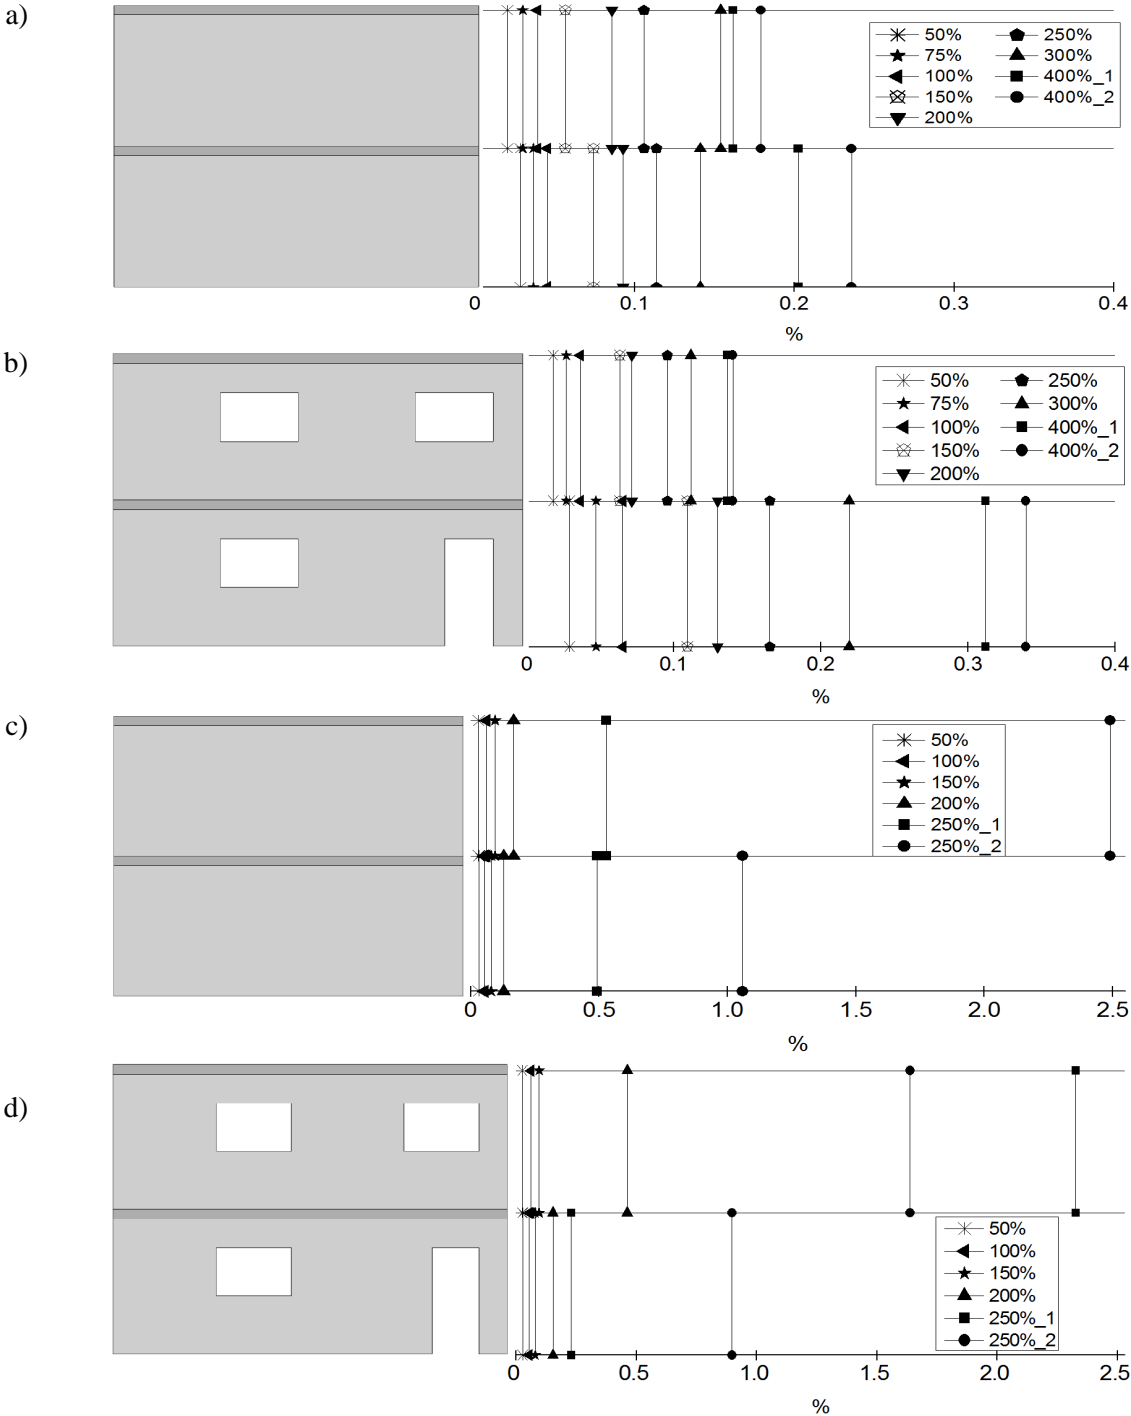
Figure 3. Interstory Drifts: (a,b) RM building and (c, d) UM building

The in-plane behavior of the two structures is analysed in terms of interstory drifts, which is defined as the percentage of the relative horizontal displacement of adjacent floors in relation to its story height. Figure 3 shows the interstory drifts in both directions for the two models.

Results from the RM building show a correlation between the incremental input series and the maximum interstory drift registered in both directions. It is observed that higher values are at the first level as well for both directions with a maximum value of about 0.35% in case of longitudinal walls. Maximum values for the second level are less than 0.18%. The results are in agreement with the damage in the sense that for this model cracks were only noticed at the first level. In general visible cracks are presented when story drift at the first level are over 0.15%.

Opposite situation is found in the UM building. In this model similar behavior was observed in both directions in which maximum interstory drifts were registered at the second level, with a value of about 2.5%, whereas the first level registered a maximum value of about 1%. From the plots it is observed that second's level drifts are higher than the first level ones since the test of 150% in which the maximum base acceleration of the shaking was 0.8g. This behavior is explained due to the accumulated damaged occurred at this stage that caused the development of a sliding mechanism through the horizontal cracks that joined around the perimeter of the building. According with (Magenes and Calvi, 1997) for unreinforced masonry walls the ultimate deformation capacity in shear is very stable when expressed in terms of drift and corresponds approximately to 0.5%. As observed, the damaged presented for the unreinforced building when interstory drifts are about this value is severe, but due to global connection between structural elements given mainly by the mortar and the bond pattern it was possible to attain higher drift without building collapse.

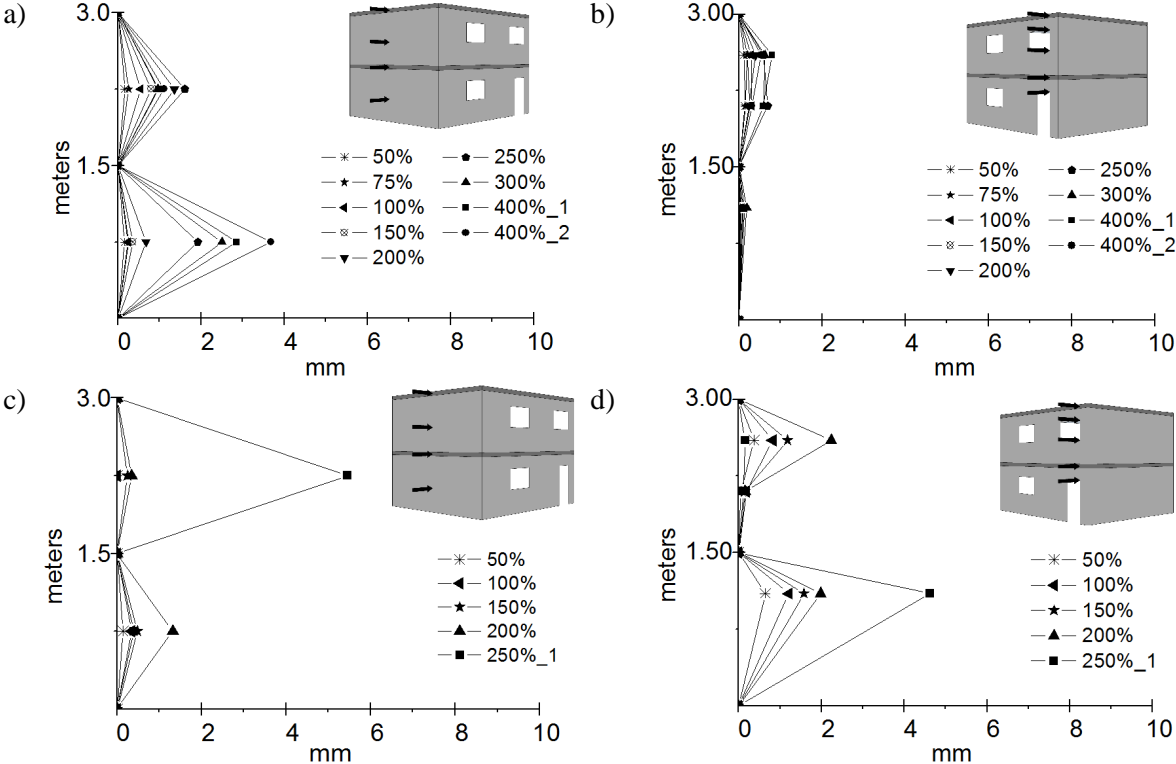
Figure 4. Out of plane displacements: (a,b) RM building and (c,d) UM building

Another important effect studied from the tests was the out-of-plane displacements. As known the vulnerability of masonry to out-of-plane loads can result in the early collapse of structural masonry walls. Figure 4 shows the out-of-plane displacements for both models. Displacements are presented as related to the slabs, in this way the actual out-of-plane displacement carried out by the walls is studied.

The structural behavior of RM building to out-of-plane forces reveals a stiff structure. In the longitudinal direction a maximum of 4mm was registered, as expected according with the damage, it

happened in the first floor. Similar to the interstory drifts, for this level an increase on input motion represent an increase in the out-of-plane displacements. This situation is different at the second floor in which maximum values are less than 2mm. Here, although with small differences, the displacements do not show relation with the increased input sets.

As expected higher maximum displacements are found in the UM building. In the longitudinal direction records from the last input test at the first floor could not be measured due to loss of equipment during the test. Maximum value at this floor is about 1.8mm for an input of 1.11g. The second floor attained a maximum out-of-plane value at the last test, input of 1.33g, near 6mm. However previous test presented, with an input of 1.11g, a maximum of 0.3mm, which means a difference of more than 5mm between consecutive tests.

In correspondence with the RM building plots, for UM building was analysed the same cutaway section in the transverse direction. Here a more consistent behavior is found in relation with the inputs in which progressive out-of-plane displacements are presented. The maximum value is about 4.5mm and was recorded at the first level. At the second level the maximum attained a value over the 2mm. The behavior of this model for the out-of-plane displacements is clearly explained for the sliding mechanism occurred and previously mentioned. As observed in recorded videos the sliding behavior was more obvious to happen in the transversal direction. This mechanism could also explain why the small out-of-plane displacements in the longitudinal direction for high input motions. Finally it is important to highlight that for the values found in the proximity of the corner the traditional bond pattern adopted presented an adequate behavior even for large values of seismic loading.

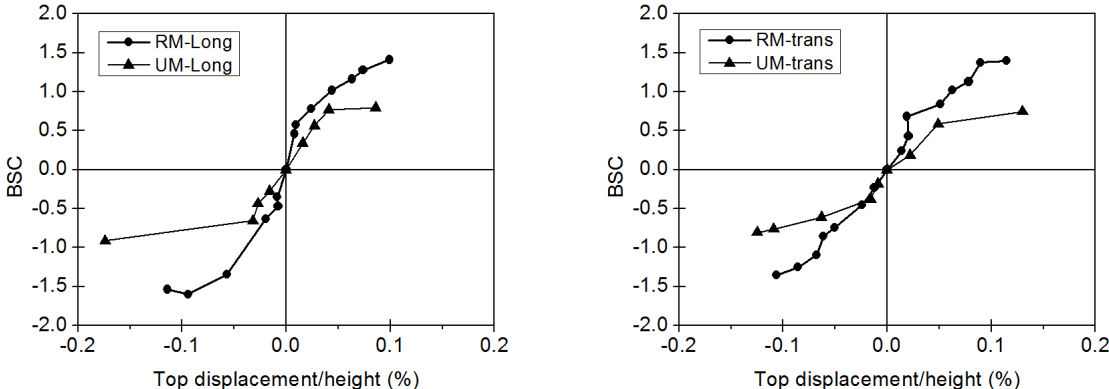
Figure 5. Hysteresis envelopes

The relation between the shear force at the base of the buildings and the global model drift allows a good understanding of the global behavior of the models. Figure 5 shows the monotonic envelopes of the dynamic behavior developed in the models during each individual test run.

The base shear has been calculated as the sum of the inertial forces developed at each story, and is given in terms of base shear coefficient (BSC), calculated as the ratio between the base shear developed in the model during each shaking test (BS) and the weight of the model above the base (W), i.e. $BSC = BS/W$.

From these plots it was evident that the models presented stiffness degradation. Here it is possible to observe how the stiffness of the RM model is higher than the stiffness of the UM building, both in the longitudinal and transversal directions. This behavior is observed since early stages and corresponds with both the higher level of damage and the larger displacements found in the UM building. However a similitude between models is found, on them stiffer behavior is presented in the longitudinal direction.

The comparison between hysteresis loops, from where the envelopes are obtained, for the two models reveals the difference in energy dissipation. The hysteresis loops found for the UM building involves more energy dissipation, particularly in case of the transversal direction, due to the predominance of the sliding mechanism. In comparison between the same input tests the displacements obtained for the UM model are considerably higher than the ones found in RM model. This behavior clearly shows the improvement in resistant capacity, stiffness performance and displacement response given by the steel reinforcement when it is used in masonry structures.

As observed the maximum values of BSC in UM building are less than 1 for both directions, whereas RM building attained values around 1.5, however the results also indicate clearly that the UM model reached the maximum capacity, while the RM model is possibly also rather close to the maximum capacity as some of the envelopes seem to present already a plateau.
