# Seismic Assessment of a Typical Masonry Residential Building in Bosnia and Herzegovina

**15 WCEE**  
LISBOA 2012

## SUMMARY:

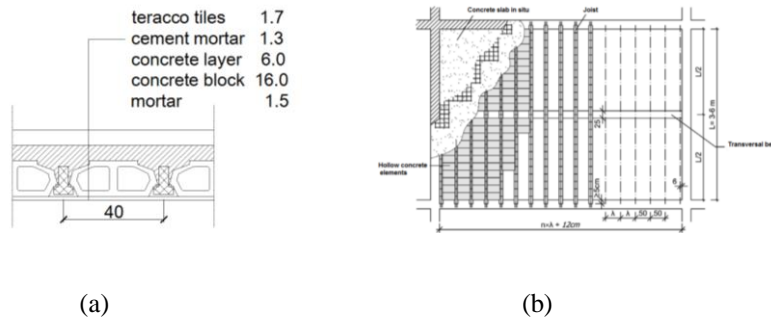
**Figure 3.** Constructive details: (a) Semi-prefabricated concrete elements; (b) Floor (Peulić, 2002).

In the plan, the structure is of dimensions 38.0m by 13.0m with 7 levels. The structure is composed of load bearing walls only in the transverse direction (y direction, see also Figure 2) with slabs made of semi-prefabricated elements. The longitudinal walls are not considered as load-resisting elements as they have been made weak by many openings as shown in Figure 1 (b). The transversal bearing walls are brick masonry walls of 0.25m thick and a non-bearing façade wall made of hollow bricks of 0.125m thick, while the inner bearing walls are solid brick walls of 0.25m thick. Bricks are of standard dimensions 25x12x6.5cm, connected by cement mortar. The slabs are made out of "Herbst" concrete hollow elements as shown in Figure 3(a). The roof is of the same construction as the floors, providing continuity of the construction, and later on the possibility for additional storeys to be added. Construction of these blocks was regulated by Yugoslavian standards B.D1.030-1965 (Peulić, 2002). The basement walls are made out of concrete. Inner perpendicular walls are 0.38m thick, while the outer (longitudinal) walls are 0.30m thick, and two inner walls are 0.25m thick. As the span is larger than 3.0m it was foreseen, as per above mentioned standards at that time, to construct a transversal beam of 0.25m width with the same height as the slab, see Figure 3(b). Visual inspection revealed that there were no major damages on the structure.

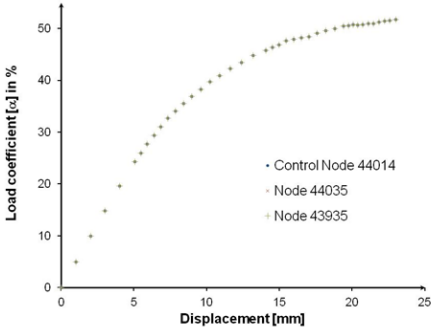
**Figure 8.** Capacity Curves for Nodes 44014, 44035 and 43935.

Figure 8 shows the capacity curve for "+Y" direction. The nonlinear behavior of the structure starts very early and the maximum load coefficient reached is of  $\alpha=0.518$ . It is also possible to observe that

the movement of the nodes at the top of the structure in the same horizontal line (nodes 43935, 44035 and 44014) as shown in Figure 8 proved the rigid floor assumption adopted in section 3.

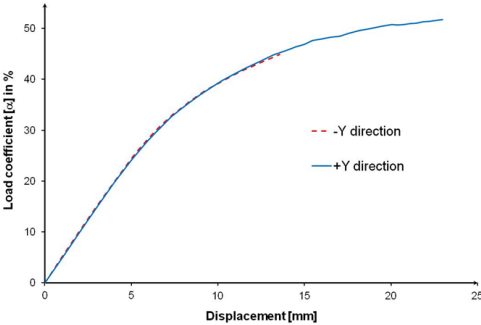
Figure 11. Comparison of Capacity Curves for "+Y" and "-Y" direction for control node 44014.

In both directions the structure is able to sustain a force in the value of 45% to 52% of its weight (Figure 11), which could be connected to the rather good characteristics of masonry. Some redistribution of the forces might have been caused due the existence of the longitudinal wall (W-X2).

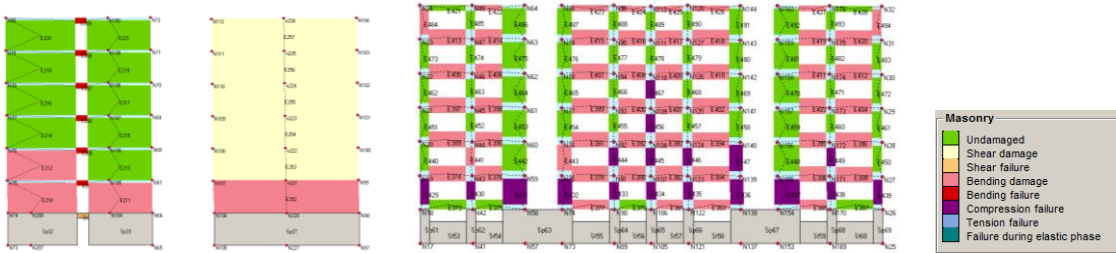
Figure 13. Damage in the walls in "+Y" direction at the failure stage: (a) W-Y4; (b) W-Y6; (c) W-X1; (d) legend.

The capacity curve of the structure while exposed to the load patten proportional to the mass in "+Y" direction is shown Figure 12. As it can be seen from Figure 13 (see also Figure 16(c)) bending damage is located at the spandrels above the doors and windows, and even in some of the walls bending failure is observed. Shear damage is seen on all the perpendicular walls (Y direction) and especially on the wall W-Y6. The basement which is made out of concrete remains undamaged during the application of the load.

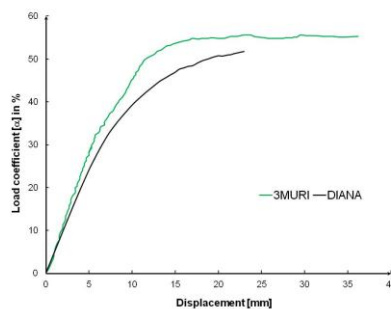
Figure 17. Capacity Curves: DIANA vs. 3MURI in "+Y" direction.

The capacity curves for the "+Y" direction obtained by DIANA and 3MURI are compared in Figure 17. The capacity curve achieved using DIANA, once the maximum strength was obtained, stopped due to convergence issues. The capacity curve obtained from 3MURI after reaching the maximum strength continues on with a horizontal plateau, as it adopts elastic-ideal plastic constitutive curves for the structural elements. The difference in the stiffness can be attributed to the rigid connection between spandrel and pier elements assumed by 3MURI. The difference regarding the maximum load coefficient is about maximum 6.9%, which can be declared as acceptable given the differences between the modeling strategies.
