## Neoformations on stony materials of modern building works

C. Alves<sup>1</sup>

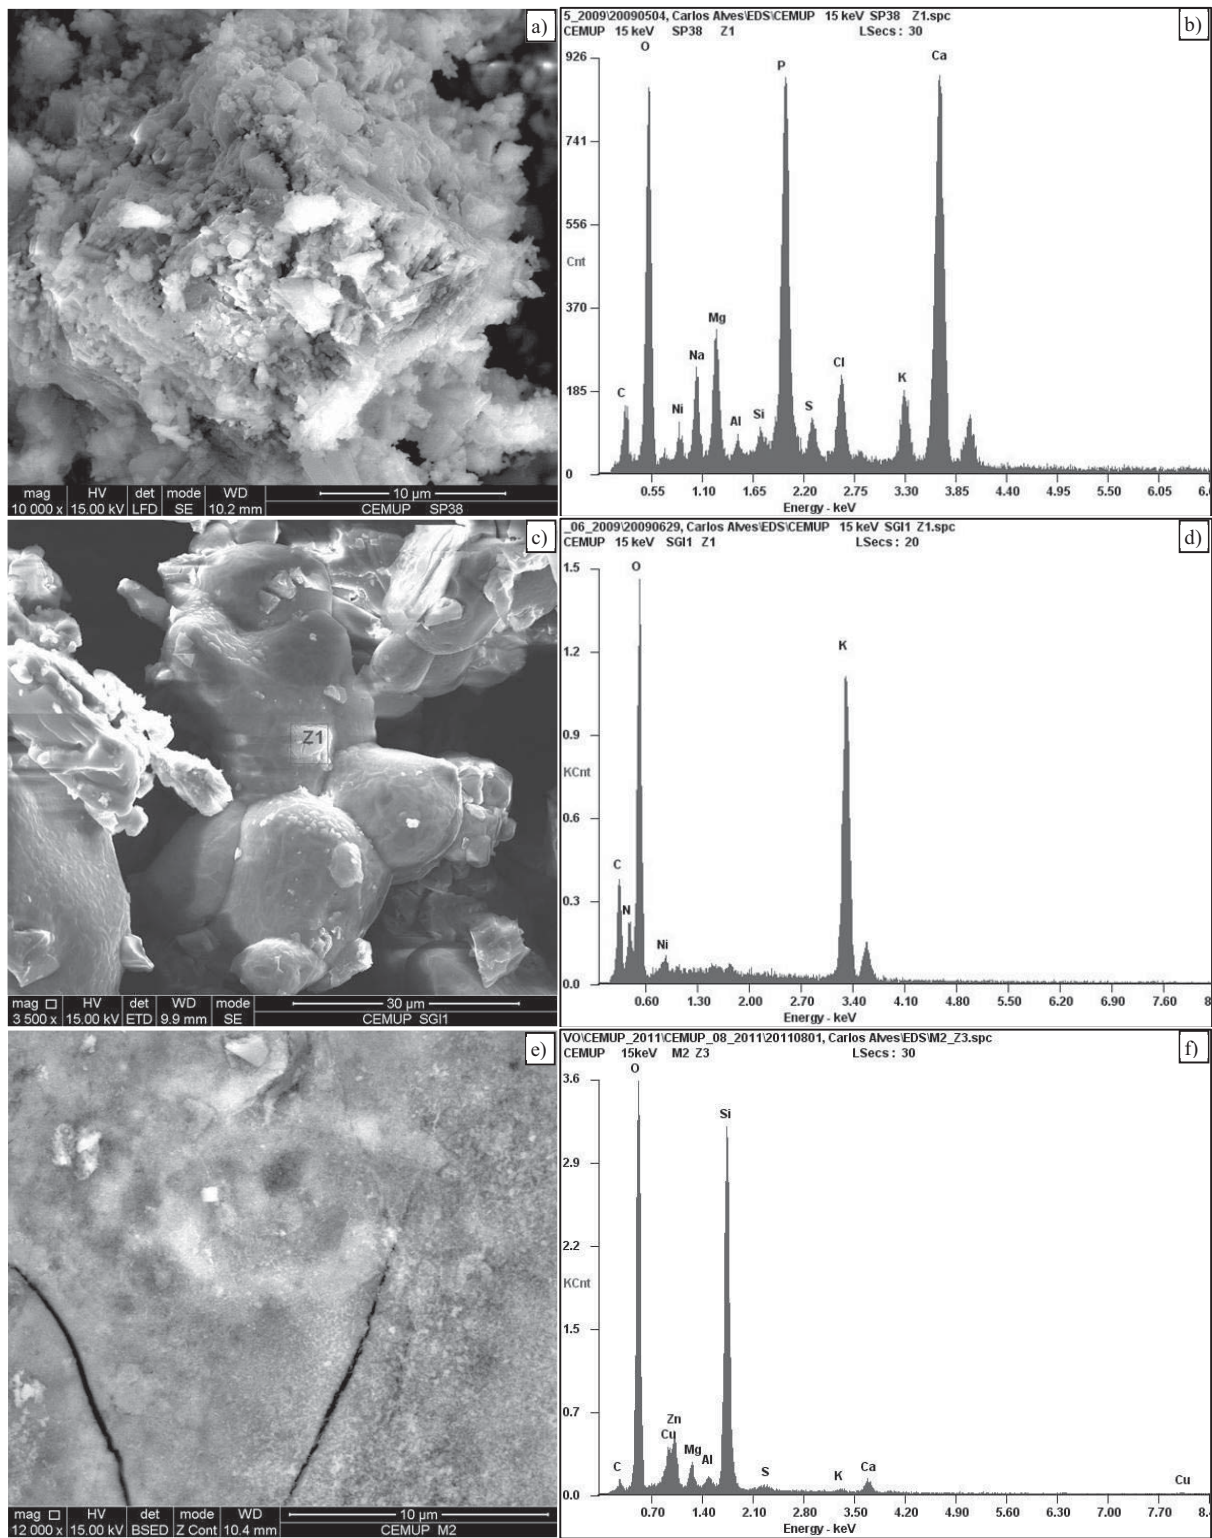
Fig. 1 – Neoformations in modern built works: a), b) phosphate aggregates; c),d) potassium nitrate; e),f) silica-rich stains. Results obtained at CEMUP laboratory (University of Oporto, Portugal).

In a study of diverse modern constructions in towns of Northern and Central Portugal were identified diverse neoformation substances in stony materials (products clearly resulting of metals corrosion were not considered in this study). The dominant inorganic coatings and stains in the studied constructions are carbonate-rich whitish ones that can present diverse morphological features. Some of these carbonate-rich coatings have showed textural features defining a kind of urban travertine and the existence of several layers suggesting diverse episodes of solutions circulation and crystals precipitation, indicating the recurrence of the neoformation processes. Phosphates aggregates were also detected in several built surfaces, including indoor areas (Fig. 1a,b). Another relatively common occurrence are efflorescences of more soluble salts, dominated by alkaline sulphates and carbonates (especially sodium sulphate) but were other salts such as alkaline nitrates (Fig. 1c,d) and chlorides and magnesium sulphates have also been occasionally found. In some buildings it was possible to observe black crusts comprising gypsum aggregates. A very rare neoformation are silica-rich stains (Fig. 1e,f) that occur associate with calcium carbonate stains and metal corrosion products. The observed neoformations show a great geochemical and textural diversity in the surfaces of stony materials of modern built works, being evidences of diverse possible pollution sources that can interact under variable environmental conditions. Besides an important role that seems to be attributable to mortars materials, there are also possible contributions from atmospheric pollutions and the presence of alkaline nitrates could be related to organic sources being admitted that they could either represent the persistence of contamination conditions from the past in the soils or the recurrence of the same polluting conditions. Also of particular interest are the textural informations indicating recurrence of neoformation episodes and the chemical associations observed even in some very small samples.
