Min Metall Explor. 2020 June 17; 37(6): 1919–1930. doi:10.1007/s42461-020-00239-0.

Investigation of Machine-Mounted Area Lighting to Reduce Risk of Injury from Slips-Trips-Falls for Operators of Mobile Surface Mining Equipment

Alan G. Mayton¹, Brendan Demich¹, Mahiyar F. Nasarwanji¹

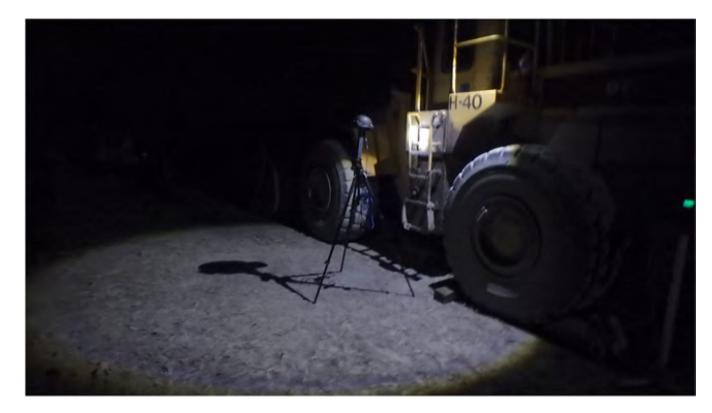
Fig. 3.

Area luminaire-1 pattern displayed in setup for measurements associated with ingress/egress on the CAT 980C wheel loader

pattern, and mounting brackets. The desired light patterns were visually selected for the areas of interest on the ground and ingress/egress systems. Area luminaire-1 provided a clearly defined circular pattern (Fig. 3) but a smaller area than area luminaire-2. In contrast, area luminaire-2 displayed a somewhat irregular and large elliptical-shaped pattern (Fig. 4). For measurements at the rear of the HTs and FELs, area luminaires were mounted in the vicinity and slightly above the row of lights and reflectors mounted in this location (back-up lights, warning lights, etc.).

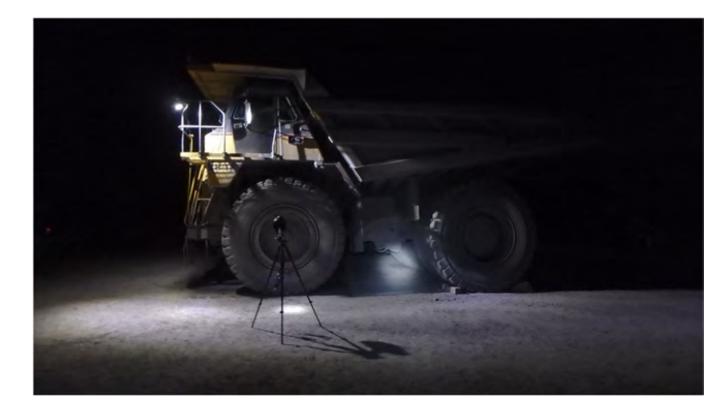
Fig. 4.

Area luminaire-2 beam pattern displayed in setup for measurements associated with the pre-shift walkaround tasks on the Komatsu HD785 haul truck

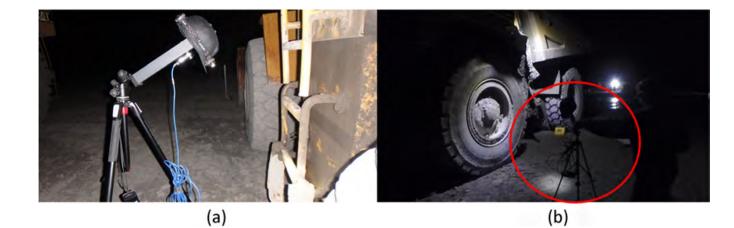
Fig. 5.

The setup for measurements that represent a mine worker at (**a**) the ladder (first rung) of the smaller front-end loader and (**b**) the ground at the driver's side front tire of the haul truck during pre-shift walk-around

Next, the selected tripod, representing the machine operator, was equipped with a mine worker's hardhat fastened to a rectangular plastic structure that allowed the T10A sensor head to be bolted at the approximate location of the worker's eye height of 1.7 m (66 in.). The tripod was positioned approximately 1.8 m (72 in.) from the ground at a marked target location and 0.3 m (12 in.) from the first rung of the ladder and on the ground at the driver's side front tire of the haul truck during pre-shift walkaround at approximately 1.2 m (48 in.) from the sidewall edge of the truck tire (Fig. 5a and b).

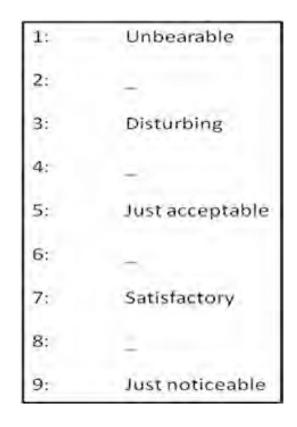
The subjective rating scale for discomfort glare from De Boer

To determine values of discomfort glare for the different area luminaires, the objective method was used to predict subjective values that make up the subjective De Boer rating scale. The De Boer method features a nine-point rating scale with odd-numbered verbal descriptors (Fig. 7). It was developed as a qualitative method for estimating discomfort glare from lighting systems [15].

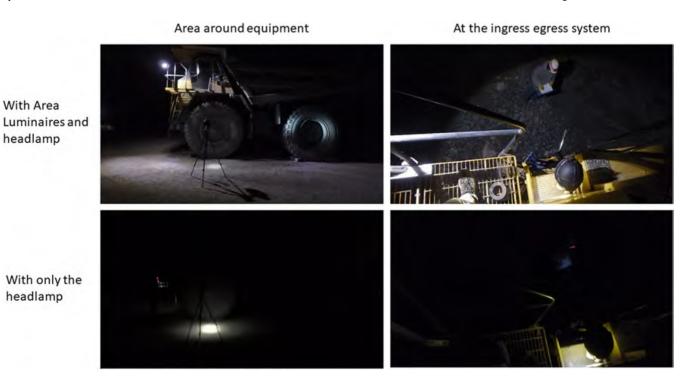
Fig. 13.

Comparison of the area illuminated using the LED area lighting plus the headlamp (top left and right images) versus the headlamp only (bottom left and right images). The scenes depicted are at ground level on the driver's side of the equipment (left images) and at the top platform of the ingress/egress system (right images)

The need for LED area lighting to supplement the task illumination provided by a headlamp is certainly demonstrated in this study. During data collection, we noted the presence of ruts 0.5–0.10 m (2–4 in.) or greater in the ground surface created by tire treads. These ruts are most pronounced after a rainfall that causes muddy operating conditions. Awareness and discernment of these hazards is critical to detecting and avoiding these slip-trip-fall (STF) rut hazards, and such awareness is not possible with the limited spot lighting from the headlamp. Rather, a broad beam and distribution pattern is needed, which can only be provided by an area luminaire that is preferably fitted with an LED source. The simple and low-cost area luminaire-1 appears to be a quick and practical solution for reducing STF injury risk. Other commercially available lights could be evaluated for use by carrying out the measurements described earlier. Of course, the location and placement of the area luminaires is critical to improving illuminance levels on the ingress/egress systems and the ground surfaces for the walkaround inspections. After optimization and securing of the area luminaires, maintenance and housekeeping are the next priority to ensure that dust, dirt, or debris does not accumulate on the lens or motion sensor that would diminish light levels.
