# Journal of Materials and Engineering Structures

## Research Paper

### Concrete beams using seawater and sea sand reinforced with steel and GFRP rebars exposed to marine environment: An experimental study

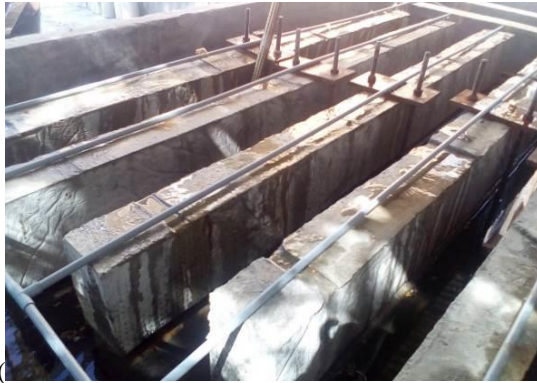
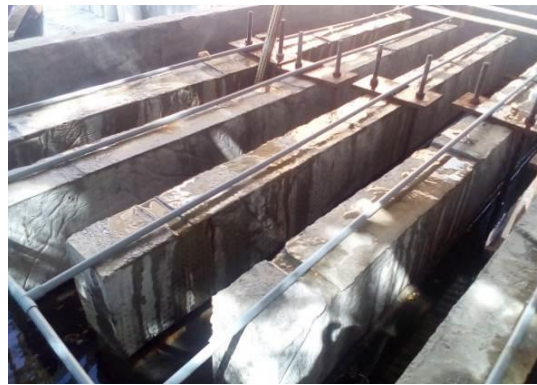
All tested beams were cured in natural conditions for 28 days. Then, the beams were loaded in a three-point loading scheme until occurring cracks in the tension zone. A couple of beams B2 and B5 were loaded together with the loading system shown in Fig. 2. This method of loading has also been used by Prof. François and his team in research on corrosion [29, 30]. When the maximum crack width reached 0.2 mm, the load was kept instant and the beams (B2, B3, B5, and B6) were kept in the marine aggressive environment generated by a spray system of seawater located along the beams in an empty room with a roof. Meanwhile, beams B1 and B4 were reloaded and tested until failure. During the first 12 months, the beams

were subjected to wetting–drying cycles in order to accelerate the corrosion process, accordingly one day of spraying and

Fig. 2). After 12 months, the beams B2 and B5 were tested until failure, and the remained beams B3 and B6 were released from spraying system and kept outdoor under initial sustained loads for 48 months.

**Fig. 2 – Seawater spraying system on testing beams.**

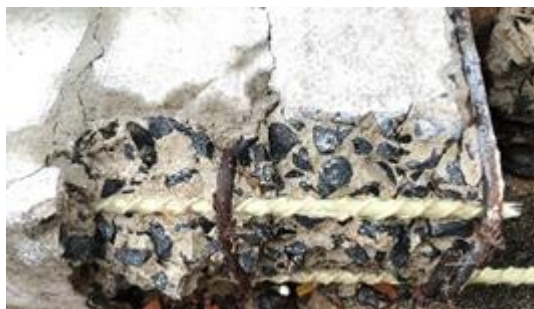
As mentioned above, one of the outstanding advantages of FRP reinforcement is their corrosion resistance. Indeed, it can be seen in Fig. 5a, and Fig. 5b that the surface GFRP rebars in RC beams exposed to the marine environment in 12 months and 60 months remains intact without any signs of corrosion damage. In contrast to GFRP reinforcement, the steel bars in RC beams exposed to seawater were significantly damaged (Fig. 5d).

a) GFRP bars after 12 months

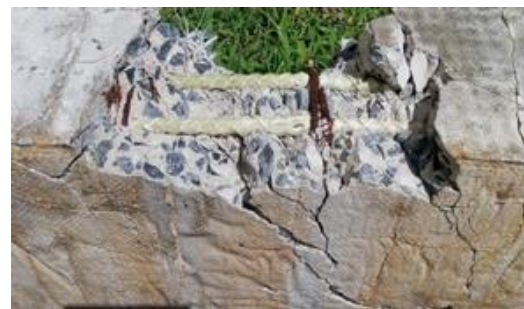
b) GFRP bars after 60 months

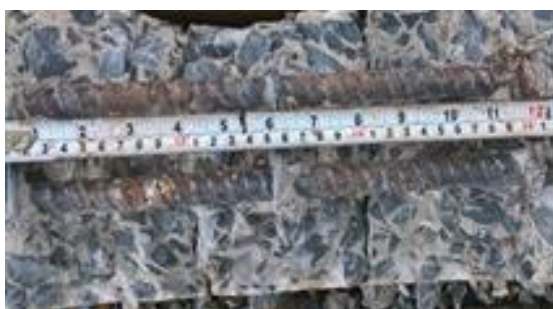
c) Steel bar after 12 months

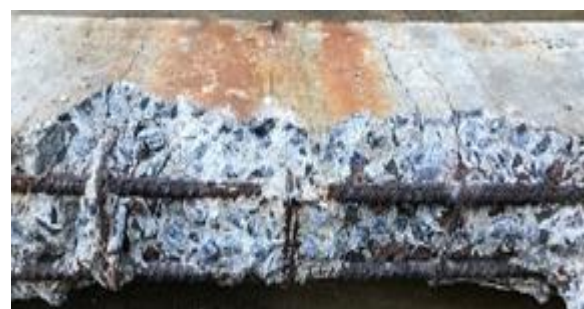
d) Steel bar after 60 months
