Seismic performance assessment of a timber log house

J.M. Branco, P.B. Lourenço & C. Aranha

ISISE, Civil Engineering Department, University of Minho, Guimarães, Portugal

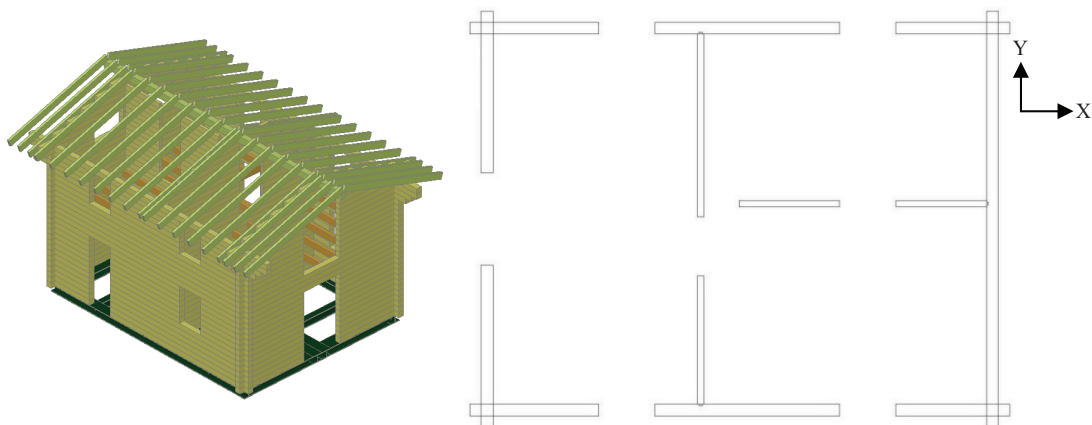
Figure 1. 3D model (left) and plan view (right) of the two-storeyed log house tested

The building is characterized by a rectangular plan of size 5.64m x7.3m. The logs used in the construction of the walls are machined and shaped both at the top and bottom to improve stability and increase the area of contact. The dimensions of the cross sections of the logs are 160mm x160mm and 80 mm x160mm for the outer and inner walls, respectively. The logs are made of glulam with 4 and 2 lamellas of 40 mm thickness, respectively. The lamellas are composed of Scots pine (*Pinus sylvestris* L.) of the strength class C24 according to CEN (2003). Additional information about the geometry and the mechanical characterization of the logs can be found in (Branco and Cruz, 2008).

The structure is symmetrical in the longitudinal direction and asymmetrical in the transverse direction. The floor beams are of size 90mm x165mm and are connected to the walls by dovetail joints. In order to guarantee rigid in-plane behavior of the floor diaphragm, the beams are superimposed by Oriented Strand Board (OSB) panels of 22mm thickness. The height of the walls on the top-most floor increases from 4.40m at the edge to 5.28m at the ridge, forming a traditional gable roof. The roof structure is characterized by massive wooden rafters inclined at an angle of 18°, over which 12 mm thick OSB panels are nailed. The section of the rafters is 70mm x190mm while the ridge has a cross-section of 120mm x 200mm.

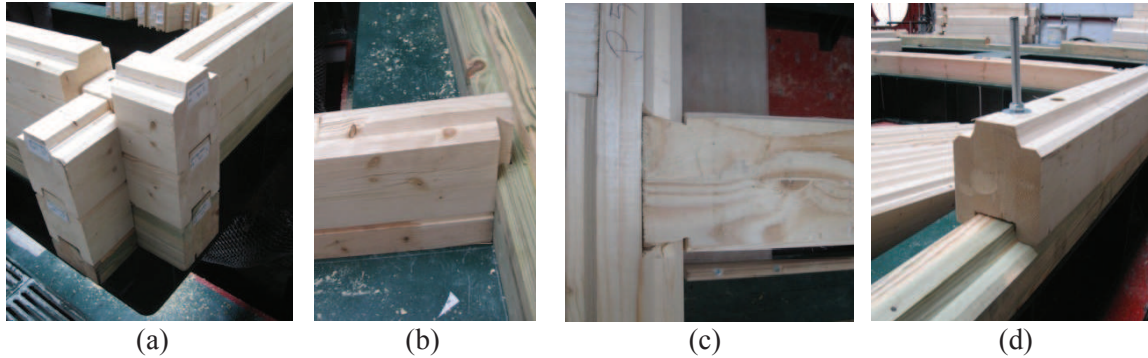
Figure 2. Connections between (a) two exterior walls (b) an exterior and an interior wall (c) floor beam and wall (d) first log and foundation

The interceptions between orthogonal walls are in the form of halved joints when two exterior walls meet and dovetail joints when an exterior wall meets an interior wall. The floor end joists are also appropriately grooved so as to fit in perfectly with the log walls. The first logs are connected to the foundation (steel base) through M16 bolts of Class 8.8 that are spaced at intervals of 500 mm. This ensures that no sliding occurs between the log house and the steel base. The connections between orthogonal walls, floor beams to the walls as well as the connection between first logs and the steel base can be seen in Figure 2.

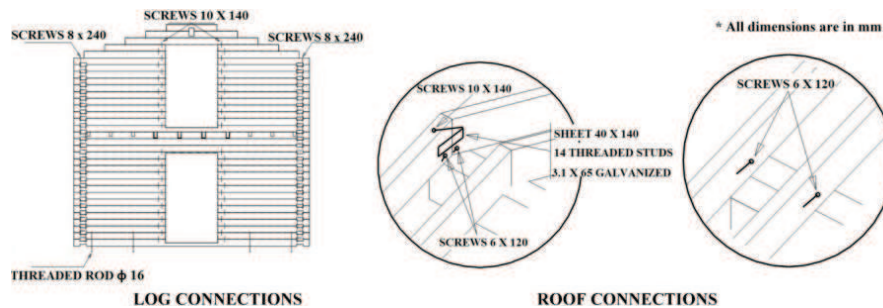
Figure 3. Structural screwed connections used in the log-house tested

To ensure the in-plane stiffness of the walls, 10 mm screws (10mm x140mm) were used around the openings and 8mm screws (8mm x240mm) in the connections between orthogonal walls. To connect the rafters of the roof structure, 10mm screws (10x140 mm) and 40mm x140mm steel plates were used near the ridge while 6mm screws (6mm x120mm) were used to make the connection between the rafters and the top of the walls. Figure 3 presents the details of the structural connections made with screws.

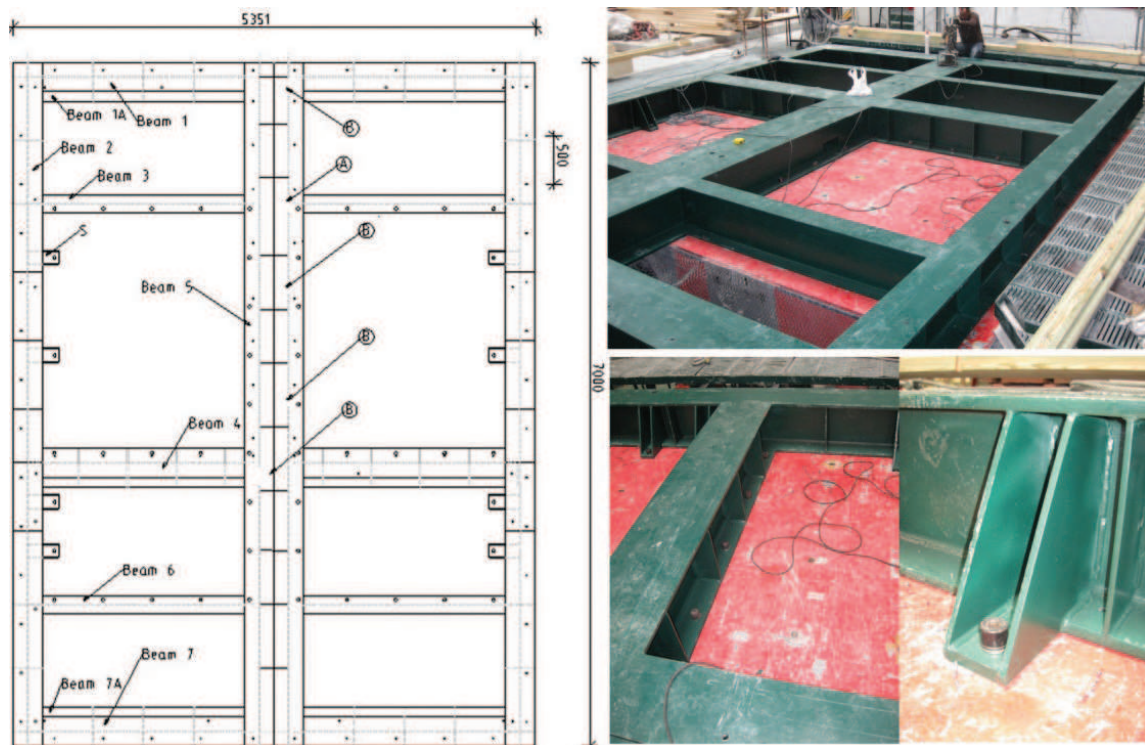
Figure 4. The steel base – plan (left), structure (top right) and connections (bottom right)

The steel base is composed of two identical rectangular sections which are 7m long and 2.675m wide that are rigidly connected together. Figure 4 shows the plan and the structure of the steel base.

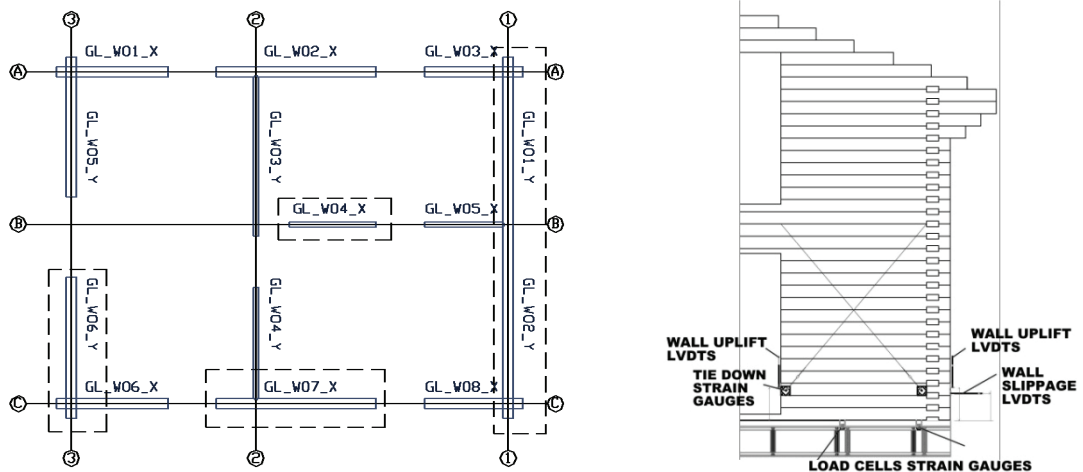
Figure 6. Monitored walls (Ground floor) and detail of the instrument locations in wall W06_Y

system focused on studying the behavior of five walls on each floor (Figure 6), two in the longitudinal direction and three in the transverse direction.

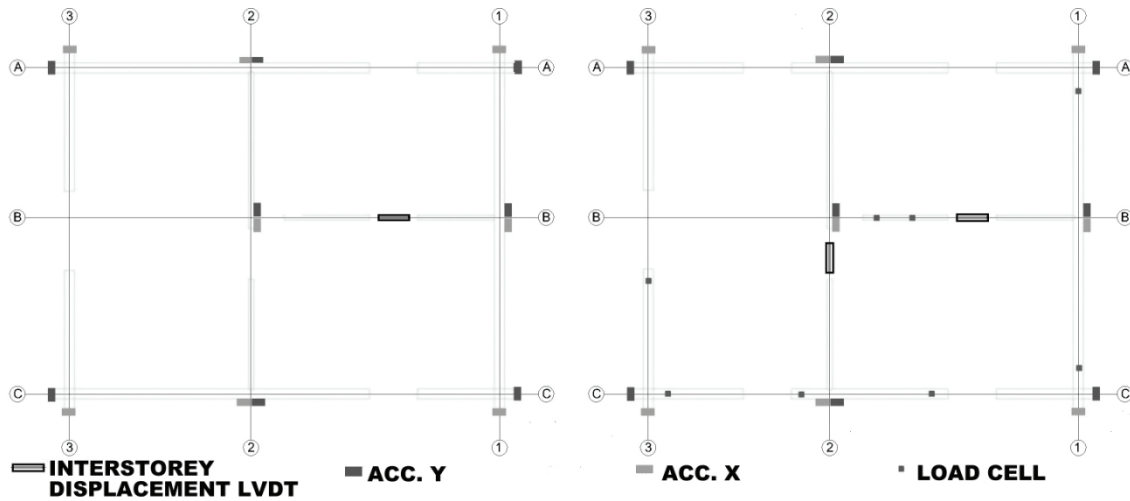
Figure 7. Location of the accelerometers, load cells and inter-storey displacement LVDTs on the first floor (left) and ground floor (right)

Figure 7 shows the location of the accelerometers, load cells and inter-storey displacement LVDTs while Figure 8 shows the instruments used.

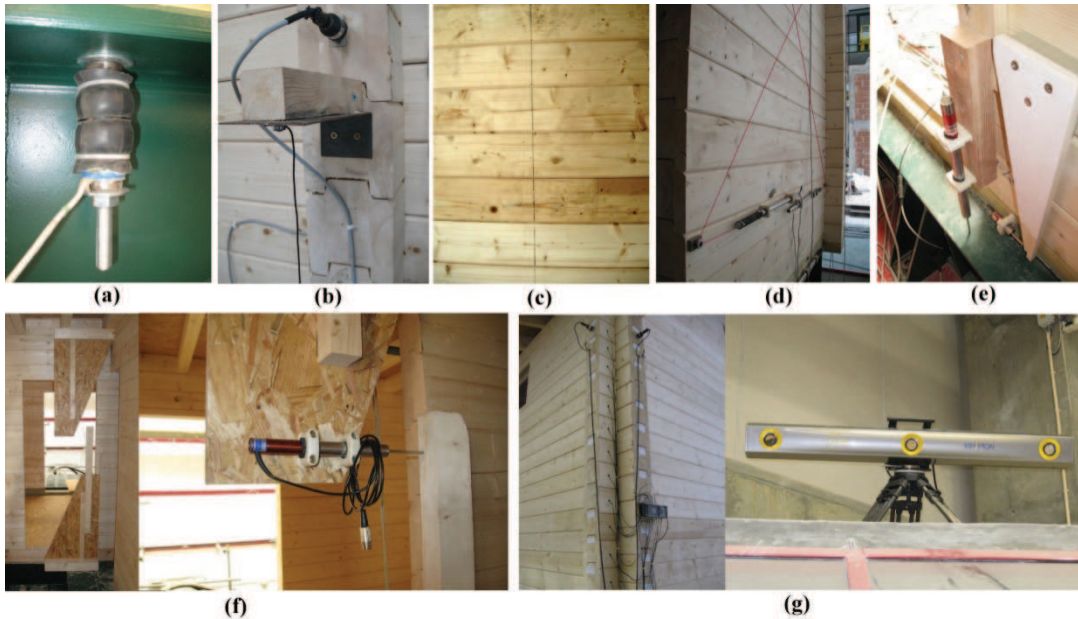
Figure 8. (a) load cell (b) accelerometer (c) indicator scroll (d) shear deformation LVDT (e) LVDT to measure sliding of walls (f) interstorey displacement LVDT (g) Optical acquisition system

Twenty-two LVDTs were used to monitor the deformations of shear walls, the vertical lift, horizontal movement and inter-storey drifts. The indicator scrolls in the form of a vertical line along the height of the wall served as an indicator for slippage between the logs. The data obtained during all the stages of testing was sampled at a sampling frequency of 125 Hz.

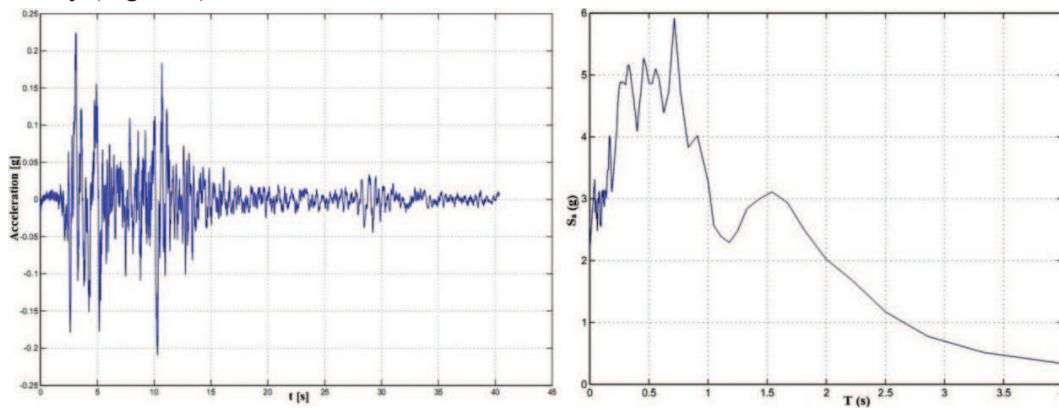
Figure 9. The accelerogram (left) and response spectrum (right) of the Montenegro earthquake recorded at the Ulcinj- Hotel Albatros station

Based on the pre-design of the test, the input signal chosen was the one that was registered at the Ulcinj – Hotel Albatros during the Montenegro earthquake on the 15th of April 1979 (Mw 6,9). The properties of the earthquake are reported in the European Strong Motion Database (http://www.isesd.hi.is/ESD_Local/frameset.htm). The acceleration time history in the x and y directions were used and the peak ground accelerations were 0.181g and 0.224g, respectively (Figure 9).

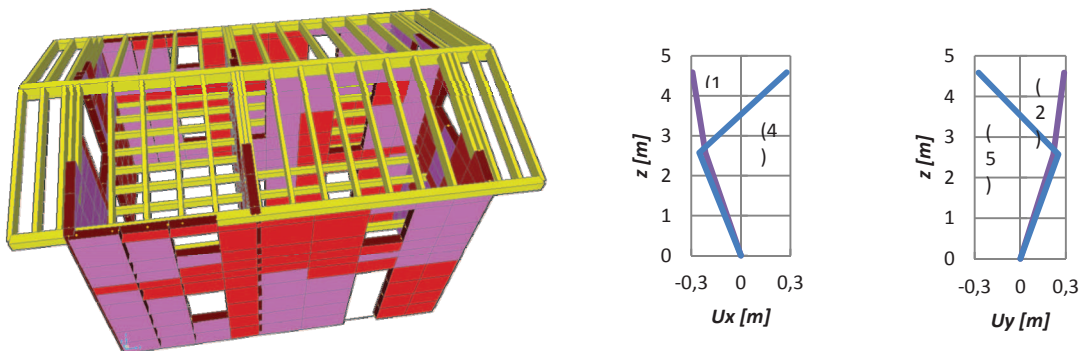
Figure 10. 3D FEM model in SAP2000 and representative translational mode shapes (number inside brackets) in the x and y directions.

The first mode shape corresponds to a translational movement in the x-direction (longitudinal axis), the second mode shape, close to the first one ($T=0.197\text{s}$) corresponds to a translational movement in the y-direction while the third mode is a torsional one and is represented by a rotation around the z-axis. With regard to the damping of the structure, the value indicated by the numeric model is much higher than the value typically assumed by codes and recommendations for timber structures ($\xi=5\%$).

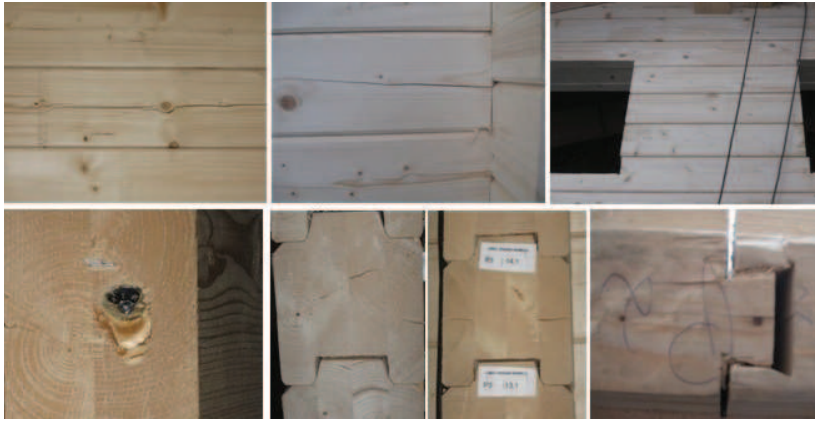
Figure 11. Damages observed in the building after the 0.5g PGA test

Some of the damages observed after the tests (see Figure 11) were:

- Fracture along the length of the log due to out-of-plane flexure;
- Fracture along the grain at connections between orthogonal walls due to shear;
- Slipping of logs due to shear;
- Damage in the vicinity of the screws;
- Internal cracks in the log section;
- Fracture at the top and bottom notches of the logs.
