# Characterization and damage of brick masonry

Paulo B. Lourenço, Rob van Hees, Francisco Fernandes, Barbara Lubelli

Key Words: Clay Brick, Brick Masonry, Mortar, Mechanical Properties, Physical Properties, Chemical Properties.

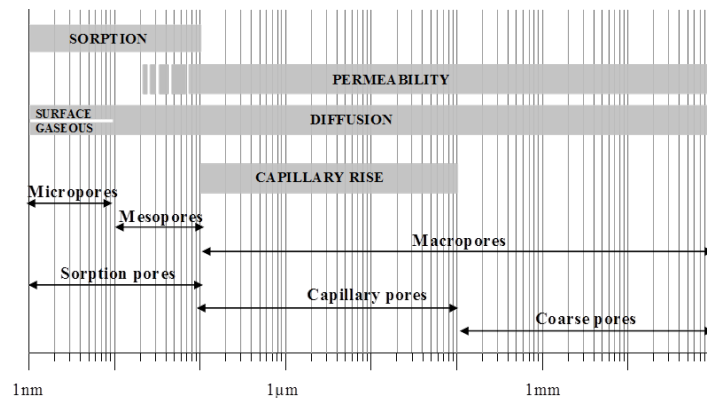
Fig. 2 Classification of pores and moisture transport mechanisms.

Moisture transport behavior is one of the most relevant physical properties of mortar, since it strongly influences its durability. Moisture transport behavior mainly depends on the porosity and the pore size distribution, which can be subdivided into sorption pores ( $< 100\text{nm}$ ), capillary pores (between  $0.1\mu\text{m}$  and  $100\mu\text{m}$ ) and coarse pores ( $> 100\mu\text{m}$ ), see Figure 2. Small capillary pores ( $< 1\mu\text{m}$ ) result from evaporation of water from the binder fraction. Wider capillary pores are formed by the intergranular space that is not completely filled by the binder. Figure 3 shows the pore size distribution of a mortar with a bimodal distribution.

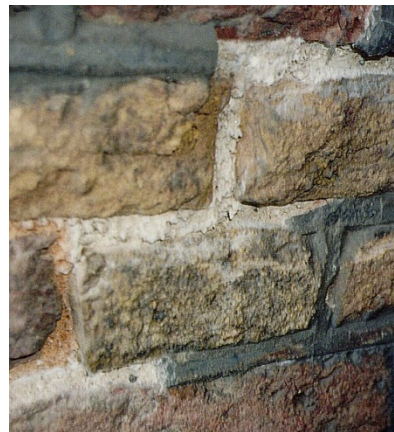
**Fig. 6** Push-out of cement re-pointing due to crystallization of salts at the interface of new pointing and old bedding mortar.

tallization causes damage to a lime bedding mortar because a physically incompatible pointing mortar was chosen. This is the case of a too dense pointing applied on a more porous lime mortar (Figure 6). Because of the hindering of the drying caused by the new cement pointing, crystallization of salts that were already present in the masonry occurs at the bedding mortar-pointing interface. This results in the detachment of the pointing (also called push-out) and also in a form of loss of cohesion (crumbling or sanding) of the underlying lime bedding mortar.

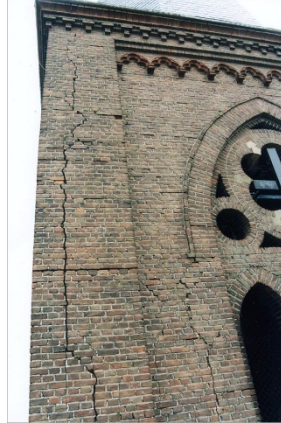
**Fig. 11:** Damage pattern that may at easily attributed to a structural mechanism.

For the time being, MDSS works with an integrated atlas in the diagnostic part of the system, which makes it possible to suggest one or more hypotheses, on the basis of the structural damage pattern that was assessed (Figure 10). Investigations should also be carried out to ascertain whether the damage pattern has appeared together with other forms of deterioration: for example, a crack may occur together with a displacement or other non-structural types of damage. There are also damage types that appear to be structural, but are actually caused by salt or frost damaging mechanisms. An interesting example is that of the church tower of Noordwijk, the Netherlands (Figure 11) [47]. The damage pattern is constituted by vertical cracks running along the corner of the tower. They are crossed by less evident horizontal cracks, running through the mortar joints. This damage pattern appears, at first sight, likely to be caused by a structural deterioration process, but it was in fact due to the formation of swelling compounds in the mortar.
