Study of the Seismic Behavior of the “Old Municipal Chambers” Building in Christchurch, New Zealand

Abstract: This paper presents a study of the seismic behavior of the “Old Municipal Chambers” building in Christchurch, which was damaged by earthquakes in 2010 and 2011. In view of its seismic vulnerability and retrofitting, finite element and equivalent frame models were used for pushover analysis. Predictions allow identifying the weak parts of the building and its expected failure modes, which are in agreement with the observed damage. Computations seem however conservative, because the building capacity curves provide insufficient strength to survive the registered earthquakes. By considering the floors as bidirectional diaphragms in the simplified model, a better behavior is observed.

Short Title: Seismic Behavior of the “Old Municipal Chambers” Building

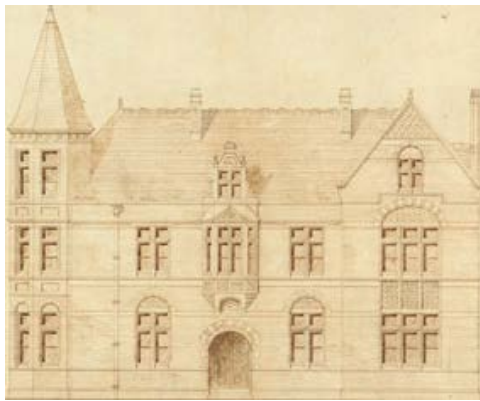
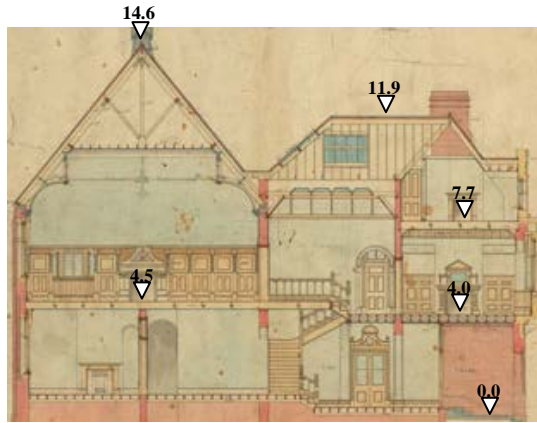
FIGURE 3 Horizontal view of East elevation and section from South (original drawings by Samuel Hurst Seager, ca. 1886).

The two storey building is constructed in solid brick (mainly red) and presents wooden floors. Drawings of the building are shown in Figures 2 and 3, as structural plans and representative elevations of the building. The building dimensions are about $19.5 \times 19.5 \text{ m}^2$ with external walls having a thickness of 0.47 m and 0.36 m in the ground storey and first storey, respectively. The storey heights are about 4.5 m and 3.2 m, respectively for the ground floor and first floor elevation. A second storey is constructed under the roof level at 11.9 m. Finally, the “Council Chamber” and the SE turret have a roof height of 14.6 m. The building is likely to have deep foundations made in concrete and extending down to a gravel layer.

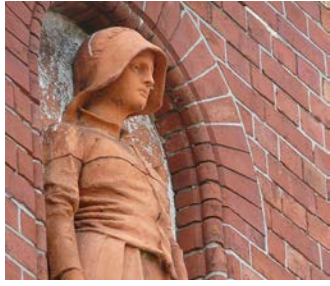
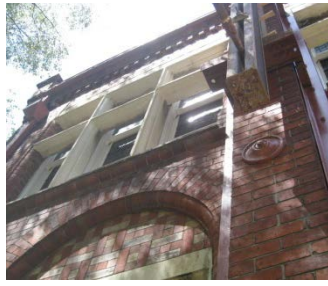
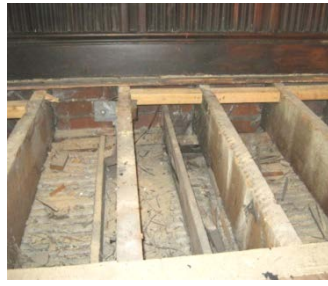
FIGURE 4 Details of the building: (a) “Industry” statue, (b) window’s frames and (c) ground floor support.

The building was subjected to subsequent modifications, which will be detailed in a next section. Photographic details of the building are shown in Figure 4, namely one of the two main statues “Industry” and “Concord” in the South wall of the Council Chamber, a bottom-to-top view of window’s frames in the West elevation, and an inspected zone in the support of the ground floor. Good quality of the brick masonry works is evident.

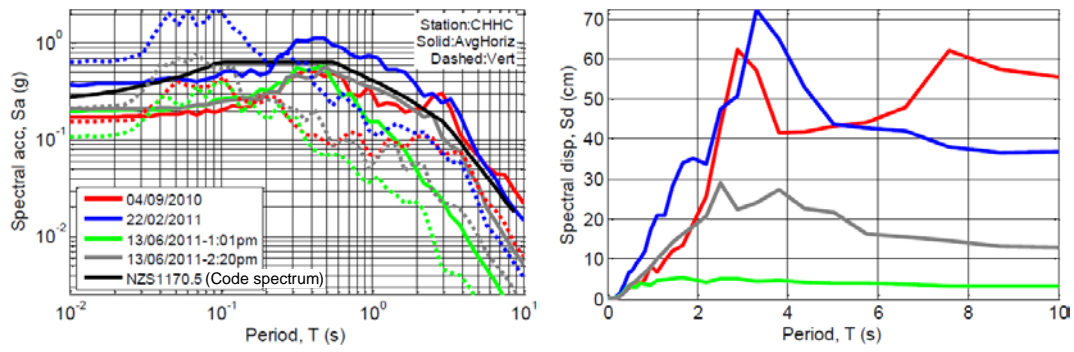
FIGURE 5 Response spectra recorded near the studied building for several seismic events, in terms of accelerations and displacements [Bradley, 2011].

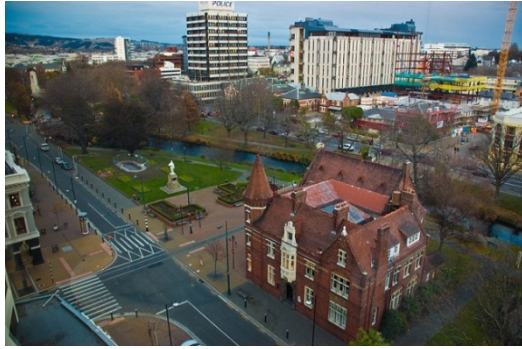
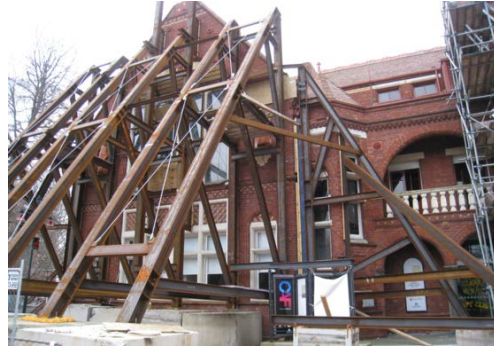
FIGURE 6 Views of the building (a) before [Photo by Phillip Capper under Creative Commons, at <http://en.wikipedia.org/wiki/File:OxfordTerraceChristchurch13June2008.jpg>] and (b) after the 2010-2011 Christchurch earthquakes.

The building has been strongly shored on the external walls, and particular care was made to protect the South façade as can be observed in Figure 6b. A detailed description of the shoring works is reported by Walters and Parker [2011]. There was no information regarding the damage in the internal walls of the building, because access inside the building was denied due to safety reasons. Given that the September 2010 and February 2011 earthquakes have different epicenter locations in the fault system, the main shakings of the two events probably occurred in different directions. However, accounting for the significant in-plane damage observed in North and South façades, it seems that the building was mainly subjected to shaking in direction E-W. However, the differentiation of damage due to the two earthquakes is not objective as the photographic survey available refers mainly to the period after the February 2011 earthquake.

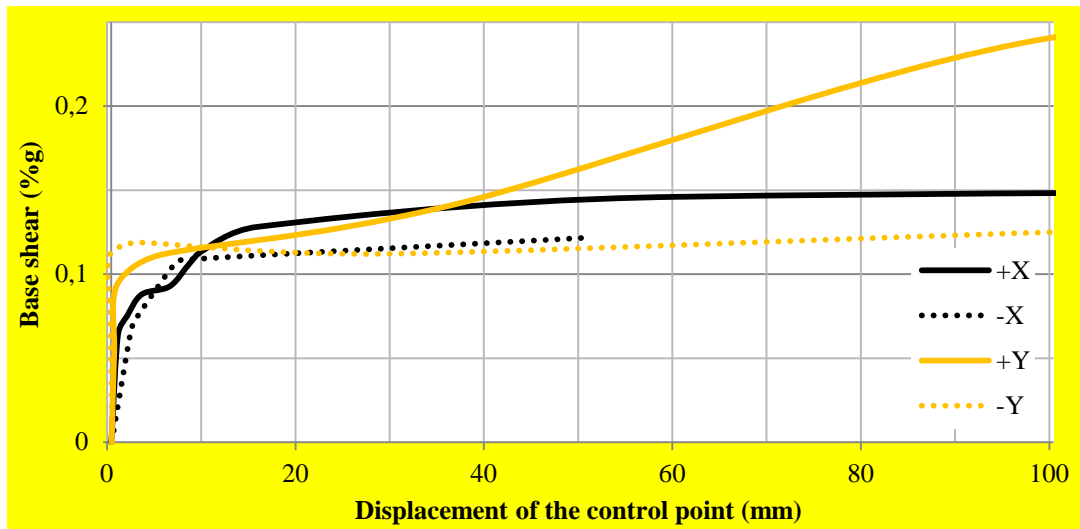
FIGURE 22 Capacity curves from the FEM analysis.

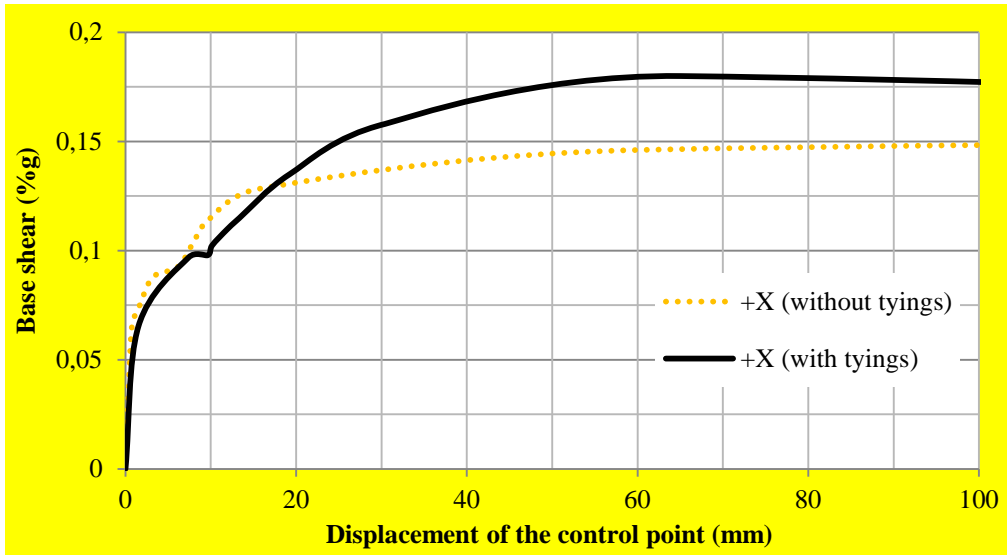
FIGURE 24 Comparison of capacity curves without and with tyings.

The failure mode in the X direction is the collapse of the SW corner of the building, and the roof is not modeled in the simulation. As the roof might provide a certain level of restraint at the top of those walls, another model was prepared using tyings between the nodes of the top left of the South façade and the top right of the North façade. This tries to simulate the existence of a relatively stiff roof in the Council Chamber, with a good connection between roof purlins and walls, or the addition of steel ties between the walls. The new analyses in the X direction provide similar results for each loading sign. In Figure 23 it is shown that a much different behavior of the building is found due to ties in the Council Chamber (refer to Figure 20a-b). The new capacity curve for that direction can be found in Figure 24, when compared with previous analysis, where it is shown that the capacity increase is moderate and virtually extinguishes for larger displacements.

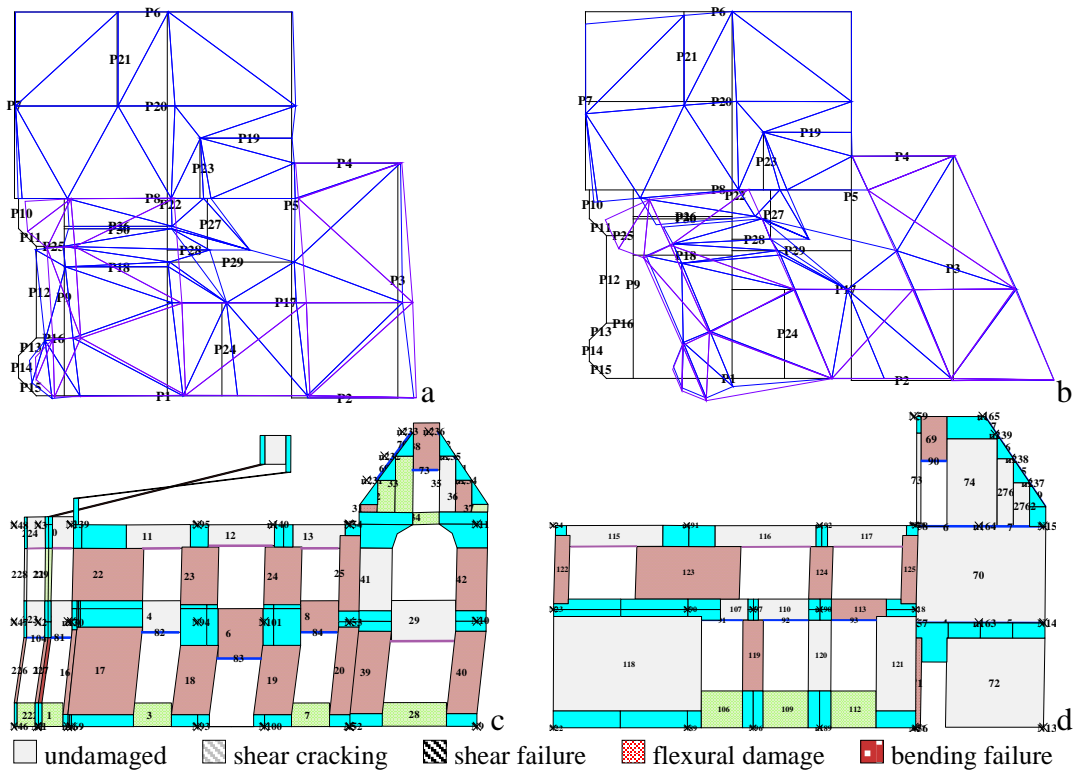
FIGURE 25 Plan deformed shape for the +X analysis related (a) to the peak base shear [x50] and (b) to the ultimate state [x20], and damaged state of (c) East (18.3mm aver. def. at 7.7m) and (d) West (5.2mm aver. def. at 7.7m) elevations relating to peak base shear [x20].

Figures 25 to 28 present deformed shapes and damage states corresponding to the analysis in the $\pm X$ (S-N) and $\pm Y$ (E-W) directions. Note that the deformed shapes are significantly magnified by the value in square brackets, with maximum displacement at the top of the building lower than 0.02 m. In the case of the $+X$ loading, a rotation of the East body of the building is identified in Figure 25a-b with major displacements in the East elevation. In this façade, at the peak strength most elements are plastic by flexure, after which a flexural mechanism of the ground storey occurs with a large drop in the base shear strength.

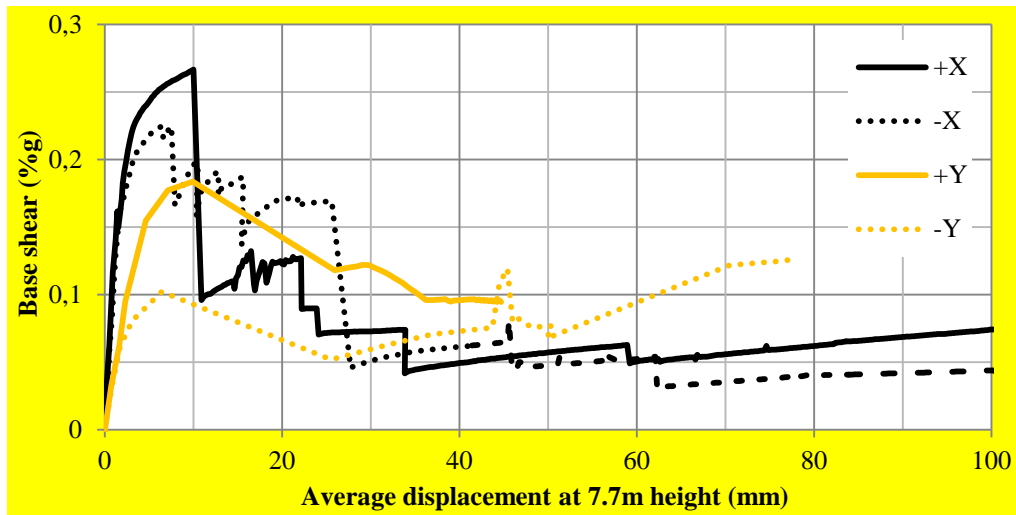
FIGURE 32 Capacity curves of the building corresponding to all the analysis.

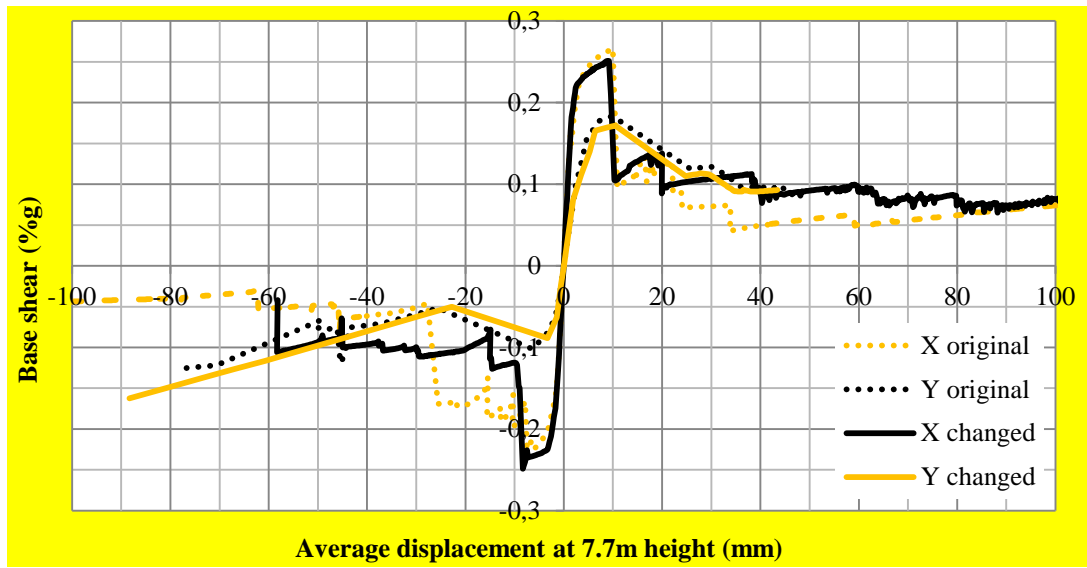
FIGURE 34 Capacity curves obtained for the original and changed building structures.

The macro-element model was updated by introducing the main changes in the building structure, with the aim to evaluate the influence of the alterations in the pushover response. From the computed capacity curves in Figure 34, it seems that the influence in the global building response of the intervention made is very low. The peak values of the base shear are about the same, but a slightly improved ductility is observed due to the reinforced concrete elements contribution.

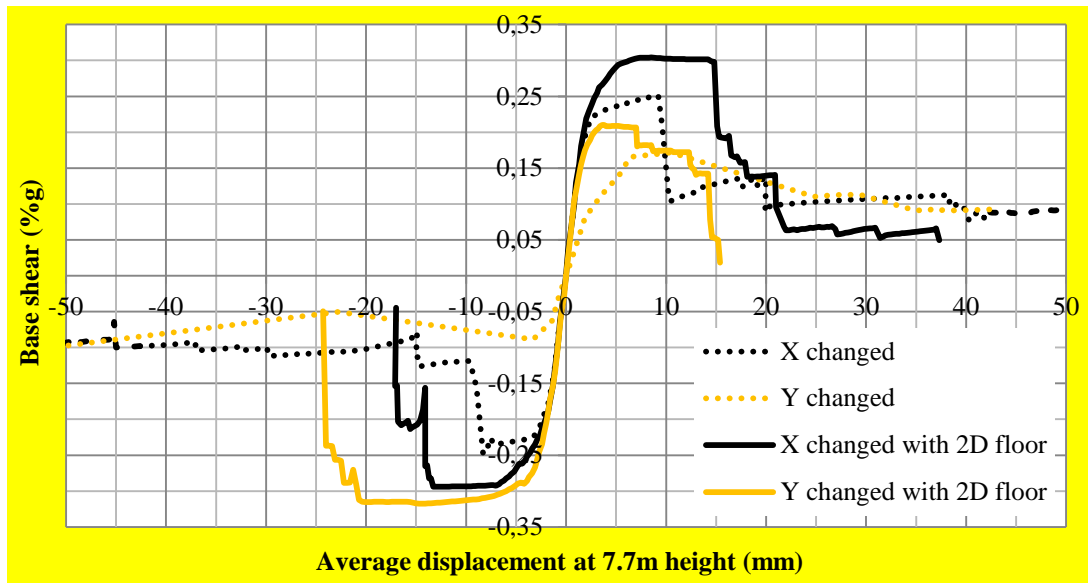
FIGURE 36 Capacity curves obtained for the altered building considering 1D and 2D floors.

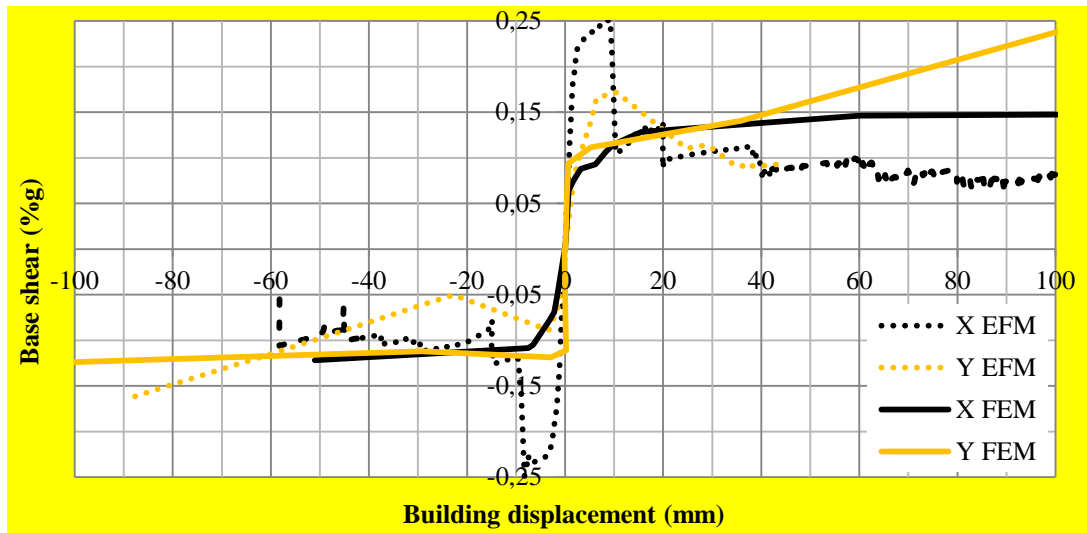
FIGURE 38 Comparison of capacity curves obtained for the FEM and 1D floor EFM models.

Figure 38 compares the capacity curves obtained from the pushover analysis on the FEM and 1D floor EFM models. Note that the results from EFM and FEM are not directly comparable, given that the diaphragmatic action is considered for the floors in the EFM model while out-of-plane failure is considered in the FEM model, and given that the assumed response of masonry piers in the EFM is brittle. Effectively, a discrepancy is observed of the predicted peak strength in the X direction, which is possibly due mostly to absence of floors in the FEM model, and because the floors in the EFM model work mainly in the X direction.

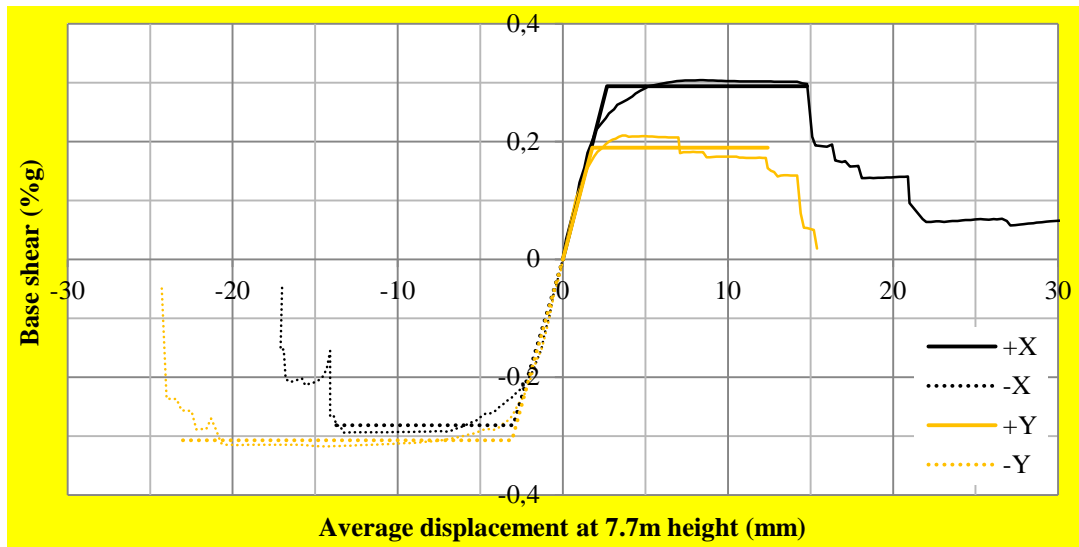
FIGURE 39 Idealized bilinear responses of the building for the EFM with 2D floor model.

In the Y direction the approximation between the two models is better. The results of both predictions seem to be very conservative, in the sense that the building survived the February 2011 Christchurch quake with a MSA of 1.0g (note that the MSA in the New Zealand code NZS 2004 is 0.66g). Therefore, it is assumed that the EFM with the 2D floor model is the one better representing the present condition of the building, as the new capacity curves in Figure 39 provide higher strength and ductility.
