Experimental investigation on the repair of rammed earth by means of injection of mud grouts

R.A. Silva, D.V. Oliveira & P.B. Lourenço
ISISE, University of Minho, Guimarães, Portugal

ABSTRACT: This paper assesses the adhesion capacity of unmodified mud grouts used to repair structural cracks on medium and large scale rammed earth specimens. Beam and wallet-specimens were manufactured using a soil from Alentejo (Portugal), whose particle size distribution had to be first corrected due to its high clay content. An “artificial” (composed by kaolin and limestone powder) and a “natural” (composed by sieved soil and limestone powder) mud grout were used to repair the specimens, which were previously tested under three-point bending and diagonal-compression and then retested. The grout injection shown to provide satisfactory results regarding the adhesion capacity, but only if it is performed with the “natural” mud grout.

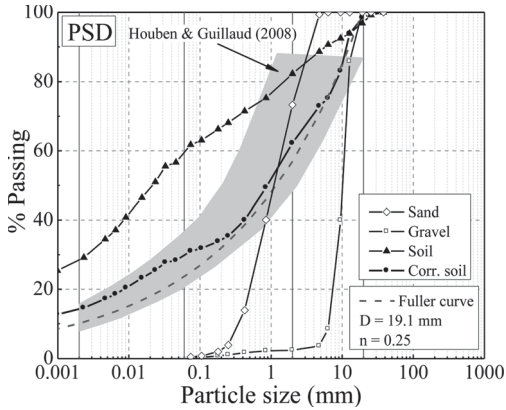
Figure 2. PSD curves of the corrective aggregates and of the corrected soil. (Credits: Authors).

The PSD correction was carried out by means of the addition of river sand and gravel obtained from crushed granite. The PSD curves of these two aggregates are given in Figure 2, as well the PSD of the corrected soil. The correction consisted in adjusting the curve of the mixture of soil, sand and gravel to the full curve of Equation (1), recommended by Houben & Guillaud (2008), in order to optimize the density of the material and, thus, its strength performance.

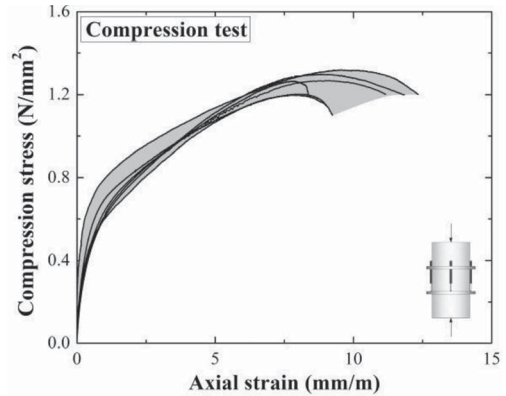
Figure 3. Compression stress-strain curves of the rammed earth cylindrical specimens manufactured with the corrected soil. (Credits: Authors).

The stress-strain curves of the specimens and the respective envelope are presented in Figure 3. Table 3 summarizes the results in terms compressive strength (f_c), Young modulus (E_0) and equilibrium water content (W_{eq}).

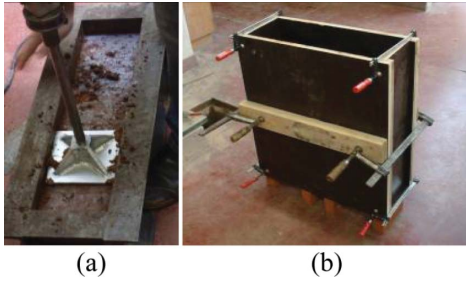
Figure 4. Preparation of the (a) three-point bending and (b) diagonal compression specimens. (Credits: Authors).

As stated, the adhesion capacity of two mud grouts was assessed by means of three-point bending and diagonal-compression tests on specimens manufactured with the corrected soil. The three-point bending specimens consisted of beams with dimensions $150 \times 150 \times 600 \text{ mm}^3$, which were compacted in three layers of similar thickness, using a metallic mould (Figure 4a). The diagonal-compression specimens consisted of wallets with dimensions $550 \times 550 \times 200 \text{ mm}^3$, which were compacted in 9 layers of similar thickness, using a high-density plywood formwork (Figure 4b).

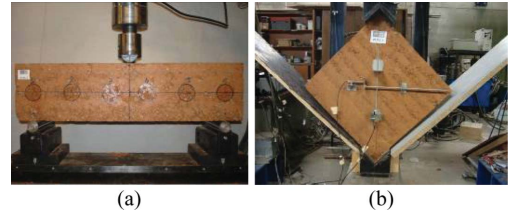
Figure 5. Tests carried out on the rammed earth specimens: (a) three-point bending and (b) diagonal-compression. (Credits: Authors).

The beam-specimens were first tested under three-point bending after drying for 6 weeks under a room temperature of about $22 \pm 2^\circ\text{C}$. The load was applied at middle span and the distance between supports was of about 500 mm (Fig. 5a). The application of the load was carried out under monotonic displacement control at a rate of $1 \mu\text{m/s}$. The testing procedure of the specimens after injection was similar, but the tests were carried out 3 weeks after the repair. The drying was processed under a room

The wallet-specimens were first tested under diagonal-compression after drying for about 12 weeks under a room temperature of about $22 \pm 2^\circ\text{C}$. The test was carried out according to ASTM E519 (ASTM 2002). The supports were 100 mm width and the load was applied under monotonic displacement control at a rate of $2 \mu\text{m/s}$. The vertical and horizontal displacements were measured in both faces of the wallet, resorting to LVDTs attached to the middle third of each diagonal (Fig. 5b). The same testing procedure was followed after repairing the wallets, which were tested 5 weeks later.

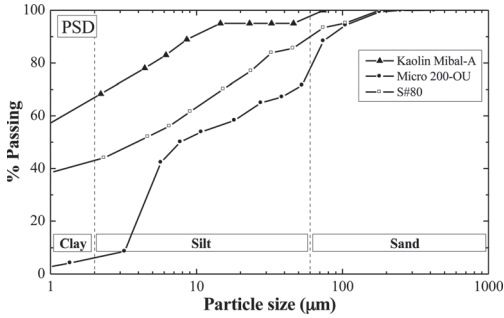
Figure 6. PSD curves of the materials composing the mud grouts.(Credits: Authors).

The compositions of the two grouts used within the experimental program are given in Table 4. The grout A is an “artificial” mud grout, constituted by kaolin powder (Mibal-A) and limestone powder (200-OU). Grouts B is a “natural” mud grout constituted by sieved soil (the same soil used in the manufacture of the specimens) with maximum particle size of about 0.18 mm (S#80) and limestone powder (Micro 200-OU) (see Figure 6 for PSD). Moreover, all mud grouts included the addition of sodium hexametaphosphate (HMP) to improve fluidity while keeping a low W/S . The Marsh cone (EN 445 - CEN 2007) flow time (1 dm^3 of grout), flexural strength and compressive strength (EN 1015-11 - CEN 1999) of each grout are given in Table 5.

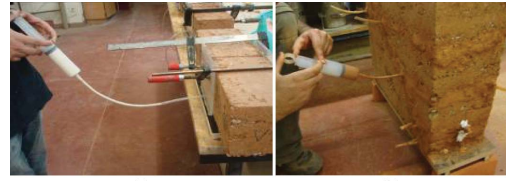
Figure 7. Injection of the (a) beam-specimens and (b) wallet-specimens. (Credits: Authors).

to mitigate the water sorption during the injection (Figure 7a). The base of the specimens was sealed using a plywood board and silicone sealant, while the sides were sealed with silicone and Plexiglas plates pressed against the specimen by means of two screw clamps. This apparatus allowed visualising the rising of the mud grout within the crack during the injection. The specimens' parts were positioned on the board such that the gap width (d_{cr}) would be of about 2 mm or 8 mm, totaling 6 specimens for each case. The injection was performed using a 100 ml syringe coupled to a 4 mm diameter tube installed at the bottom of one of the Plexiglas plates. For each set of six specimens with the same d_{cr} , three specimens were injected with grout A and other three with grout B.

mortar prepared with soil sieved through ASTM sieve #4. Plastic tubes with 6 mm diameter were installed in one of the sides of the specimens such that they penetrated about 4 cm in the wallets and that their spacing was inferior to 10 cm. A 100 ml syringe with water was injected in all tubes 1 hour before injecting the grouts in order to mitigate the water sorption by the wallets. Only the grout B was used to inject the five specimens, and their injection started from the bottom tubes up to the top ones, using the same 100 ml syringe (Fig. 7b).

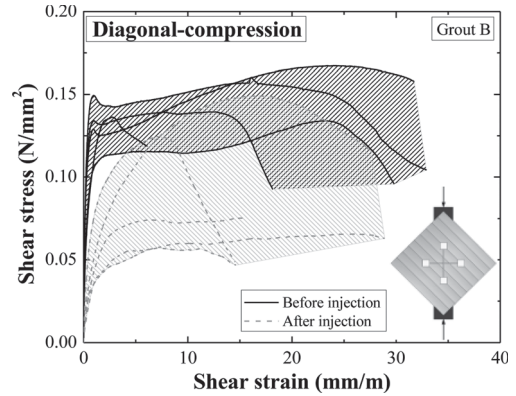
Figure 8. Shear stress—shear strain curves of the wallets before and after injection. (Credits: Authors).

the initial state of the specimens. The injection of mud grout B was unable to recover the initial shear stiffness of the wallets, but it allowed similar level of deformations (Fig. 8). This is a consequence of the absence of coarse aggregates in the failure surface of the wallets after injection, which is almost coincident with that before injection. These aggregates promote stiffness due to their interlocking effect, but they were lost in the reassembling of the specimens and were not reintroduced with the injection.
