## Aging Effect on the Integrity of Traditional Portuguese Timber Roof Structures

### ABSTRACT

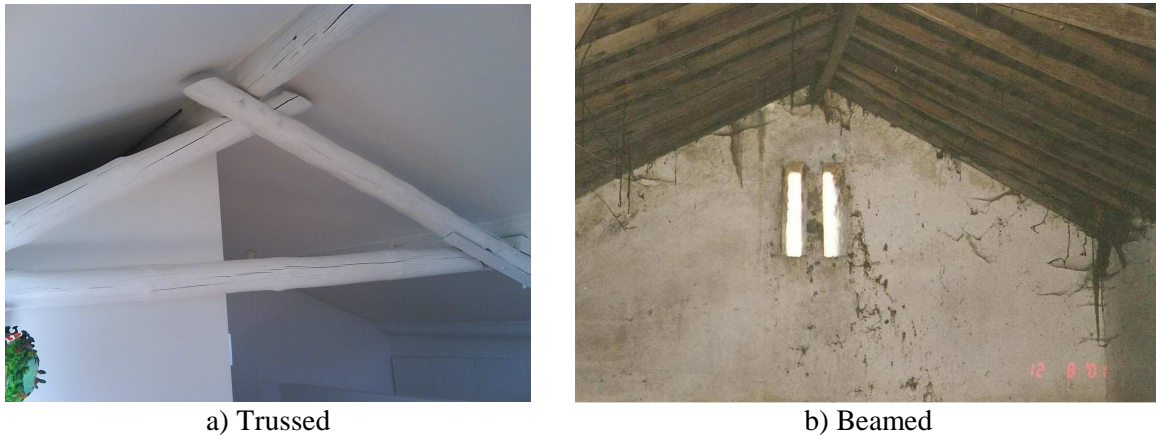
The most common traditional Portuguese roof structures of dwellings are trussed timber systems as shown in Fig. 1-a, or beamed system as depicted in Fig. 1-b. In both cases, the trusses or the beams support the purlins; in turn, the purlins support the boards, which themselves support the roof covering. The traditional type of roof covering may change along the national territory but ceramic tiles are the most widely used in the Portuguese context.

**Figure 1.** The most common traditional Portuguese roof timber structural systems.

A constructed beamed roof timber structural system solution of a traditional Portuguese dwelling was briefly described. This is one of the most common roof structural solutions applied in the context of construction of Portuguese dwelling. The main structural element of this system, a three hinged arch, was designed according to the current applied regulations and it was determined that the existing cross section of the beam was oversized. The aging effect of the timber was not taken into account in this analysis.

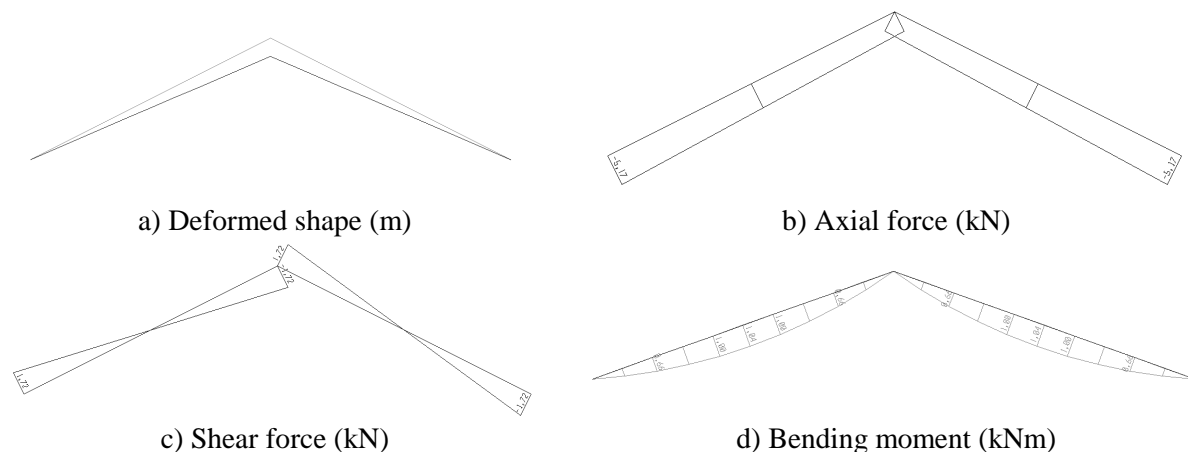
The most severe combination of loads for this structure was the one related to the dead load. The respective results of both the deformed and forces diagrams are depicted in Fig. 3.

**Figure 3.** Diagrams.

Using the results derived from the structural analysis and the recommendations given in ENV 1995-1 EC5 [1998], the designed cross section for the beams, if fixing the beam's width to  $b = 0.07$  m, corresponds to a section of  $0.07 \times 0.05$  m<sup>2</sup>. Note that this cross section is obtained purely from an academic point of view since in a general sense the element's largest cross sectional area moment of inertia should be mobilized to resist the greatest bending moment. Comparing this result with the existing cross section we concluded that the analysed roof structure is indeed in conformance with the recommendations given in ENV 1995-1 EC5 [1998]. In fact, it is oversized. as well, the aforementioned cross section design resulted from the verification of the ultimate limit state condition when considering bending with compression, or as expressed in ENV 1995-1:

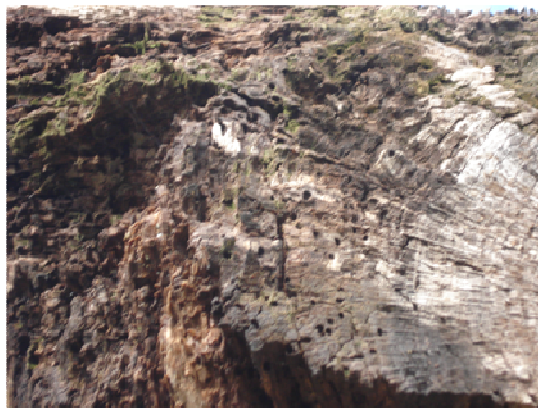
Hoffmeyer stated in Timber Engineering [1995] that wood is a natural, organic cellular solid. It is a composite made of a chemical complex of cellulose, hemicellulose, lignin and extractives. It is highly anisotropic. These are some of the reasons why wood is perhaps considered one of the most complexes building materials with which to design. The analysis of the wood's aging effect, in particular for timber structures, becomes even more complex because it is a time dependent and a process difficult to predict. A timber beam is shown in Fig. 4a that is the remaining element of what was once the timber floor of a traditional Portuguese dwelling. The advanced level of deterioration of this beam is clearly evident in Fig. 4; this level of deterioration was a result of the unprotected conditions in which the beam was to perform and the nonexistence of conservation measures to the beam over time. In this case, the aging effect has been materialized by a progressive process of material degradation complemented by a reduction of cross section as illustrated in Fig. 5.

**Figure 5.** Detail of the degradation stage of the left edged of the beam.

We consider that the material degradation corresponds to the material changing due to fungal attack. Its physical properties, such as density  $\rho$ , and the stiffness properties, such as the modulus of elasticity  $E$  and the shear modulus  $G$ , are all affected. Since this change progresses through time the above material properties become time ( $t$ ) dependent (i.e.  $\rho(t)$ ,  $E(t)$  and  $G(t)$ ). This process of progressive material degradation is schematically represented, in a simplified way, in Fig. 6. As illustrated in Fig. 6 the aging effect manifest itself as different layers of material each at specific degradation levels that are formed over time. This scenario suggests that there is an increasing of anisotropy through time and, consequently, an increase in the complexity of modelling aged timber structures.

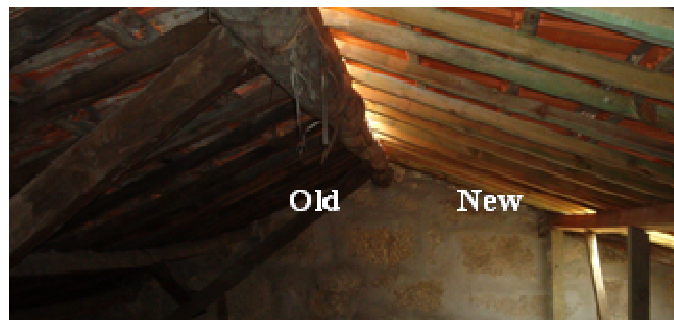
many cases, the amount of waste material is smaller than 10% (i.e. 90% reusable) and that the deterioration was mainly caused by decay (surface and internal), splits, and mechanical damage. Pine wood is of course a species that has been extensively analysed following several years of direct exposure to weathering. In the same context, Marzo [2006] concluded that ancient timber elements may have their original modulus of elasticity decreased by approximately 25% and as a result of several factors, such as: material aging, poor construction labour, weak connections, among others. Meanwhile, Pilt *et al.* [2009] concluded that the ancient timber may have its strength capacity decreased by approximately 15%. In general, these authors propose practical analytical procedures to simplify the previously described complexity related to the aging effect of timber concerning the application of old timber in the building industry. In particular, in a sustainable and economical perspective, this may give guidance for cases like the one shown in Fig. 9.

**Figure 9.** Coexistent old and new timber structural elements.
