## 9<sup>th</sup> International Masonry Conference 2014 in Guimarães

# An overview of seismic strengthening techniques traditionally applied in vernacular architecture

ORTEGA, JAVIER<sup>1</sup>; VASCONCELOS, GRAÇA<sup>2</sup>; CORREIA, MARIANA<sup>3</sup>

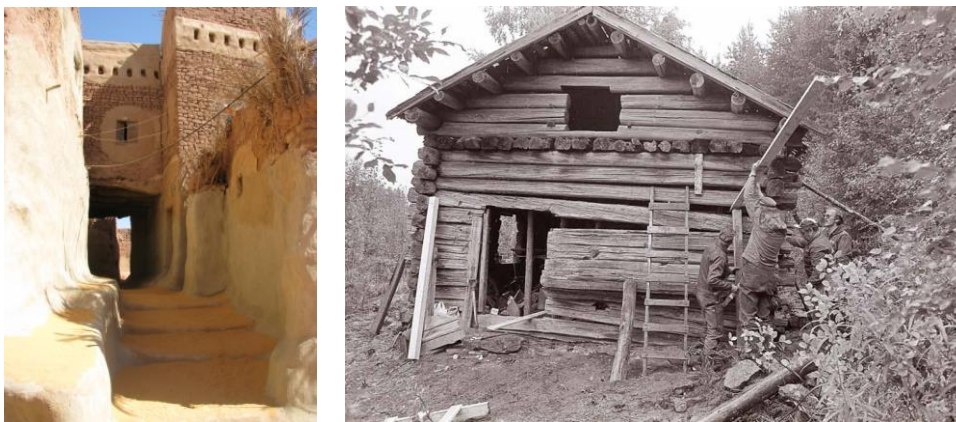
**Figure 1.** Examples of the adequacy of vernacular architecture to its surrounding natural environment: (left) earthen vernacular architecture in the Egyptian desert [7]; (right) timber vernacular construction in the Norwegian forests [8]

The construction materials traditionally used in vernacular architecture are stone, brick, wood and earth. Their application in a region and their exact use depends therefore on the characteristics of the soil and sub-soil, the proximity to rich forests resources, the available stones in the area and the climatic conditions. As a result and opposite to the current world's homogenizing tendency, vernacular architecture is extremely heterogeneous (Figure 1) and constitutes an invaluable heritage throughout the world worthy of preservation. But also, due to this great variety of building types, work on the built vernacular heritage requires a deep knowledge and investigation of the place, the traditional techniques and materials, and should be cautiously approached in order to undertake a successful intervention [5] [6].

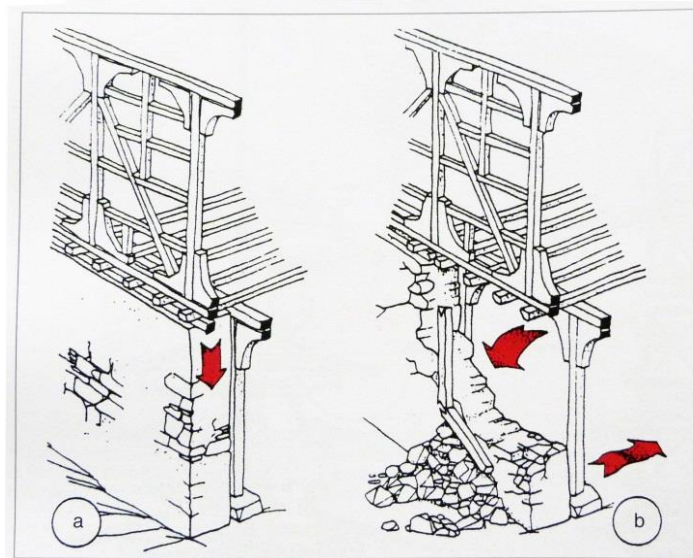
**Figure 3.** Dual bearing structure in Lefkas, an example of controlled partial collapse [4]

Some cultures understand earthquakes differently, accepting the destruction and damage caused by them, building structures that can be easily reconstructed and using materials that can be reused. Ferrigni et al. [4] consider that this passive approach is typical of oriental cultures. An example of accepting partial controlled collapse can be found in the Greek island of Lefkas. Here, buildings are constructed with load bearing stone masonry walls. There is also a second structure made in wood independent from the first one. The masonry walls can collapse in the event of an earthquake but the timber structure will continue to stand, so that the walls can be easily and rapidly repaired (Figure 3).

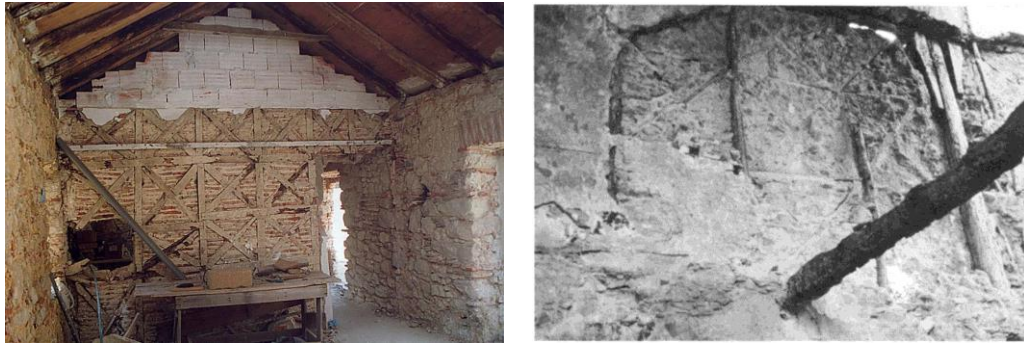
**Figure 4.** (left) 'Pombalino' wall in a house in Alcácer do Sal, Portugal [12]; (right) Internal wall showing the timber frame structure characteristic of the 'casa baraccata' system in Calabria, Italy [16]

Sometimes earthquake protection regulations are designed and introduced by central governments after an earthquake. The development of these regulations can induce the adoption of the proposed seismic resistant construction techniques by local communities and become endemic in some regions. This happened in Portugal after the destructive 1755 Lisbon earthquake, when a timber frame construction based on the naval experience of Portuguese sailors [13] was implemented in the new city plan. The system, known as ‘Pombalino’, has been widely studied [14] [15] and consists of a resistant and flexible cage structure composed by vertical, horizontal and diagonal timber members filled with light masonry, and used in the interior of each building. Now, examples of ‘pombalino’ construction applied in vernacular architecture can be found in many parts in the country (Figure 4). In Italy, the government introduced a similar system, known as ‘casa baraccata’, after a series of earthquakes in 1783, in Calabria [16]. Now, also wooden interior frames can be observed in many buildings in the region (Figure 4).

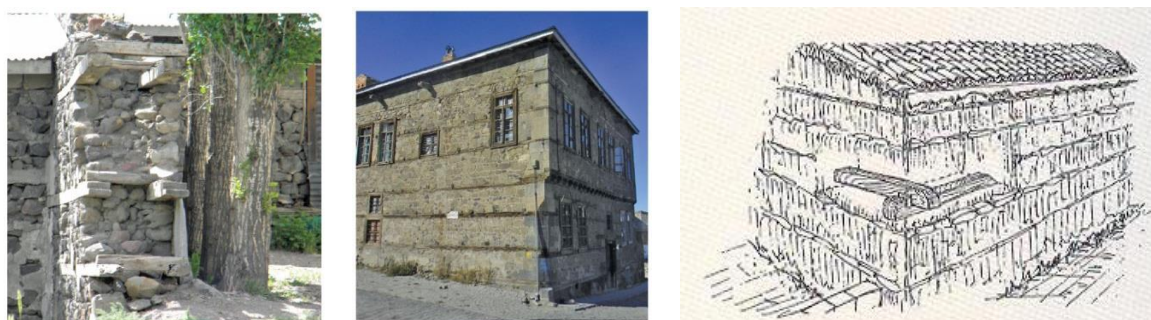
**Figure 5.** (5a-left) Timber horizontal elements, known as ‘hatil’, embedded in a masonry wall in Turkey [19]; (5b-middle) Traditional house with horizontal timber beams in Erzurum, Turkey [19]; (5c-right) Horizontal timber elements embedded in rammed earth wall in Alentejo, Portugal [23]

An effective seismic-resistant technique often observed in vernacular buildings is the insertion of wooden horizontal elements in the masonry wall. Stone masonry walls with embedded timber beams can be observed in many highly seismic regions in the world, such as Turkey [19], India [20], Pakistan [21], Macedonia [22] or Italy. The timber beams are usually positioned parallel to walls in both sides, and other timber elements are positioned perpendicularly, linking both beams and creating a ladder like arrangement (Figure 5a). This timber lacing technique ties the wall together, keeping them from spreading and out-of-plane overturning, and also imparts ductility to the system. The capacity for energy dissipation is very high due to the inherently high friction of the system (stone-stone and stone-timber) [20]. In Portugal, horizontal timber elements can also be found inserted in rammed earth walls in some regions, most likely also as a seismic reinforcement (Figure 5c).

Another favorable effect of this technique is the arrest of cracks development within the masonry wall. For this same purpose, horizontal brick bands extended through the walls and subdividing the masonry have been also widely used historically. They can be observed in Italy, in Turkey, in rammed earth construction in Peru [24] and also in Portugal [12].

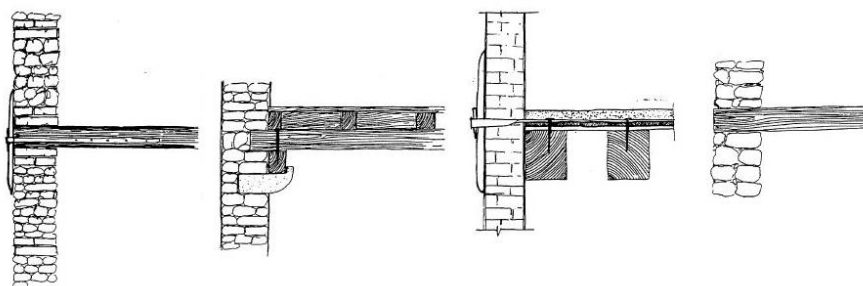
**Figure 6.** Examples of floor to wall connections in Veneto region, Italy [25]

The improvement of wall to floor and wall to roof connections has been traditionally achieved by the piercing of the masonry wall with wooden floor beams and roof rafters. The empirical solutions to assure a tight connection between walls and floors and walls and roofs were wooden pegs or beams resting on the whole width of the walls. Metal brackets and ties were also applied [25] (Figure 6).

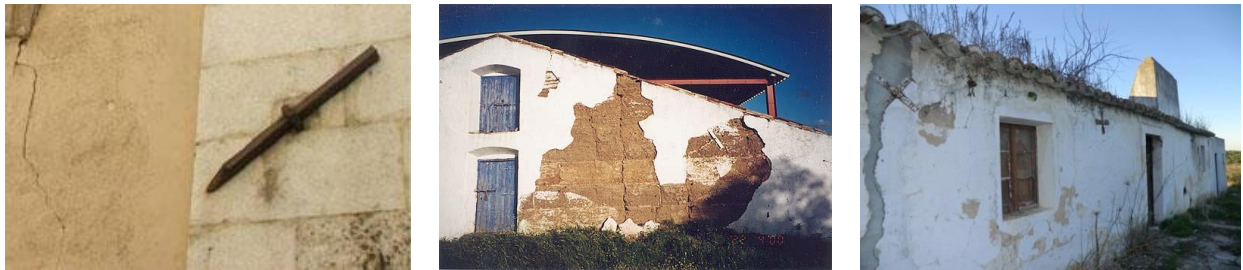
**Figure 8.** (8a-left) Metal ties can be easily found all over Italy [17]; (8b-middle) Tie-rods on a gable rammed earth wall in Safara, Portugal [12]; (8c-right) Tie-rods in vernacular building in Melides, Portugal (Photo by CI-ESG, 2013)

As previously stated, the importance of making effective links between the structural elements in order to ensure the 'box behavior' of the building is critical. Ancient communities were already aware of this fact and, as a result, metal and wooden ties have been applied for a long time as a reinforcement measure in highly seismic regions such as Italy (Figure 8a). This type of strengthening measure has been also widely applied in Portugal in order to improve the structural stability [13] and they can still be observed in many examples of Portuguese vernacular architecture (Figure 8b & 8c).

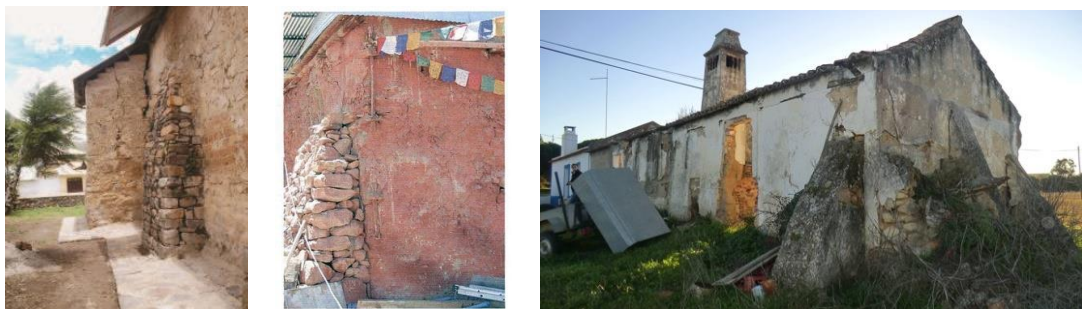
**Figure 9.** (9a-left) Stone buttress in adobe masonry chapel in Peru [28]; (9b-middle) Rubble stone corner buttress reinforcing the earthen walls of an ancient Buddhist temple in the Western Himalayas in India [29]; (9c-right) Buttress reinforcing a ruined rammed earth vernacular construction in Melides, Portugal (Photo by CI-ESG, 2013)

Buttresses can be built at the same time as the building, as a deliberated feature, or they can be added on to older masonry, as a reinforcement measure. Buttresses can counter the rotation of the façade thanks to their sheer mass. They can be found again, in most of the highly seismic regions, where masonry is the main construction system, such as Italy, Peru [28] or India [29] (Figure 9a & 9b). In Portugal, buttresses are also common in vernacular architecture, being introduced in earthen constructions to counteract the lateral forces exerted by roofs, arches and vaults [10]. They may also have a seismic concern origin and they can still be found in many vernacular buildings (Figure 9c).

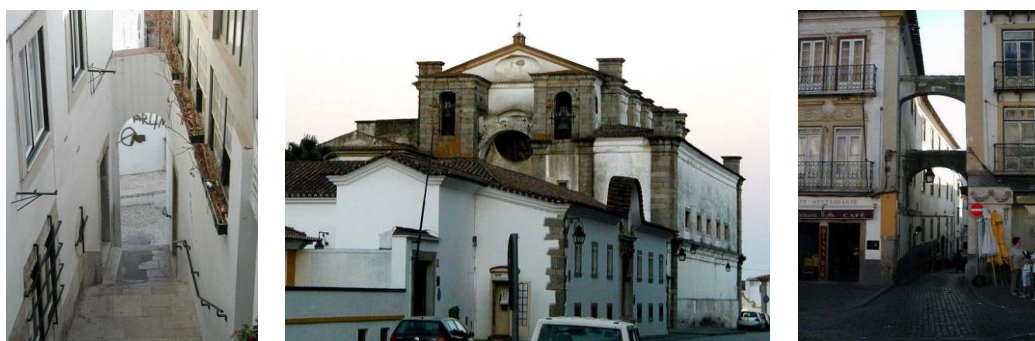
**Figure 10.** (10a-left) Counter arch in Lisbon, Portugal [12]; (10b-middle) Counter arch in front of the rose window in Igreja do Espírito Santo, Évora, Portugal [12]; (10c-right) Counter arches in Évora, Portugal [12]

In urban environments, other elements that perform a similar reinforcement task are external stairs, counter arches in between buildings, vaulted passages and loggias. These reinforcement types are very much present in villages built mainly on stone, such as Italians [4], but in Portuguese cities like Lisbon and Évora, many of these features can also be found (Figure 10).
