## 9<sup>th</sup> International Masonry Conference 2014 in Guimarães

# Direct Sonic and Ultrasonic Wave Velocity in Masonry under Compressive Stress

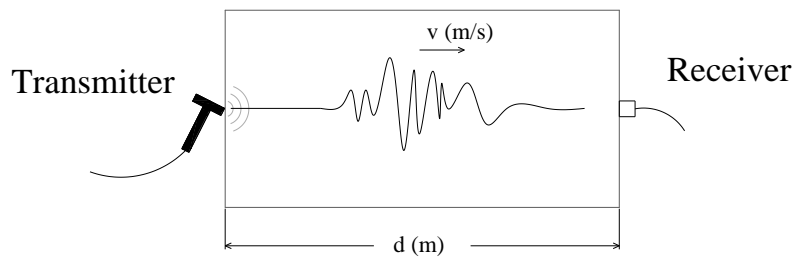
**Figure 1.** Basic concept of a direct sonic test

The precise velocity, energy and wavelength of each wave are determined by the physical and mechanical properties of the materials through which the wave passes. It follows then that studying the changes in a wave's signal as it passes through a material can provide information about the material's properties. Since wave velocity is the quickest and easiest property to distinguish and it is used most often in sonic testing, it will be the main focus of these studies. The velocity of a wave traveling through a material can be calculated simply using the time that it takes the wave to travel a certain distance,  $d(m)$ , as shown in Figure 1 and Equation 1.

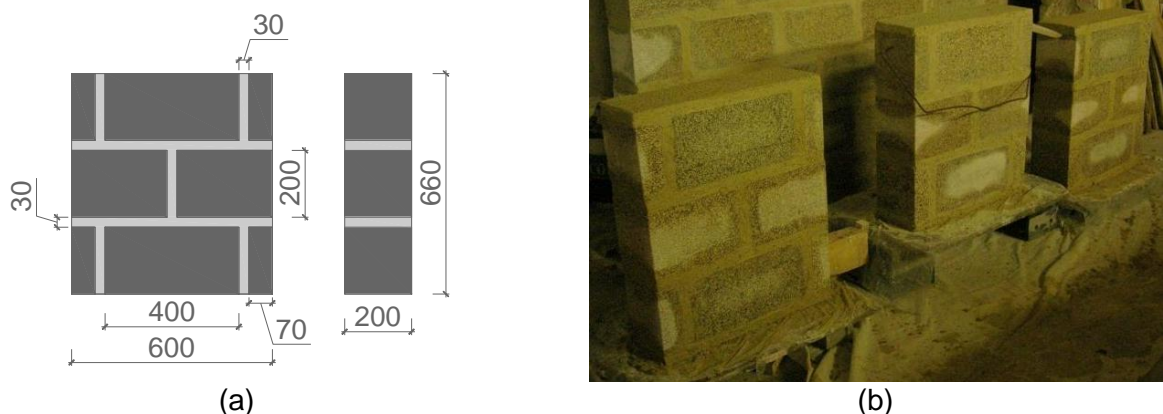
**Figure 2.** Masonry wallet: (a) design showing front and side profiles; and (b) completed construction of the three specimens [dimensions in mm]

Small masonry wallets were constructed for the purpose of studying non-destructive tests on masonry loaded in compression in the masonry's elastic range. Three specimens were constructed in accordance with the European Standard for compression testing of masonry specimens [8]. Materials used for the construction were 40 cm by 20 cm by 20 cm granite blocks, cut in accordance with the masonry specimen dimensions, and a low strength cement-lime mortar. The design of the masonry wallets and their construction is shown in Figure 2. The wallets were cured uncovered in the laboratory basement.

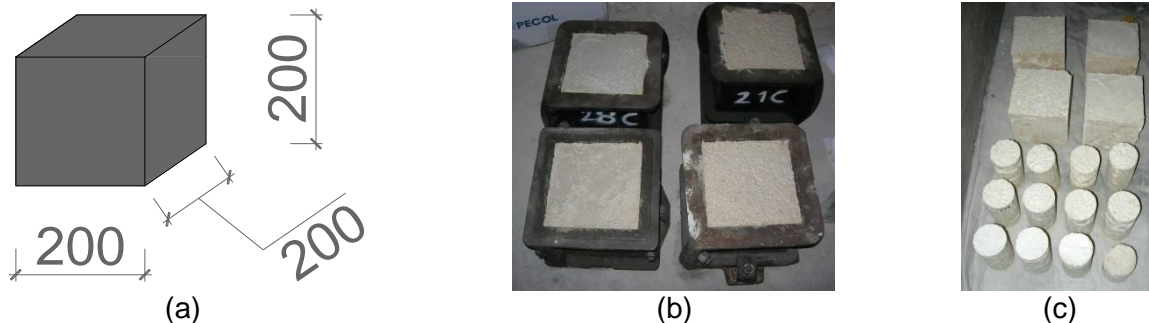
**Figure 3.** Material specimens: (a) granite cube dimensions [mm]; (b) mortar cubes in molds; and (c) mortar cubes and cylinders curing

Granite cubes were cut to the size of 20 cm by 20 cm by 20 cm, as shown in Figure 3a, for ultrasonic testing while the granite is under compressive loads. Four mortar cubes with dimensions of 15 cm by 15 cm by 15 cm were also cast concurrently with, and using the same mortar as, the construction of the wallets (Figure 3b). The mortar cubes were cured under the same conditions as the wallets and were demolded after 3 weeks.

The four mortar cubes shown in Figure 3b and c were tested as described in the previous section. The cubes were labeled MR1 – MR4. Since the compressive strength of the mortar was determined to be approximately 0.32 MPa, the maximum load was selected to be 3 kN, which is equivalent to a stress level of 0.133 MPa, less than half the compressive strength, ensuring that the specimens would be compressed only in the linear elastic range. Each load step was then set to 0.5 kN. The average standard deviations of the three velocities taken at each of the load levels were 9 m/s, 13 m/s, 7 m/s, and 7 m/s for specimens MR1, MR2, MR3, and MR4, respectively. Test results are shown in Figure 11a.

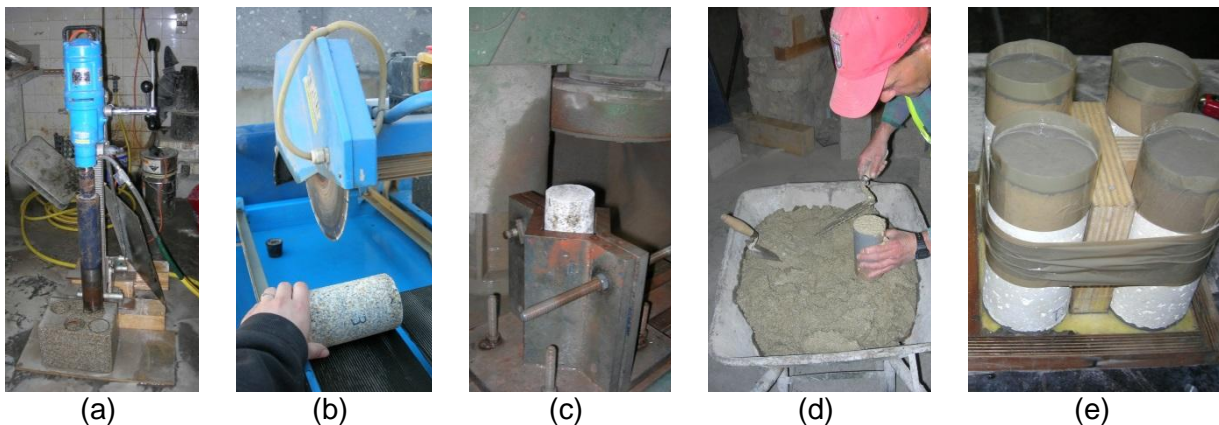
**Figure 4.** Cylinder preparation: (a) granite coring; (b) sawing granite cores to the correct height; (c) rectifying the granite cylinder ends; (d) casting mortar cylinders; and (e) capping mortar cylinders

To determine the material properties of the granite and mortar used in the masonry wallets, additional cylindrical specimens were made for compression testing. Seven granite cylinders were cored from two granite blocks from the same batch of granite used for the masonry wallets (Figure 4). The cylinders were approximately 73.5 mm in diameter and cut and rectified to approximately 150 mm in height. The cores were dried at 100 °C for 6 hours and then placed in the same curing environment as the masonry wallets. Eight mortar cylinders, labeled R13-R20, were cast concurrently with, and using the same mortar as, the construction of the wallets. The average diameter of the cylinders was approximately 70 mm and the average height approximately 150 mm. The mortar specimens were demolded two weeks after casting and stored in the same conditions as the masonry wallets until testing. Two days before testing the mortar cylinders, thin layer cement caps were added to ensure a smooth transfer of load to both ends of the specimens.

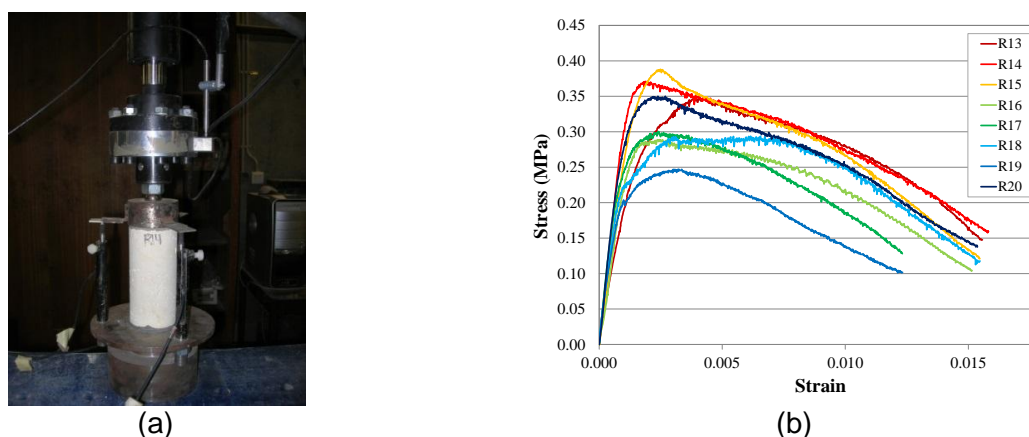
**Figure 6.** Mortar cylinder compression test: (a) test setup including LVDTs used to measure vertical displacement of the entire specimen for calculation of the Young's Modulus; and (b) results of the eight tests

The mortar cylinders were tested in uniaxial compression to determine the Young's modulus and compressive strength of the mortar. The loading rate was 2  $\mu\text{m/s}$  and was controlled by an external LVDT. The test set-up is shown in Figure 6a and the results of the mortar cylinder compression tests are shown in Figure 6b.

The average compressive strength was calculated to be approximately 0.32 MPa with a standard deviation of 0.048 MPa. The Young's Modulus was calculated using the portion of the stress strain curve between 5% and 40% of the maximum stress, approximately the linear portion of the graph, for each specimen. The average Young's Modulus was calculated to be 281 MPa with a standard deviation of 57.6 MPa.

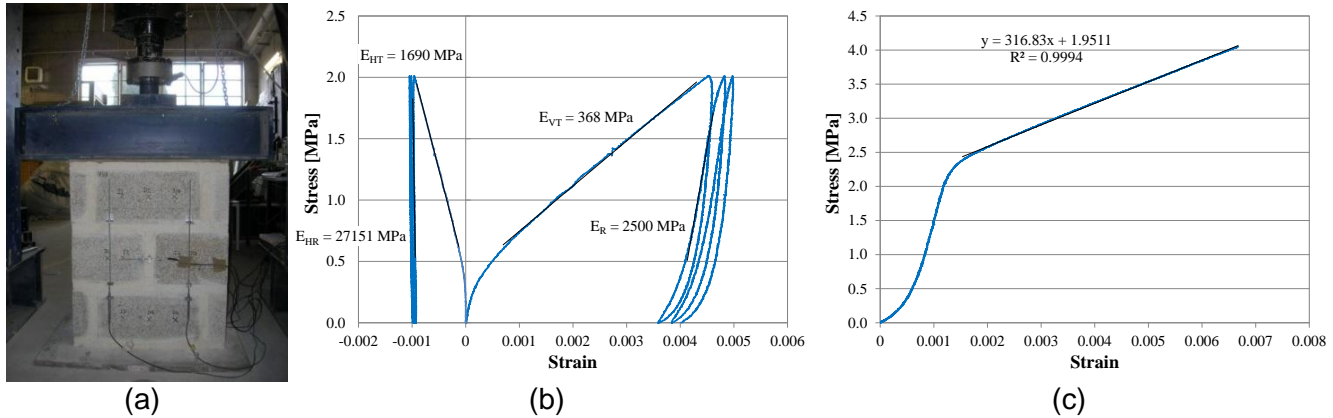
**Figure 7.** Masonry wallet testing: (a) complete test set-up; (b) RS1 Young's Modulus test results; and (c) RS1 compression test results

The masonry wallets were tested in compression using a steel frame and a 600 kN load cell to determine their Young's modulus and compressive strength. The positioning of the LVDTs was determined based on British Standard, Methods of test for masonry – Part 1: Determination of compressive strength [8]. The complete test setup is shown in Figure 7a.

Before performing the tests, the compressive strength of the masonry was estimated to be 2.25 MPa using the European Standard 1996-1-1 part 3.6.1.2 [9]. This estimation was used for determining the maximum compressive load for the first Young's Modulus test. Following the first Young's Modulus test, the results of the first compressive test revealed that the compressive strength of the masonry was much higher than the estimated value. The first specimen was tested with a loading rate of 0.1 kN/s and a maximum loading of 60 kN. The second and third specimens were tested with a loading rate of 0.3 kN/s and a maximum loading of 250 kN. The average vertical and horizontal LVDT results for the third specimen tested, the RS1 specimen, are shown in Figure 7b. The tangent loading modulus,  $E_{VT}$ , was determined from the linear loading portion of the vertical LVDT data (Figure 7b). Since the RS1 test was the most successful test of the three, the tangent Young's Modulus of the masonry was taken as 368 MPa. The reloading modulus,  $E_R$ , was determined to be 2.5 GPa from the first reloading cycle of the vertical LVDT data (Figure 7b). A trend line was also fit to the initial loading of horizontal LVDT data (Figure 7b) and the value of the slope,  $E_{HT}$ , displayed. Using the inverse slopes of the trend lines from the initial loading data in the vertical and horizontal directions, the Poisson ratio was calculated to be 0.218.

It can also be seen in the results for the RS3 specimen that the sonic velocity decreases as an initial load is applied. The initial vertical loading causes the horizontal movement of the units outward as shown in the horizontal LVDT data in the Young's Modulus tests (Figure 7). This movement creates cracks or voids in the joints. After the initial drop of the sonic velocity, as the compressive stress is increased there seems to be little influence on the sonic velocity, only the variation due to the variability of sonic testing can be seen. The increasing vertical pressure does not close the initial voids in the joints and the measured sonic velocity remains the same.

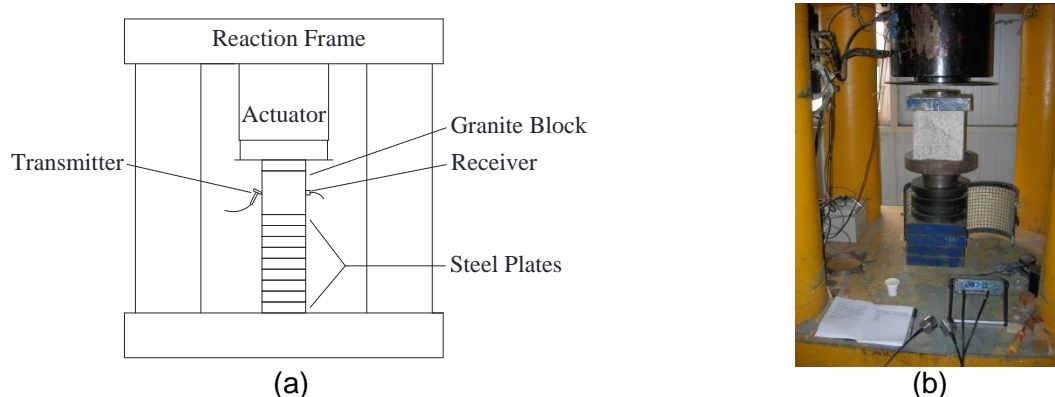
**Figure 8.** Granite block test setup: (a) schematic; and (b) ultrasonic test equipment

The granite block tests were conducted in the same frame and with the same load cell as the granite cylinder compression tests as shown in Figure 5b. A schematic of the test setup for the granite block tests is shown in Figure 8a. The load was applied to the specimens vertically in a step-wise procedure. The specimens were loaded at a rate of 4 kN/s. At each load level the load was held constant for 5 minutes while three ultrasonic readings were taken. The three readings were averaged for each load level. The ultrasonic signals were transmitted horizontally through the specimen from the center of the left side to the center of the right side. Vaseline was used to ensure contact between the sensors and the granite surface. The test equipment and set-up are shown in Figure 8b.

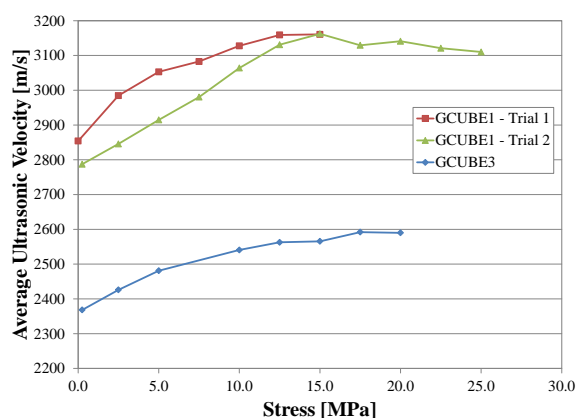
**Figure 9.** Granite block test results

Two granite block tests were performed on granite cube GCUBE1 and one on GCUBE3. In the first test on GCUBE1 the maximum load was 600 kN and the load steps were 100 kN. Following this test the block was left uncompressed for 48 hours. In the second test on GCUBE1 the maximum load was increased to 1000 kN with load steps of 100 kN. For the GCUBE3 specimen the same load steps were used up to a maximum load of 700 kN. The average standard deviation for the three ultrasonic velocity values taken on each load level was 13 m/s for GCUBE1 and 7 m/s for GCUBE3. The average results are shown in Figure 9. It can be seen in these results that initially as the compressive load or stress in the granite increases, the ultrasonic velocity also increases. As the stress level increases the ultrasonic velocity levels off or even starts to slowly decrease. To confirm these results and determine if the initial trend is linear more tests are necessary. The difference in the initial ultrasonic velocities between the two test specimens can be attributed to the variability of the granite, shown in the results of the cylinder compression tests, the surface roughness of the granite and connection between the sensors and the granite, and any unseen flaws within the material.

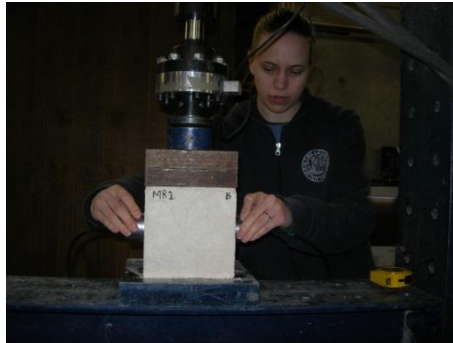
Figure 10. Mortar block test setup including positioning of ultrasonic sensors

The mortar blocks were tested in the same frame and with the same 50 kN load cell as the mortar cylinders. Figure 10 shows the test setup and the ultrasonic sensors being applied during a test. The load was applied to the specimen vertically in a step-wise procedure. The mortar cubes were compressed at a rate of 5 N/s starting from a preload of 0.3 kN. At each load level the load was held constant for 3 minutes while three ultrasonic readings were taken. The three readings were averaged for each load level. Ultrasonic waves were transmitted horizontally through the specimen from one side to the other as shown in Figure 10. Vaseline was used to ensure contact between the sensors and the mortar surface.

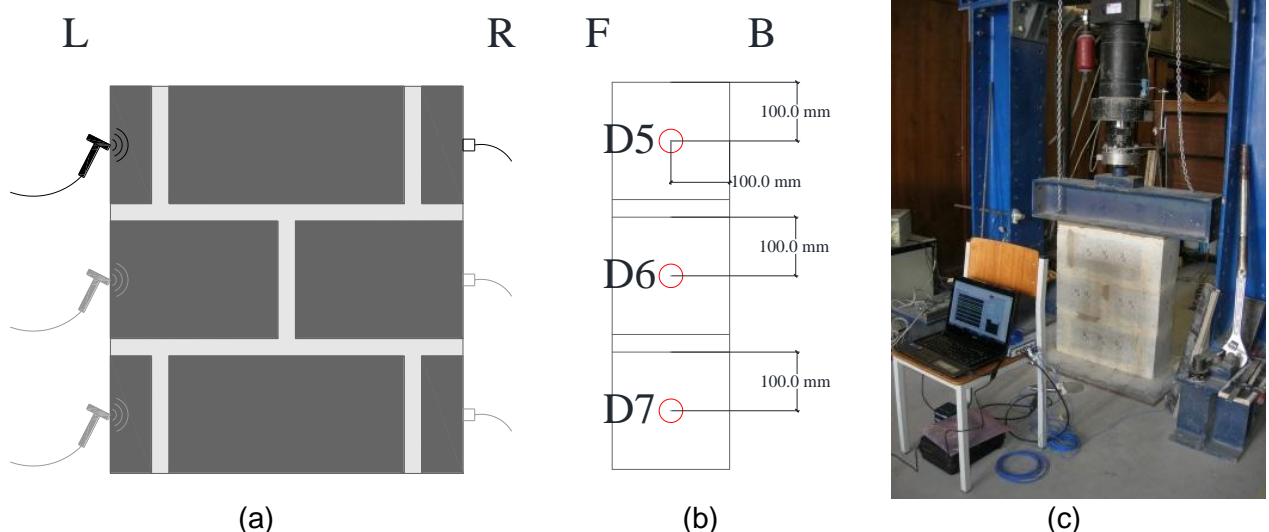
**Figure 12.** Masonry wallets compression and sonic test setup: (a) direct sonic test transmission and reception points; (b) labels and locations of points; and (c) complete test setup

The masonry wallets were tested in the same frame and position as they were tested for the Young's modulus test, as described previously in the paper. Tests were conducted by transmitting a sonic wave through the masonry by hitting the granite with an instrumented hammer and receiving the signal on the opposite side of the specimen with an accelerometer. There were three point combinations to be studied, labelled D5, D6, and D7, corresponding to the top course, middle course, and bottom course of masonry, as shown in Figure 12a and Figure 12b. By measuring the distance between the transmission point and the reception point and calculating the time it took the wave to pass through the masonry by selecting the points in time at which the wave was transmitted and received, the average velocity of each transmitted wave could be determined. For each set of transmission and reception points, ten hammer hits or waves were transmitted through the masonry and recorded. The average of these ten hits was considered the average sonic velocity for that set of points.

The surface of the specimen and connection between the sensors and the material can impact the recorded wave velocity. Thus, measurements were taken in both directions, from left to right and right to left. Since the material is the same between these point combinations it can be assumed that the difference in sonic velocity is due to the surface conditions. The two average values from each point combination for left to right and right to left were averaged to create a single set of data for each point combination.

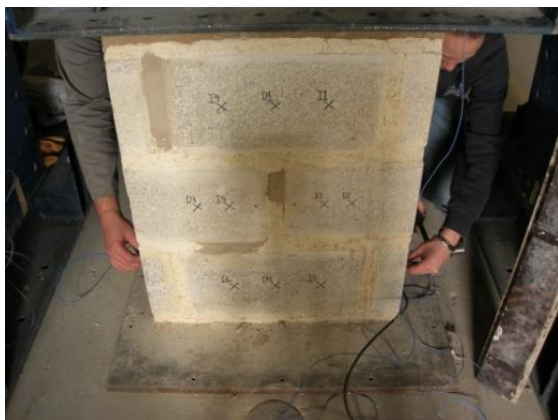
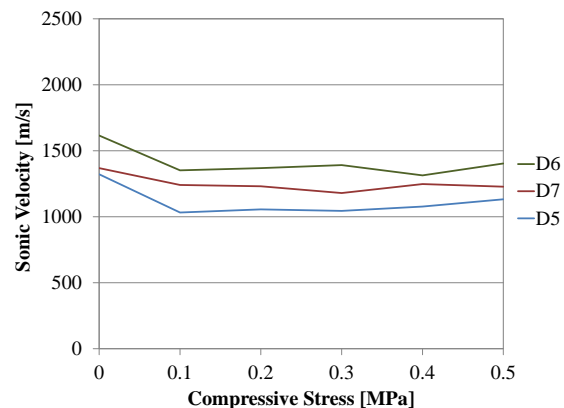
**Figure 13.** Compression sonic testing of masonry wallet RS3: (a) testing the D7 points; and (b) average results

Figure 13a shows the sonic testing being conducted on the first wall, RS3, at the D7 points and Figure 13b shows the results from the tests on the RS3 specimen. The results show that, despite the compressive stress that the masonry is under, the sonic velocity is always greater in the second course of masonry. This is due to the fact that it has only one vertical mortar joint that the wave must pass through, while both the first and third courses have two vertical joints. Each time the wave must pass through a joint, the overall average velocity is reduced because the wave moves slower through the mortar than it does through the granite, as shown in the ultrasonic tests performed through the individual materials.

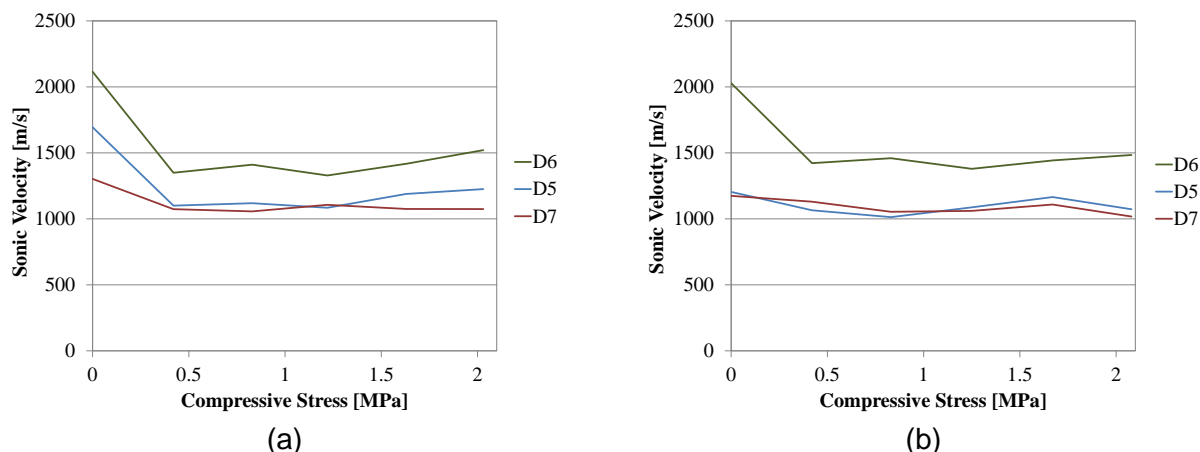
**Figure 14.** Average results from compression sonic testing of masonry wallets: (a) RS2; and (b) RS1

The results of the compression and sonic tests on specimens RS2 and RS1 are shown in Figure 14. These results also show that for all stress levels the sonic velocity at the D6 points, through the central masonry course, is higher than for the other two point combinations. This confirms that the number of mortar joints that the wave must pass through impacts the average sonic velocity. These results also show the same drop in sonic velocity from when the masonry is unstressed to when it is compressed.

The results for the RS2 and RS1 specimens show that there could be a slight increase in the sonic velocity for the D6 points as the compressive stress is increased beyond approximately 1.25 MPa. However, this increase is very slight and may only be the random variation of the sonic tests. More tests would need to be conducted to confirm this trend. Additionally, no trends or correlations can be seen for the other points, D5 and D7. Thus, it can be concluded that for regular masonry made of granite and weak mortar, compressive stresses after initial vertical loading and up to approximately 2 MPa do not significantly affect direct sonic test results.
