## 9<sup>th</sup> International Masonry Conference 2014 in Guimarães

# Spectral-based Damage Identification Technique on an Earthen Mock-up Construction tested on a Shaking Table

MASCIOTTA, MARIA GIOVANNA<sup>1</sup>; LOURENÇO, PAULO B.<sup>2</sup>; RAMOS, LUÍS F.<sup>3</sup>;  
VASTA, MARCELLO<sup>4</sup>; STURM, THOMAS<sup>5</sup>; CAMPOS-COSTA, ALFREDO<sup>6</sup>

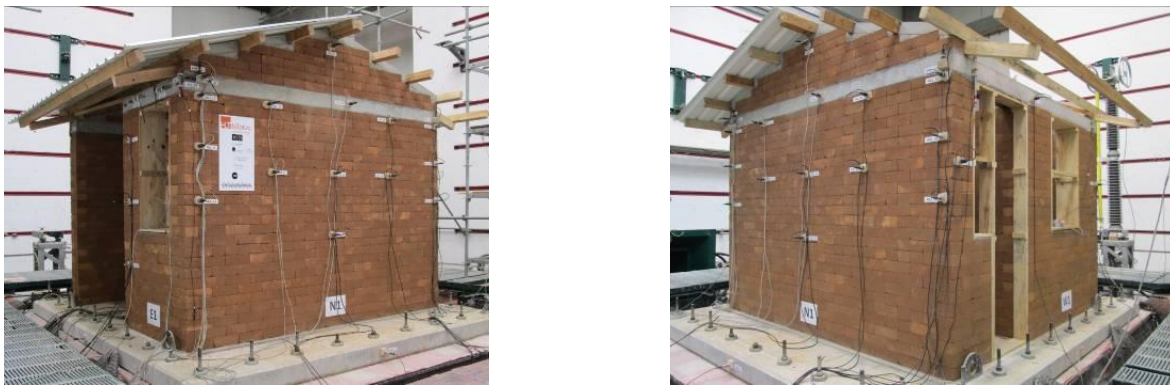
A physical model with compressive earthen blocks masonry (with interlocking) was built in the Laboratório Nacional de Engenharia Civil (LNEC), located in Lisbon, Portugal (Figure 1). Since the necessity to respect the limitations of the shaking table in terms of weight capacity, plan size and maximum allowable height, the mock-up was not exactly a scaled model based on “true replica” principles. The plan size was reduced, whereas the main structural features of the original house, such as ratio between in-plane dimensions, walls distribution and in-plane asymmetries, were maintained. On the contrary, the size of the CEBs were kept the same as the original ones, which resulted in an increased wall density, but this approximation did not affect the purpose of the study here presented.

**Figure 1.** Earthen mock-up on the shaking table: North-East (left) and North-West (right) views

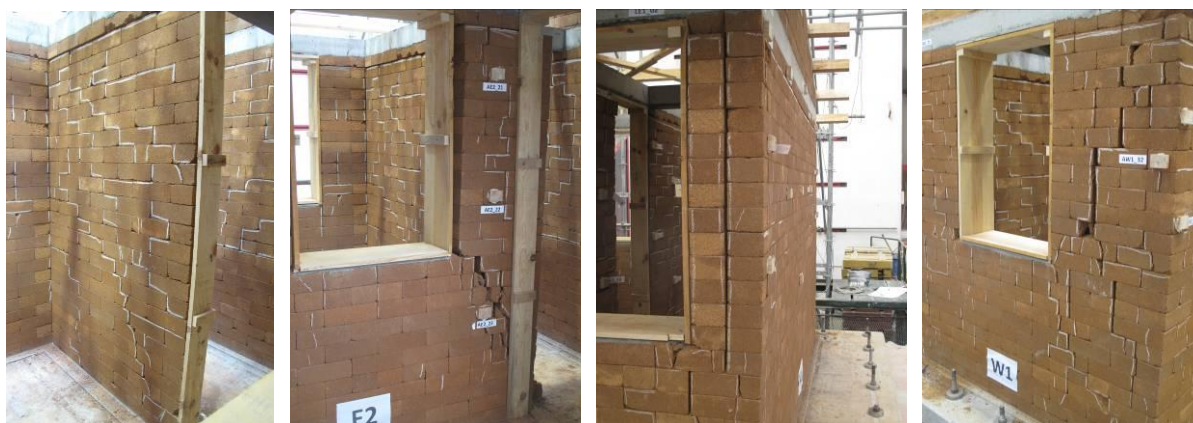
Up to stage 6, namely till reaching a target scale of 100% of the input signal, the prototype was not affected by any serious visible cracks. The only exception was a horizontal crack occurred in the upper part of the single-leaf partition wall (Figure 6), that began swinging as simple supported wall from this stage on. After stage 6, the model started losing that kind of box behaviour that the concrete ring beam, together with the gables, was providing to the structure, thus a horizontal crack progressively appeared along the upper part of all the facades. Apart from that, no severe damage was observed till the last phase (stage 9), when one of the piers of the East wall cracked starting to overturn for rotation in its plane and the West-South corner started rotating out of its plane (Figure 6).

**Figure 6.** Crack pattern: a) inner wall, b) East pier, c) South-East and d) South-West corners

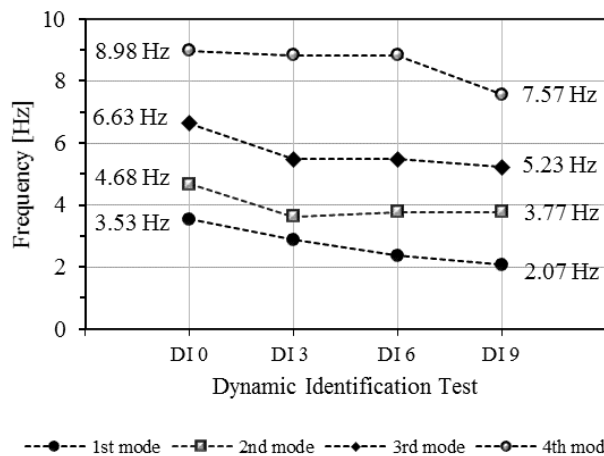
Test by test the amplification of the seismic action caused the increase of the damage that resulted in the progressive degradation of the structural stiffness of the mock-up. Because of that, the eigenfrequencies of the structure progressively went down decreasing up to 41%, as in the case of the first mode. Figure 8 presents the evolution of the natural frequencies estimated by the spectral-based method with increasing input.

Mode	DI 0	DI 9	$\Delta\omega$ [%]
1 <sup>st</sup>	3.53	2.07	-41.36
2 <sup>nd</sup>	4.68	3.77	-19.44
3 <sup>rd</sup>	6.63	5.23	-21.12
4 <sup>th</sup>	8.98	7.57	-15.70

**Figure 8.** Evolution of the eigenfrequencies with increasing damage
