SAHC2014 – 9th International Conference on
Structural Analysis of Historical Constructions
F. Peña & M. Chávez (eds.)
Mexico City, Mexico, 14–17 October 2014

THE IMPORTANCE OF INTEGRATED PROJECTS IN HISTORIC CONSERVATION EDUCATION

5 CASE STUDY - 13TH CENTURY HOUSE, PRAGUE, CZECH REPUBLIC

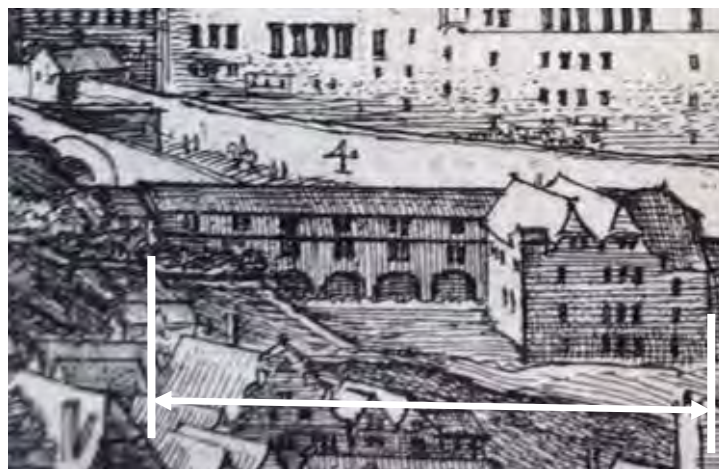
Figure 2 – East Elevation 1632

This SA-7 project is a very large house dating to the late 13th century near Prague Castle. Figure 1 shows an aerial view in 2011. Prague Castle and the east stairs are above the building. North is to the right. It appears in early drawings and first shows up in written records in 1407. The house was added onto several times. In 1672, it became a Theatine Monastery and functioned as such until 1883 when the monastic order was abolished. Figure 2 is a drawing from 1632 showing the east elevation.

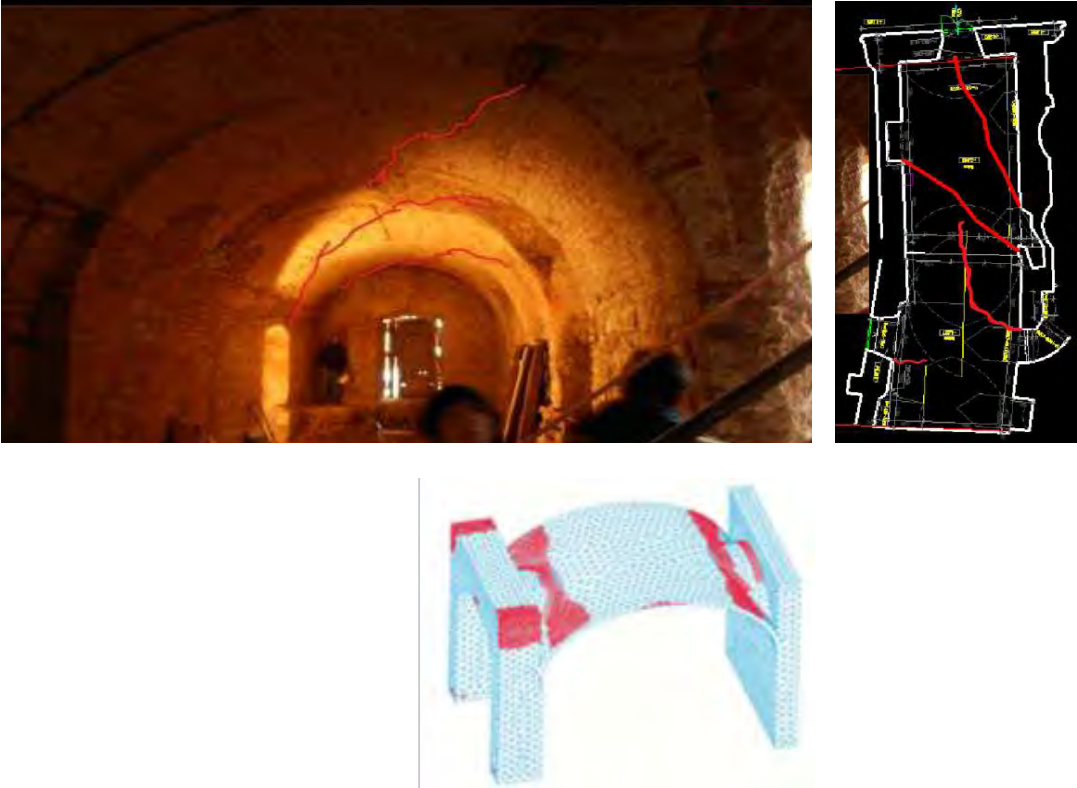
Figure 4 – Interior view of vault (left); crack mapping (right); non-linear analysis of vault to determine crack locations (lower center)

The Masonry Vaults Group studied vaults in two areas of the building. The group performed material characterization; visual assessment of vaults and supports; graphical analyses of vaults as constructed; FEM analyses of current conditions; development of interventions for repair and strengthening and FEM modeling of strengthening interventions (Fig. 4); develop cost estimates.
