## Protection of cultural heritage from earthquakes: The NIKER project and the related research at UMinho

Daniel V. Oliveira<sup>1</sup>, Paulo B. Lourenço<sup>2</sup>

**ABSTRACT:** The European Commission has recently funded a major research project (NIKER) which aimed at developing an integrated methodology for the systemic improvement of the seismic behaviour of cultural heritage assets. This paper provides an overview of the project and presents the most relevant contributions from University of Minho as partner of the project.

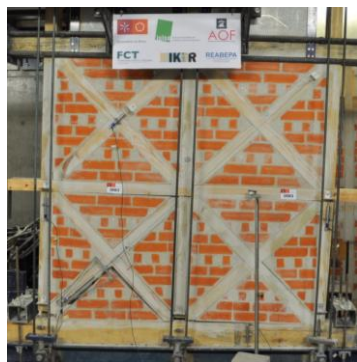
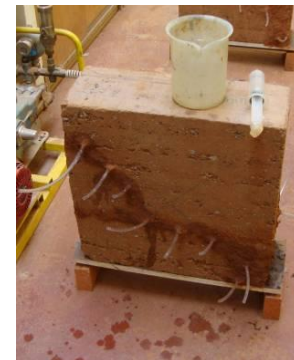
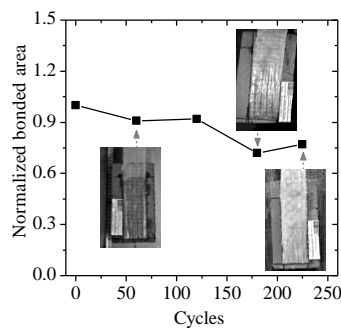
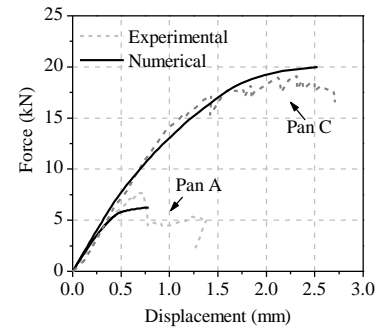
Figure 2. Main contribution from UMinho to the NIKER project: (a) and (b): timber framed walls; (c) and (d): rammed earth walls; (e) and (f): durability of composite materials; (g): wall-to-floor connections; (h) and (i): wall-to-timber framed wall connections.

The University of Minho (UMinho) played an important role inside the NIKER consortium, coordinating 2 of the work-packages and developing active research within the other work-packages. The contribution of UMinho to the most relevant project outcomes can be summarized as follows, see also Figure 2:

- Characterization of the in-plane cyclic behaviour of timber framed walls and definition of appropriate strengthening techniques for the timber joints (both experimental and numerical activities) [2];
- Development of an earth-based grout for injection of rammed earth walls (experimental activity) and characterization of structural rammed earth components under shear loading (both experimental and numerical activities) [3];
- Analysis of the bond durability of composite materials applied to masonry structures (both experimental and numerical activities) [4];
- Characterization of the cyclic behaviour of wall-to-floor connections (experimental activity) [5] and of wall-to-timber framed wall connections (both experimental and numerical activities) [6] [7].

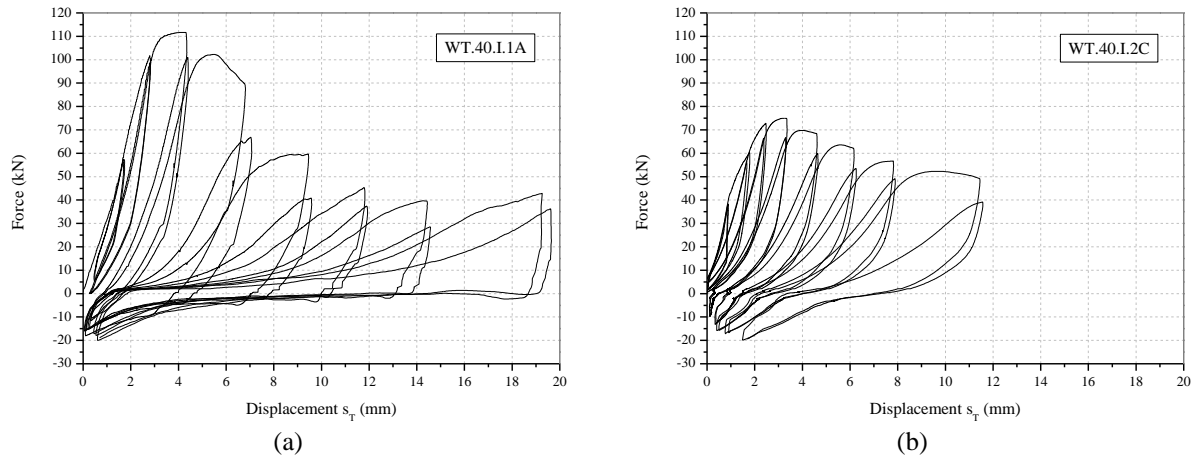
Figure 8. Typical pull-out force-displacement curves for injection anchors: (a) bottom part; (b) top part.

Force-displacement hysteresis loops of specimens WT.40.I.1A and WT40.I.2C represent the typical curves of tests performed at the bottom and top of the wall, respectively, see also Figure 8. The pinched hysteresis loops show a great similarity, being controlled by bond slip phenomena at the grout/masonry interface. The cyclic behaviour shows a strength and stiffness degradation with the increasing steps and an accumulation of residual displacements. The descending branches of the cycles pushed the specimen as much as 0.5 mm, which caused the development of compressive forces. The values of this force obtained for top and bottom of the walls were very close (21.0 kN and 23.9 kN), not portraying the clear distinction noticed for tension. Residual displacements and compression forces depend greatly on the composition of the interface grout/masonry and surrounding masonry.

All tests showed combined cone-bond failure with sliding at the interface grout/masonry and masonry breakout. Tests at the top showed a higher influence of the masonry cone while tests at the bottom showed bond failure at the grout/masonry interface as the major contributor for failure.

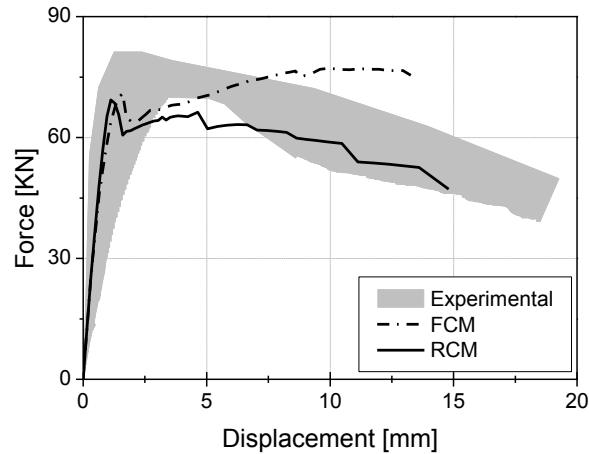
Figure 10. Force-displacement curves for the RCM and FCM formulations and experimental envelope.

The force-displacement curves coming from the FCM and RCM are depicted in Figure 10, as well as the experimental envelope obtained from the force-displacement curves of three tests. The comparison of the numerical analyses (FCM and RCM) against the experimental envelope does not show significant differences concerning the linear behaviour and peak force, as expected. Although both numerical curves present a sudden decrease in load capacity just after the peak, the post-peak response exhibits considerable differences. The FCM formulation provides a continuously increase of the force after peak, which is not in agreement with experiments. In fact, the experimental post-peak envelope shows clearly a gradual force decrease with respect to displacement, which is well captured by the RCM formulation. This last approach provides a maximum force of 69 kN (90% of the average experimental value) and an ultimate displacement of 15 mm.

Figure 10 shows clearly that the shear modelling can have a great influence on the post-peak behaviour of this type of structures, making the difference between a realistic structural modelling of the system and an incorrect overestimation of strength, even if the first peak is independent of the model.
