Canterbury Cathedral – Structural Analysis of the South Aisle

Georgios Karanikoloudis

Portugal | 2014

# Master's Thesis

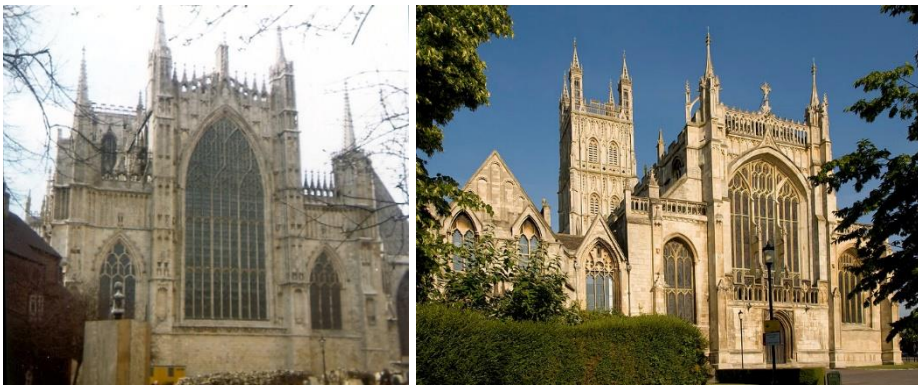
Figure 2-4. (Left) York Minster Cathedral, England, York (1338-1408). Equilateral arches at the east front ("York Minster" 2014). (Right) Gloucester Cathedral, England (1089–1499). Depressed arches at the east front ("Gloucester Cathedral" 2014).

Pointed arch: A pointed arch, unlike the semi-circular or segmental one, transfers the horizontal thrust to the vertical abutments at a much steeper angle, thus decreasing the horizontal component. Every opening window and passage is constructed with a pointed arch that can have many shapes or styles (Figure 2-3, 4). This allowed the architects to raise the Gothic vaults at a much higher level, attaining forms with flexibility, verticality and slenderness. Many designs were implemented to fill in these windows with stained glass and stonework supporting frames, called tracery. The Gothic arch can have the main following configurations: ("Gothic Architecture" 2014a; "Gothic Architecture" 2014b)

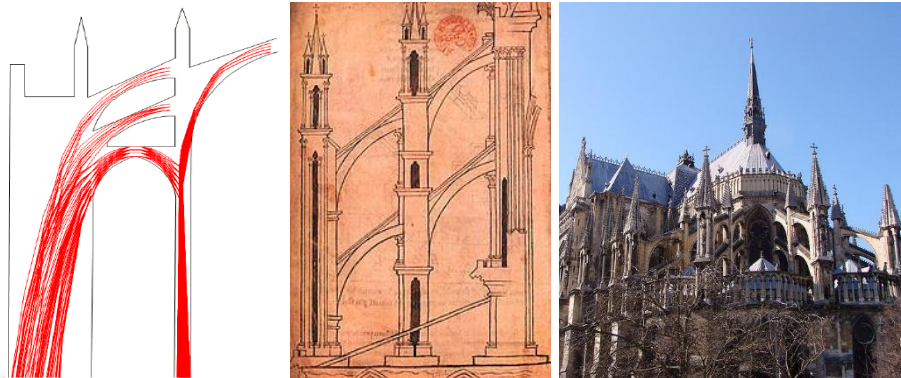
Figure 2-6. (Left) In the appearing typical section of a Gothic Cathedral, the upper flying buttress receives the lateral thrust from the weight of the roof, the wind and the weight of the clerestory wall, whereas the lower one counteracts the lateral outward forces from the weight of the nave vaults. Many possible thrust lines are shown (Luca et al. 2014). (Middle) Villard de Honnecourt's drawing of the flying buttresses system at Reims Cathedral ("Reims Cathedral" 2014). (Right) Exterior view of the east front of Reims Cathedral at Reims, France (1211-1275). System of flying buttresses ("Reims Cathedral" 2014).

Flying buttress: A significant feature of Gothic architecture is the free standing buttress in a sloping arch shape, attached in between the nave's exterior wall and the vertical buttresses of the aisles, choir and transept walls. In Gothic cathedrals there can be one or two flying buttresses per cross-section on each side. Their main role is to counteract with the outward lateral pressures and bulging effects from the vaults and the roof system, transferring them downwards to the piers and vertical buttresses (Figure 2-6) ("Gothic Cathedral and Church Construction"2014).

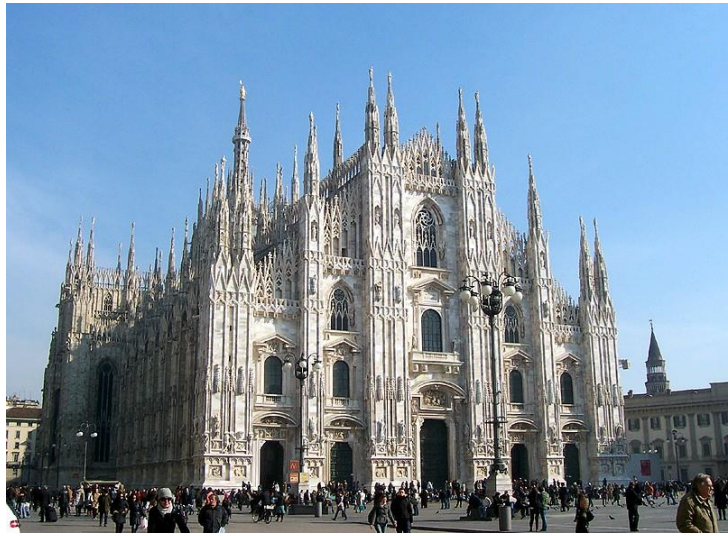
Figure 2-9. Milan Cathedral. Advanced use of pinnacles and spires in the vertical arrangement of piers, buttresses and roof gables ("Milan Cathedral" 2014).

Pinnacles & Tall spires: The vertical character of Gothic architecture is emphasized by the addition of many vertical decorative components, such as pinnacles and spires. Buttresses, piers and gable ends are prolonged above the roofline with smaller size pinnacles. Milan Cathedral constitutes as an extreme example of this feature (Figure 2-9) ("Gothic Architecture" 2014a).

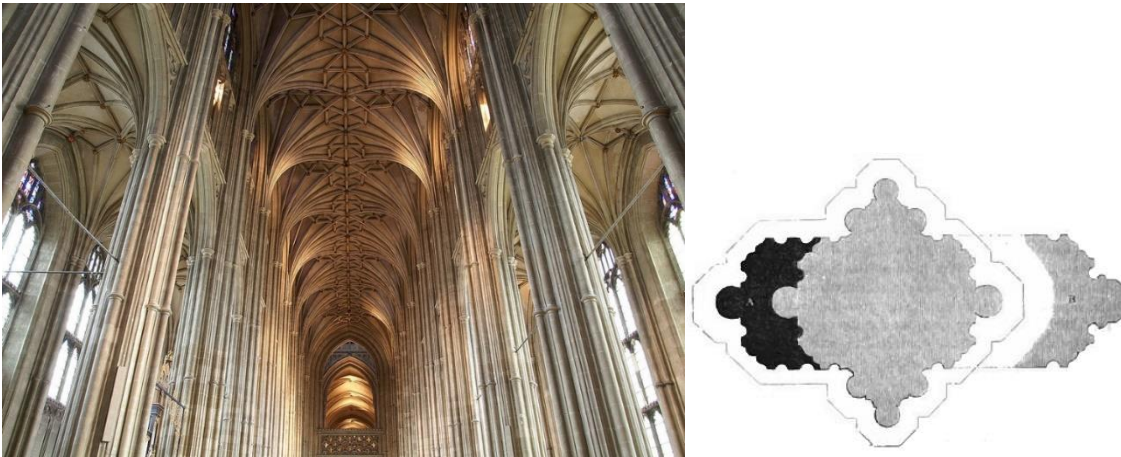
Figure 2-15. (Left) View of the central nave of the Canterbury Cathedral (1070-1834) in the UK. The pier molds are incorporated with the arch molds, resulting in a vertical continuity, thus creating a series of tree-like patterns ("Canterbury Cathedral" 2007). (Right) Pier section in the nave (center section), additional portion of the pier next to tower (left section) and arch mold (right section) (Willis 1845).

The vertical character of Gothic architecture is also emphasized by sweeping the vertical shafts engraved in structural elements from floor to ceiling, where they meet the ribs of the vaults, giving often the impression of a tree like arrangement with various branches (Figure 2-15) ("Gothic Architecture" 2014a).

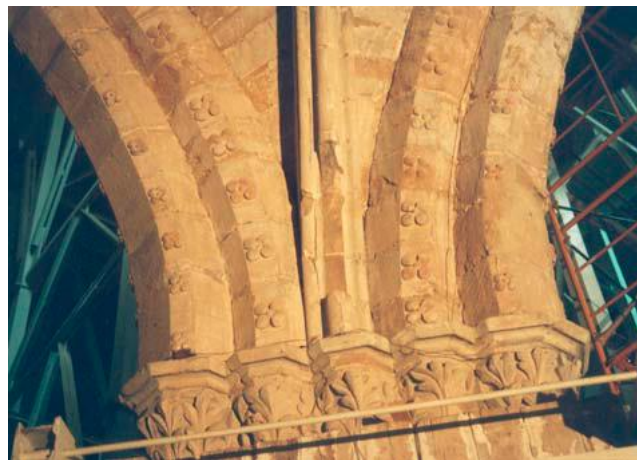
Figure 2-24. Pier of Tarazona Cathedral. Under excessive compressive stresses stone crushing and detachment occurred (Roca et al. 2005)

Cracks under compressive failure of masonry can lead to sudden overall structural failure and can propagate in concentrated areas, such as longitudinal cracks in columns due to high compressive stresses. Creep phenomena is also of relevance for crack propagation, sometimes induced by load redistribution. Damage can occur even under moderate compressive stresses (Figure 2-24) (Binda et al. 2008; Roca et al. 2005).

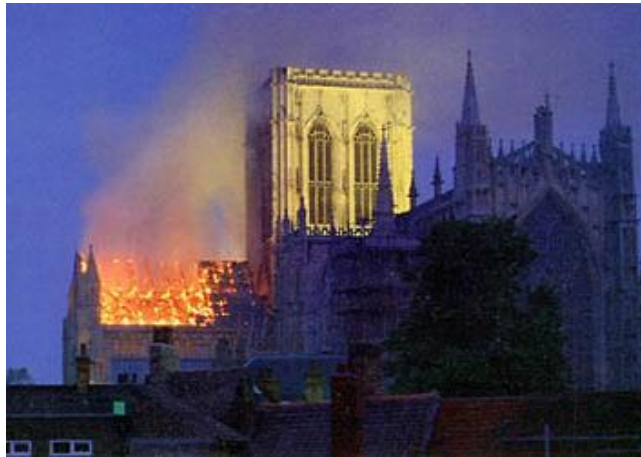
Figure 2-25. In 1984 a great fire, believed to have been caused by a lighting strike, destroyed the timber roof of the south transept of York Minster. Additional damage was caused by the vast quantities of water used to put out the fire. ("An Introduction to the History of York" 2014)

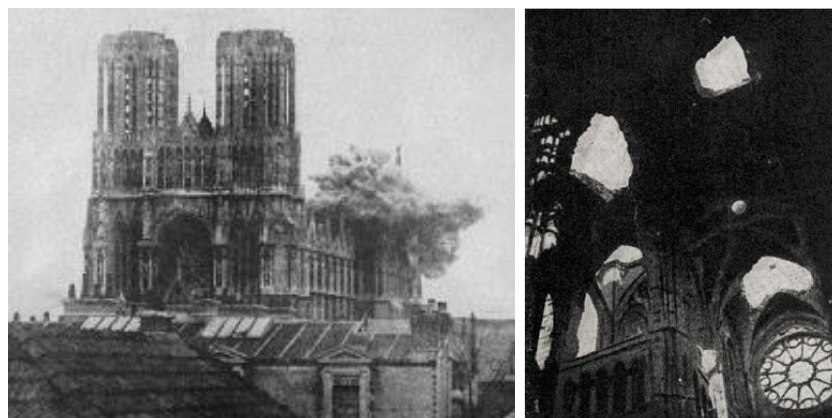
Figure 2-28. Reims Cathedral, Reims, France. (Left) Picture at the time of struck from German shellfire in September 1914. (Right) Inside view. Holes in the vault system from the bombarding (Theodossopoulos et al. 2008).

Many Gothic Cathedrals undertook immense damage from accidental actions, such as blast waves or even direct hits from shelling during the warfare combats. Devastating effects such as sudden collapses of the roof structure under fire, loss of equilibrium of the lateral walls, partial collapse of the vaults was the outcome in many great Gothic Cathedrals across Europe (Figure 2-28) (Theodossopoulos et al. 2008).

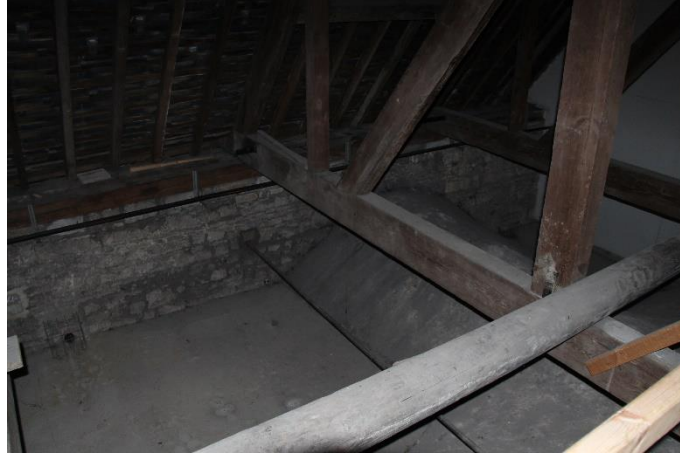
Figure 2-38. View of the interior nave roof void, depicting the concrete infill layer and the drilled hole for drainage.

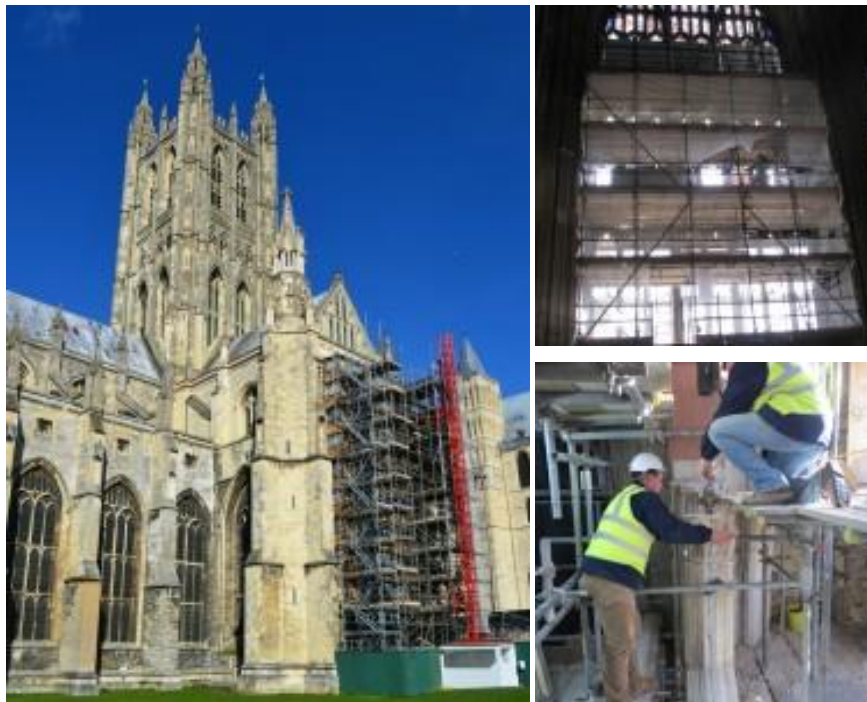
Figure 2-39. (Left) The Great South Window of the South West Transept behind scaffolding. (Right above) Inside view of the Great South Window tracery of the South West Transept. The glass panels have been removed and stone parts are been taken off piece by piece. (Right below) Process of removal of damaged stone masonry in the Great South Window tracery of the South West Transept which will later be replaced by replicas. View of the tracery at top level. ("The Great South Window" 2014).

In October 2013 the new appointed Surveyor of the Fabric was Jonathan Deeming. The Great South Window of the South West Transept tracery experienced extensive damage (cracks and fracturing), mainly due to embed iron rusted bars and outward tilting. Given the widespread damage and after all the stained window panels have been removed, the tracery is being currently repaired in all its extent, by stone replacement of damaged parts (Figure 2-39). The project is bound to be completed by summer 2015 ("The Great South Window" 2014).

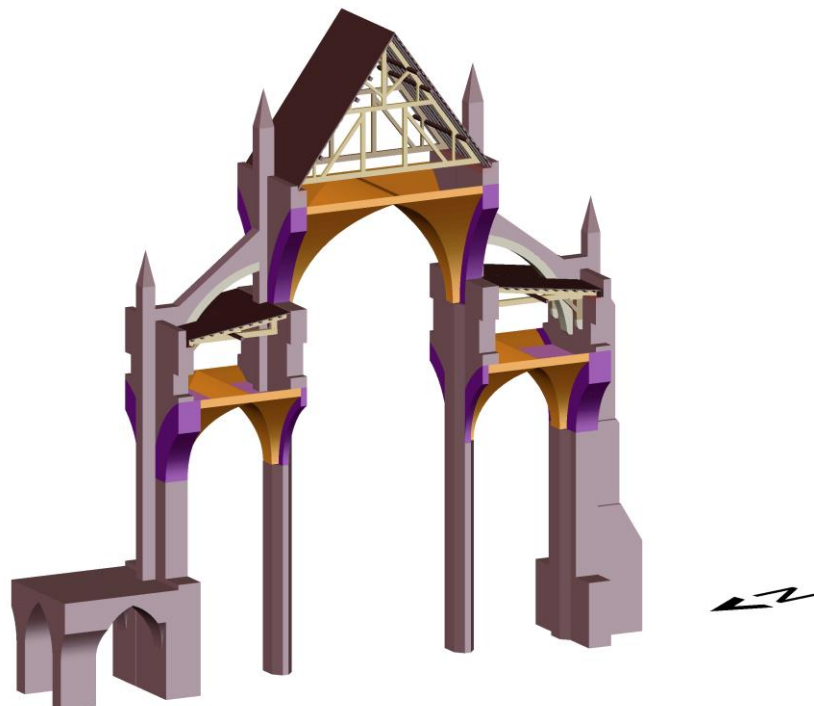
Figure 3-4. Generated geometrical model of the critical transverse cross section of Canterbury Cathedral's nave and the adjoining part of the cloister.

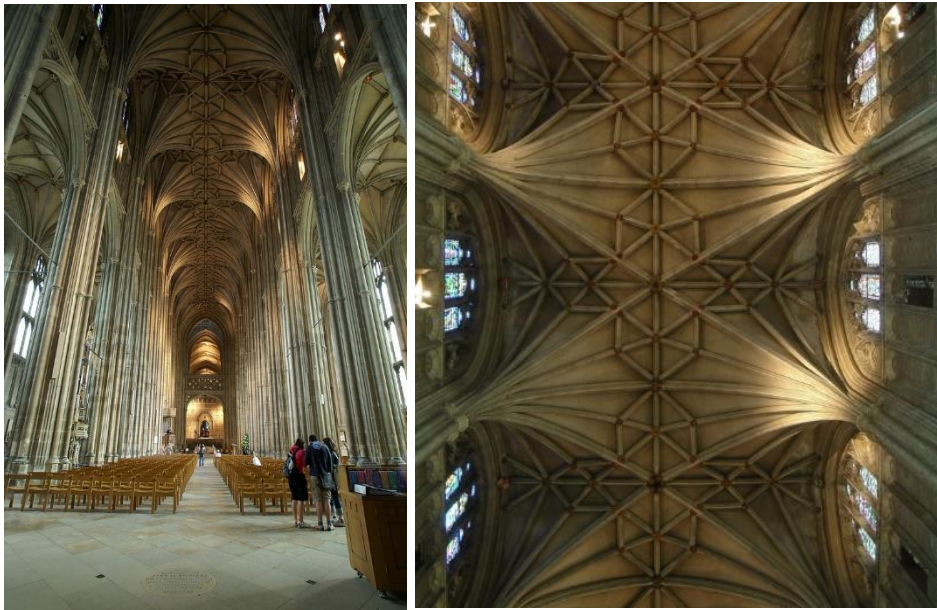
Figure 3-6. (Left) View of the nave of Canterbury Cathedral looking east. (Right) View of the Gothic lierne quadripartite cross vaults of the nave of Canterbury Cathedral (Photographic survey).

The plan configuration of the nave of Canterbury Cathedral, measured from the axis of the transversal ribs and the centre axis of the piers has 48.6 m of length, 10.5 m of width and 24.6 m of inner height. The nave is organised in 8 bays with an inscribed plan, measured from the axis of the nave arches and the transversal ribs respectively, of 11.1 x 6.1 m, covered with Gothic lierne quadripartite cross vaults and equilateral pointed arches. The main diagonal and transverse ribs intersect in bosses, whereas the secondary ones intersect in nodes around the perimeter of the central boss (Figure 3-6). The vaults have a clear span of 9.4 m and 5.2 m in the transverse and longitudinal direction, respectively, and a rise of 6.3 m. During the geometrical survey, the thickness of the nave vault, as measured from a cylindrical void in boss was 0.8 m. Taking in to account a portion of the boss and the intersecting diagonal ribs that project below the web of the vault, the design shell thickness of the vaults was accounted as 0.4 m. The ribs are considered an essential part of the vault's structural system, providing safe enclosure of the web masonry (Theodossopoulos 2006). Nevertheless, for simplicity of the generated 3D CAD and FE model and due to the limited information regarding their size and configuration, the diagonal and transversal ribs were not accounted for in the model. Adjacent equilateral pointed nave arches of 4.0 m clear span, 5.4 m rise and 0.9 m width are the structural elements of the clerestory walls. The nave vault and adjoining arches are depicted in Figure 3-7.

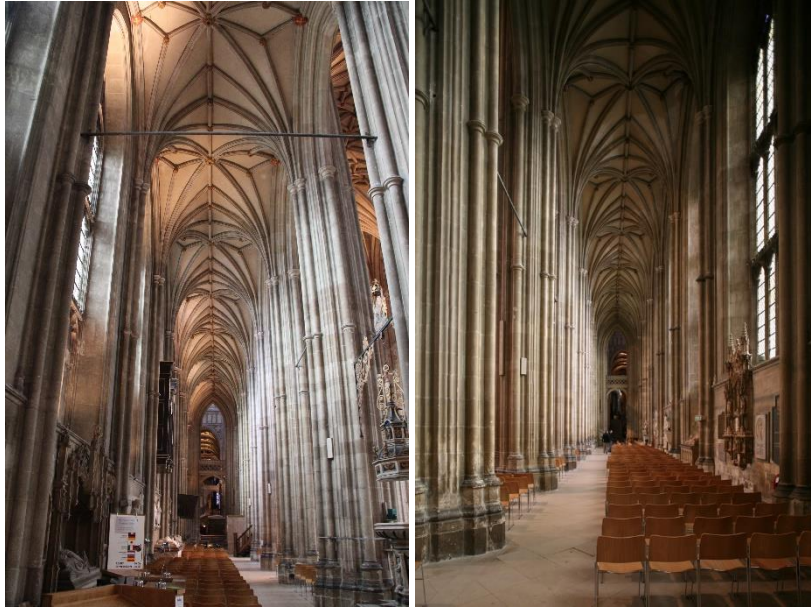
Figure 3-8. (Left) View of the north aisle of Canterbury Cathedral looking east. (Right) View of the south aisle of Canterbury Cathedral looking east (Photographic survey).

The lateral aisles of Canterbury Cathedral comprise 8 bays with compartment dimensions, measured from the axis of the arcade arches and the transverse ribs, respectively, of 6.6 x 5.9 m and 15.1 m in height. The vaults are Gothic lierne quadripartite cross vaults, drawn from equilateral pointed arches. The adjacent arcade arches have a clear span of 4.0 m, 3.5 m rise and 0.9 m width, whereas the arches

of the aisles windows have a clear span of 2.9 m, with 2.9 m rise and 1.4 m width. The thickness of the vaults in the lateral aisles was considered equal to that of the nave, i.e. 0.4 m. The lateral vault configuration and the adjoining arches are depicted in Figure 3-8 and 9.

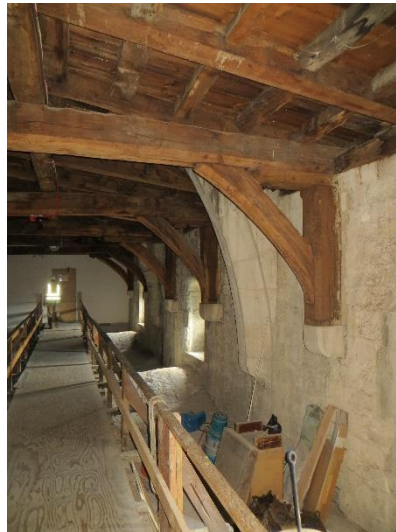
Figure 3-13. View of the roof void in the south aisle looking west (Photographic survey).

The roof of the south aisle of Canterbury Cathedral is single pitched of about 8°, with a covering span of 5.0 m. The timber trusses are placed with a spacing of 2.7 m (centre axis) and on the side of the buttresses the tie beams rest on wall plates over the upper surface of the buttresses. An adjoining post and curved brace timber elements, fixed on a small cantilever, counteract the bending and vertical forces. From the inner side, the tie beam and principal rafter are attached separately to the walls of the triforium. Thus, the trusses of the lateral aisles are not considered a hinged truss system. The external roof coating is large size lead sheets, attached on a system of timber roof battens (Figure 3-12 and 13).

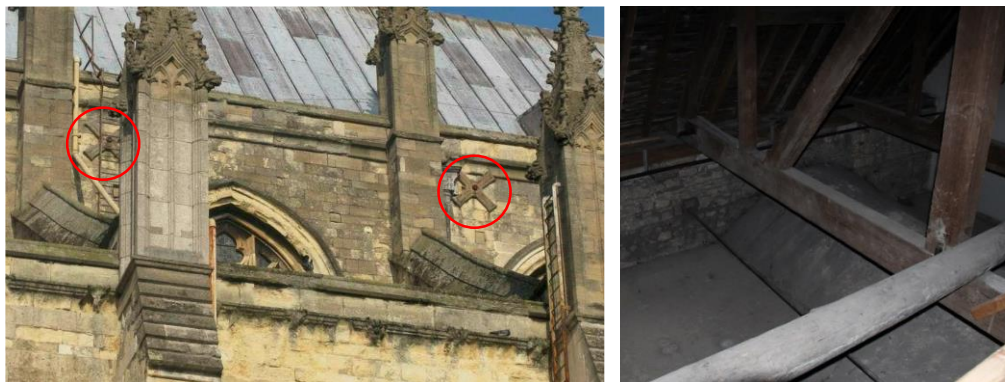
Figure 3-14. (Left) External view of the nave clerestory walls of Canterbury Cathedral, depicting the two anchor cross shaped plates on the right side of each transverse section (Morton Partnership Ltd). (Right) Inside view of the roof void in the nave of Canterbury Cathedral, depicting the iron tie in the clerestory walls above the vaults (Photographic survey).

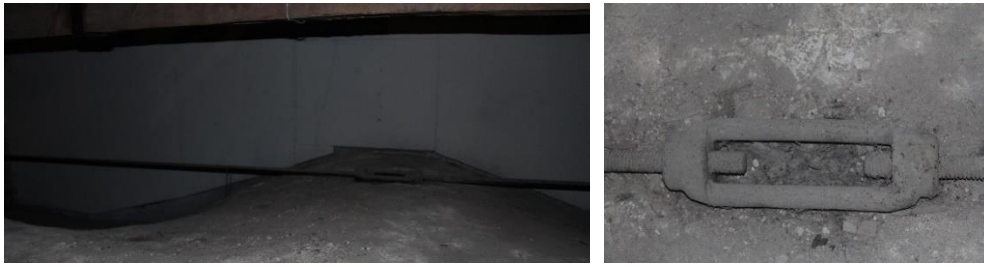
Figure 3-15. (Left) View of the iron tie at mid span (Right) Coupling system at the mid span of the iron tie (Photographic survey).

A system of wrought iron ties is present in each section of the nave of Canterbury Cathedral. The ties run along the nave span, placed on the right side after each corresponding section, 0.9 m below the level of the adjacent clerestory walls and their diameter is 0.043 m. Most probably an initial post tensioning force was applied to the ties, through the coupling system at mid span. The ties were externally anchored to the clerestory walls, through a cross shaped pattress plate on either side (Figure 3-14 and 15). During the visual inspection it was noted that the ties corresponding to case study area (Figure 3-1) were under tension, whereas the others were loose, when they were induced to vibrate.

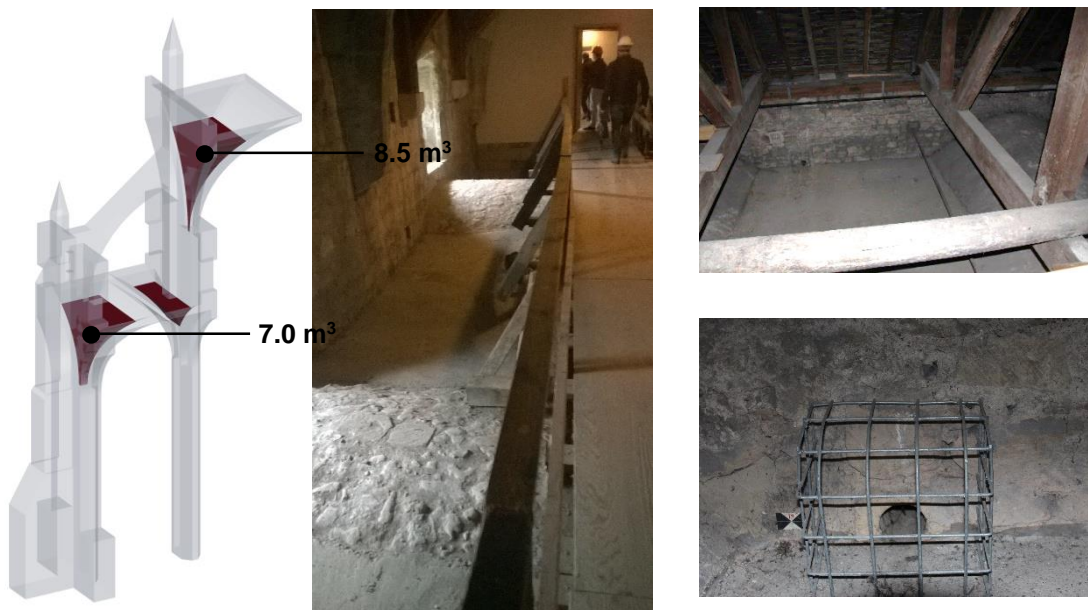
Figure 3-16. (Left) 3D representation of the south 3D CAD model of the critical nave section of Canterbury Cathedral, depicting the infill volumes. (Middle) Infill and cross vault system at south aisle roof void. (Right up) Infill and cross vault system at nave roof void. (Right down) Drilled hole in the exterior wall at the level of concrete layer infill, used for drainage (Photographic survey).

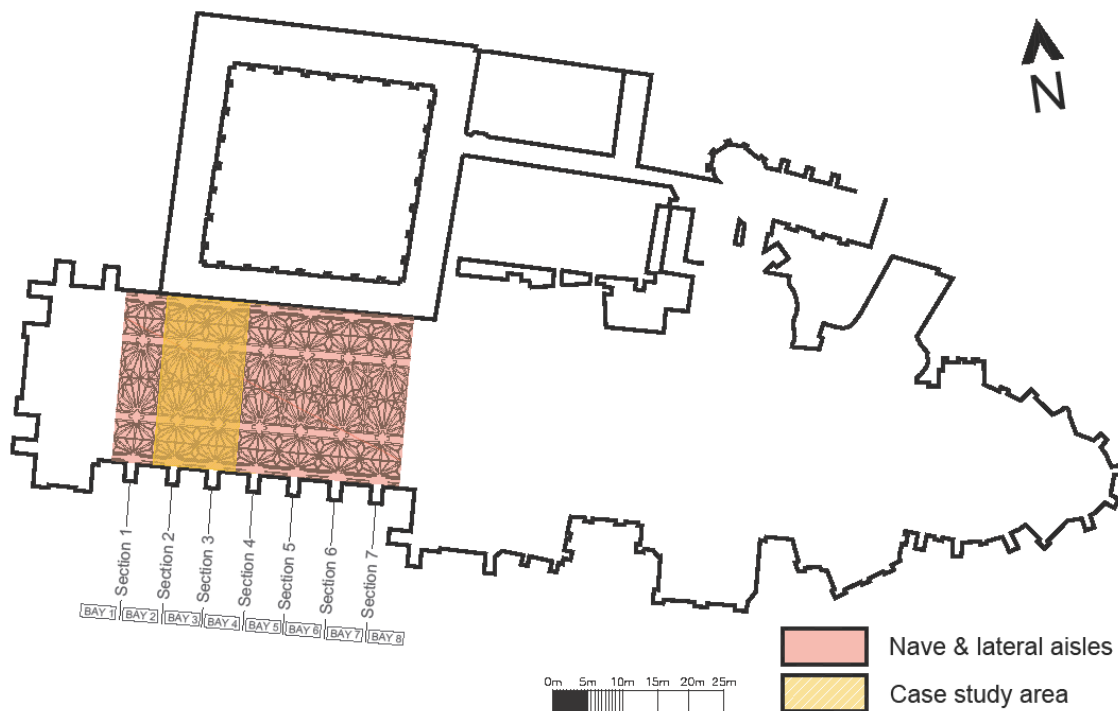
Figure 4-1. Top plan of Canterbury Cathedral depicting the sections and bays of the nave and lateral aisles, consisting the case study area (Morton Partnership Ltd).

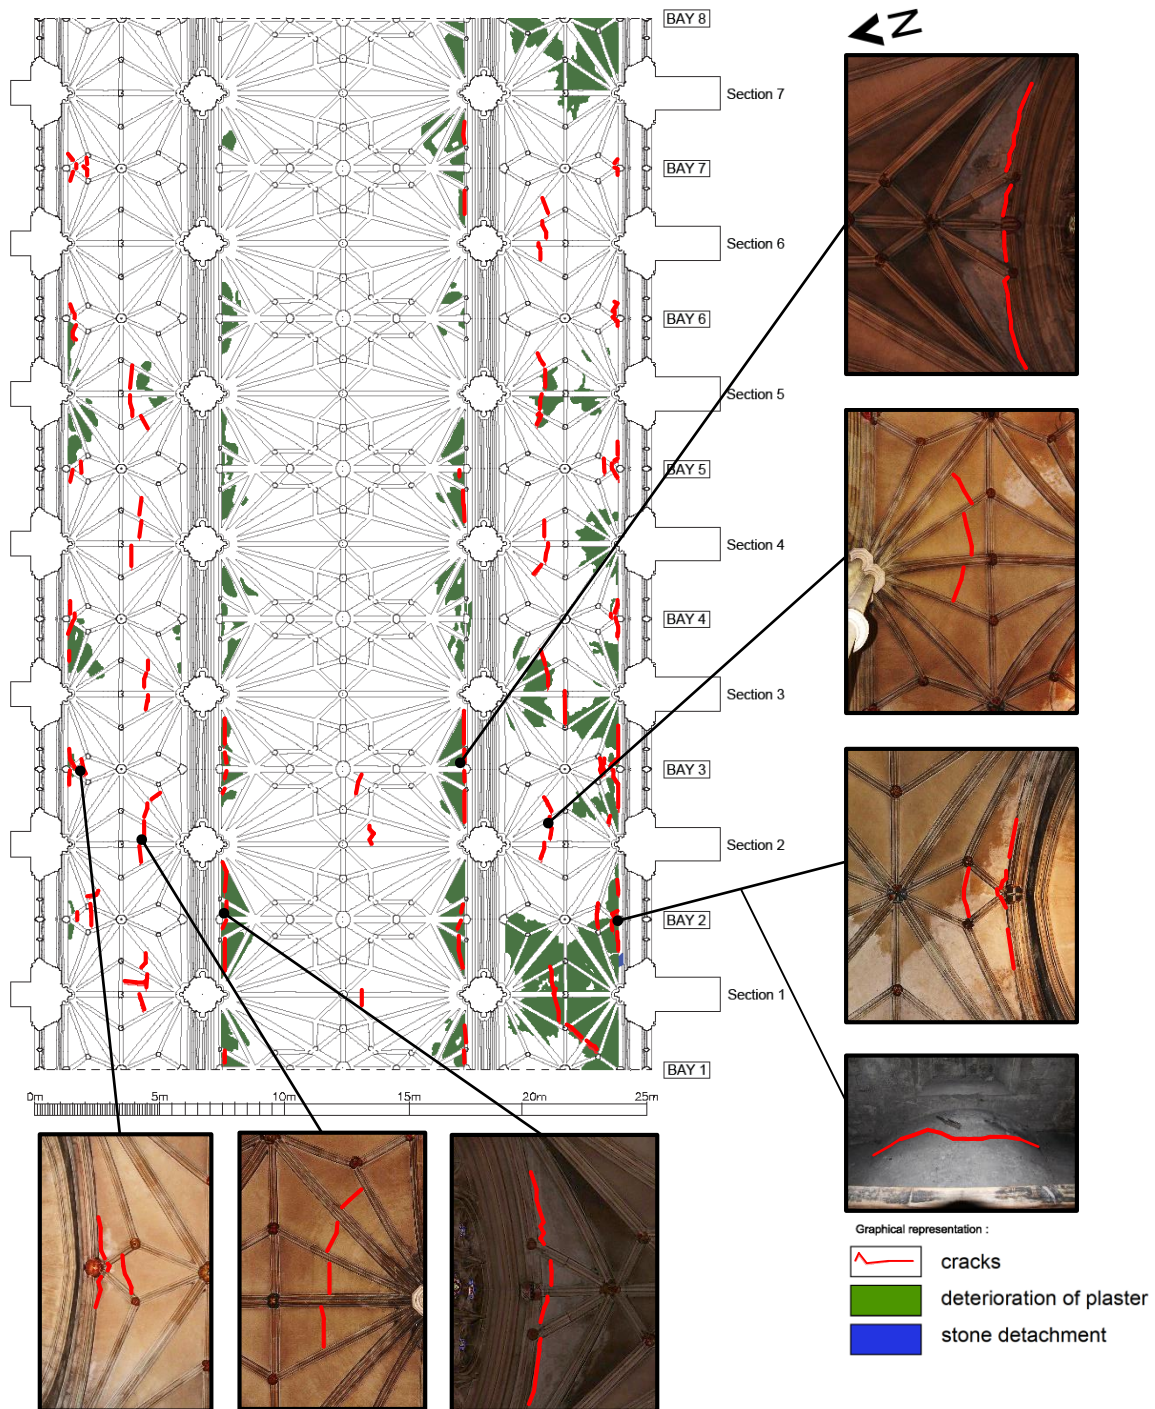
Figure 4-3. Damage map of the intrados of the vault system in the nave and lateral aisles of Canterbury Cathedral.

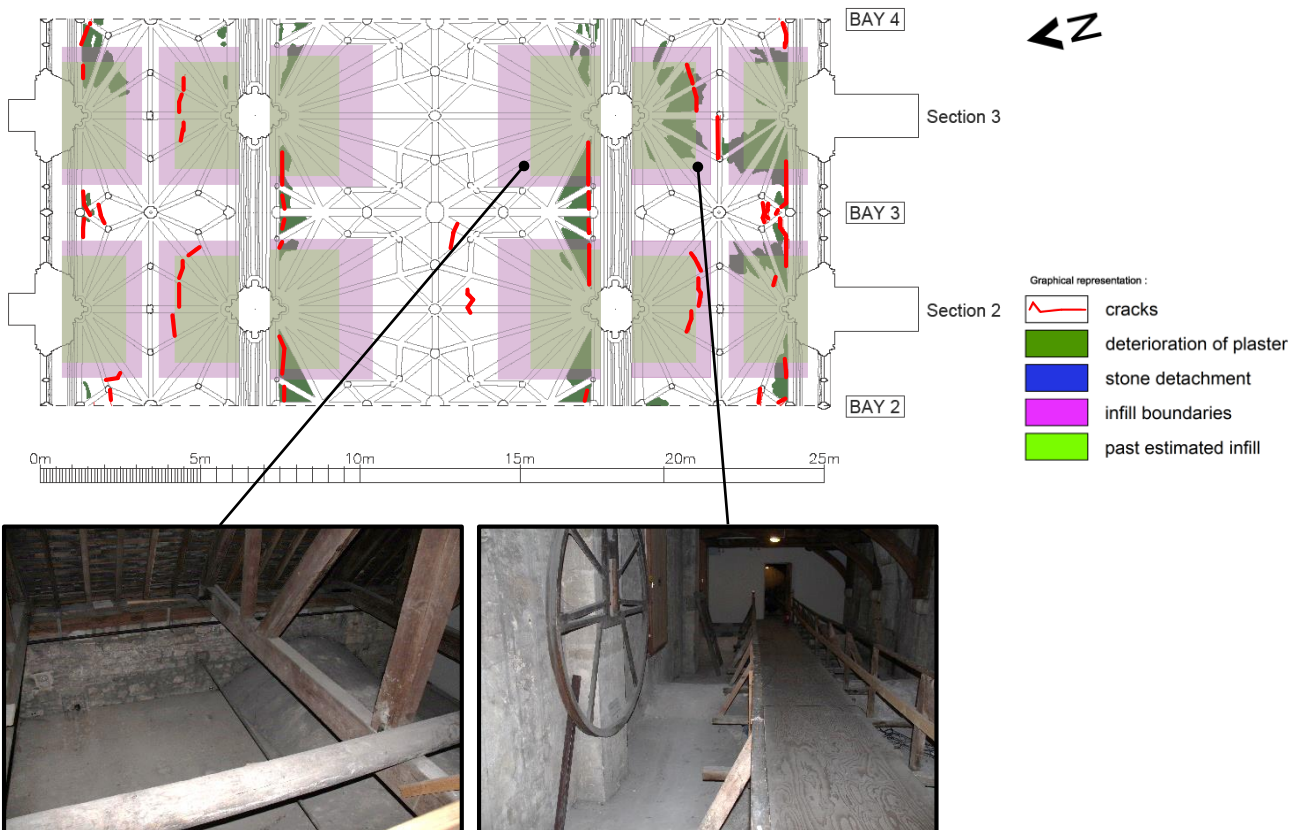
Figure 4-5. Damage map of the case study area, which depicts the current and former estimated infill boundaries.

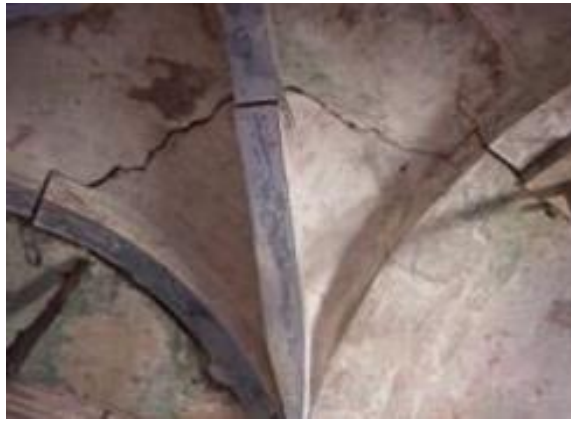
Figure 4-6. Corner detachment of a vault, provoked by differential settlements and rotations at base, in the Monastery of Salzedas, Portugal (Lourenço et al. 2008).

Another possible cause related to the documented damage is the imposition of differential settlements in some part of the foundation soil of the structure. Matching crack patterns, induced by differential settlements are detachments of corners and outward leaning of structural elements, resulting in a redistribution of stresses and resetting the structural system in a new state of equilibrium (Figure 4-6). Local soil failures that cause differential settlements can be triggered by modifications in the foundation soil, caused by vibrations from civil works, dead load increase, water leakage of underground pipes, changes in underground water level etc. (Figure 4-7).

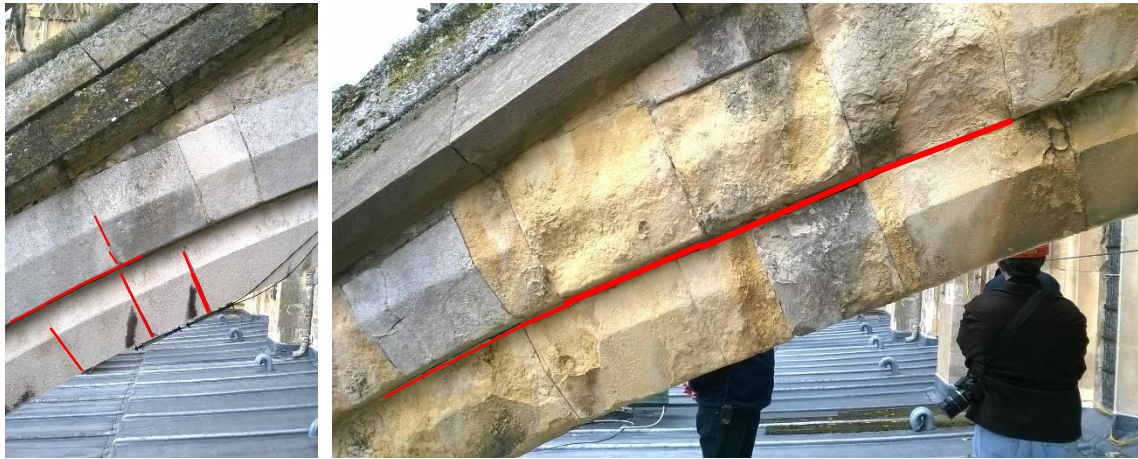
Figure 4-11. Crack patterns of joint failure from west view of flying buttress 2 (Left) and 3 (Right) of the south aisle of Canterbury Cathedral.

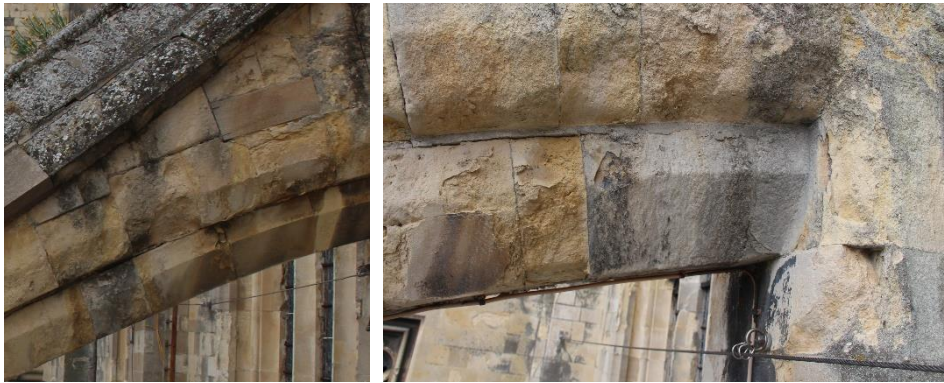
Figure 4-12. Crust formation and flaking in large areas of Caen stone masonry from west views in the flying buttress 3 of the south aisle of Canterbury Cathedral.

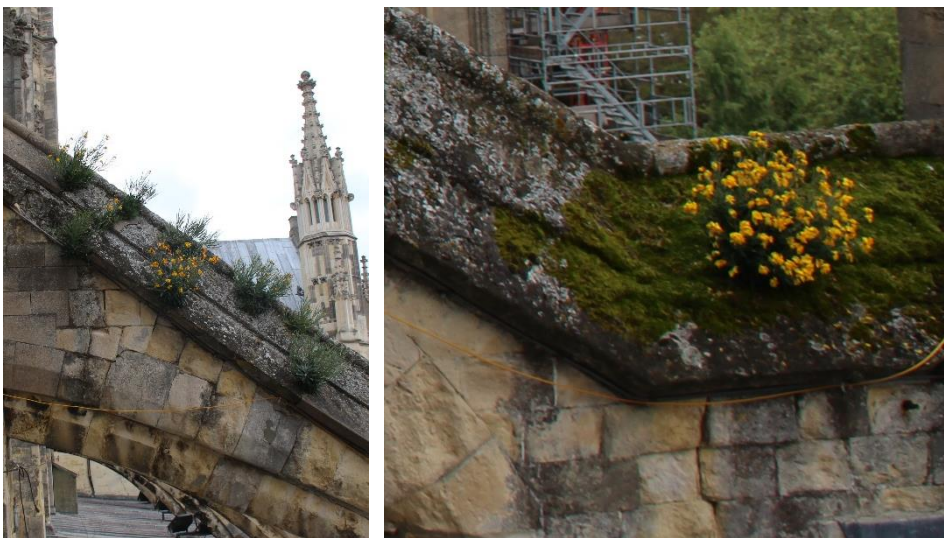
Figure 4-13. Biological growth in form of algae, mosses and higher plants in the upper surface of flying buttress 3 (east view) in the south aisle of Canterbury Cathedral.

Biological growth consists mainly of minute biological organisms such as mosses and algae, which cover large surfaces of the upper part of the flying buttresses and of higher plants, but only in small areas, as shown in Figure 4-13.

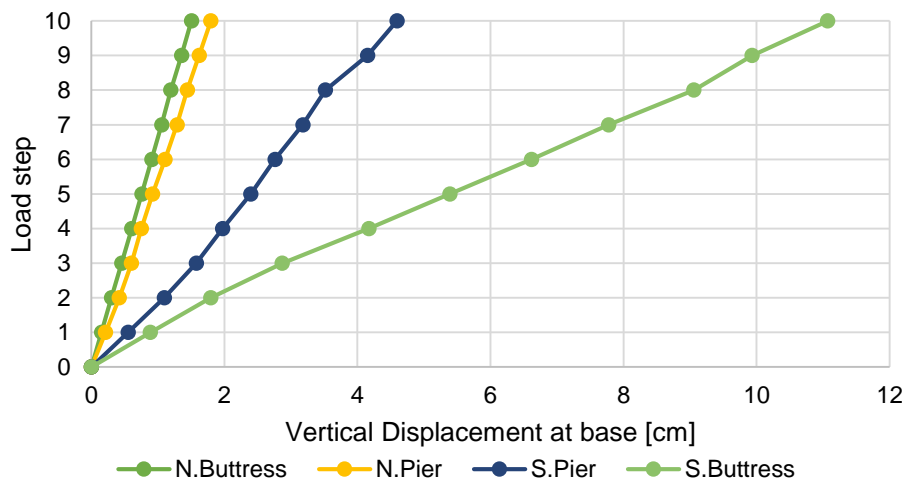
Figure 7-20. Load displacement diagram, depicting the vertical displacements at the base of vertical abutments, under dead loading.

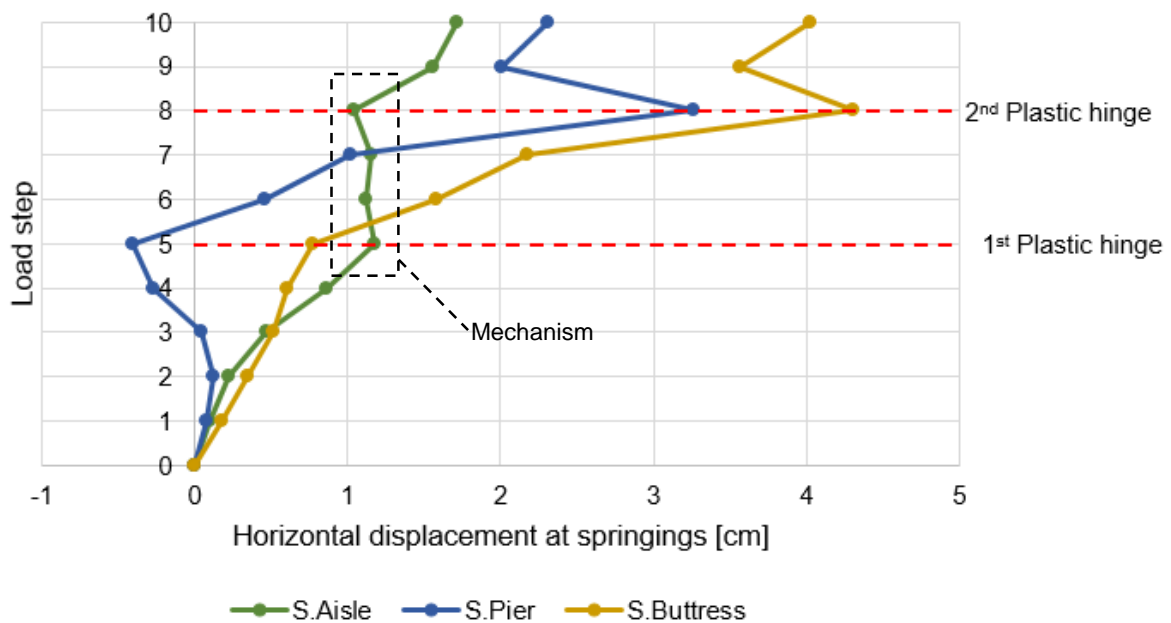
Figure 7-21. Load displacement diagram, depicting the span opening and absolute horizontal displacements of the south aisle vault, under dead loading.

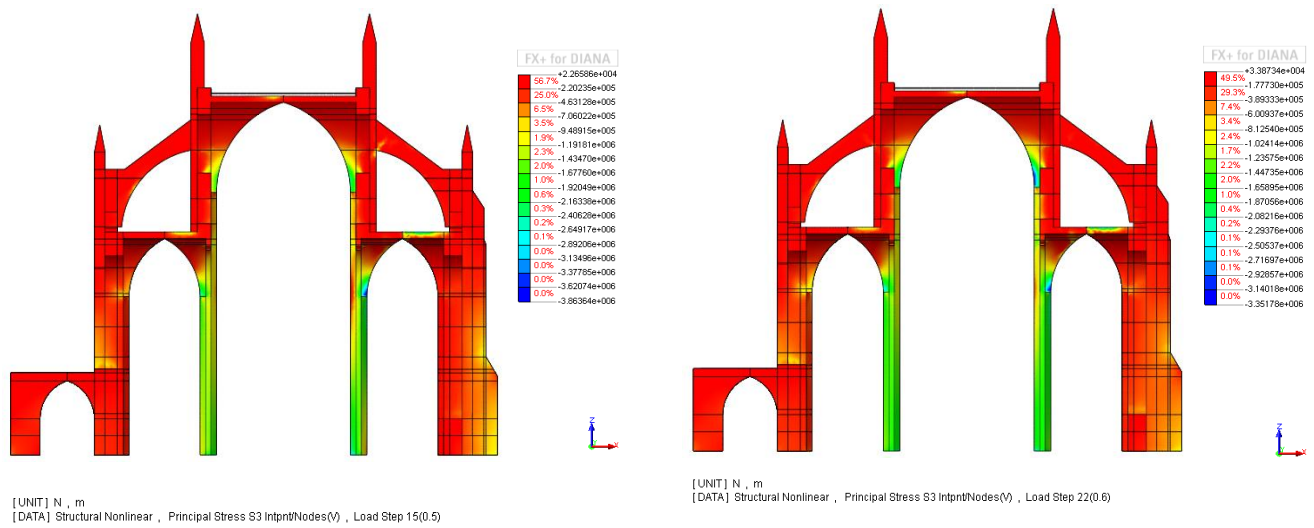
Figure 7-26. Distribution of minimum principal stresses of Model 1 (Left) and Model 2 (Right), at a corresponding load step of a 3 mm crack width at the middle span of the south flying buttress.
