# Seismic behaviour of vernacular architecture

CHAPTER · SEPTEMBER 2015

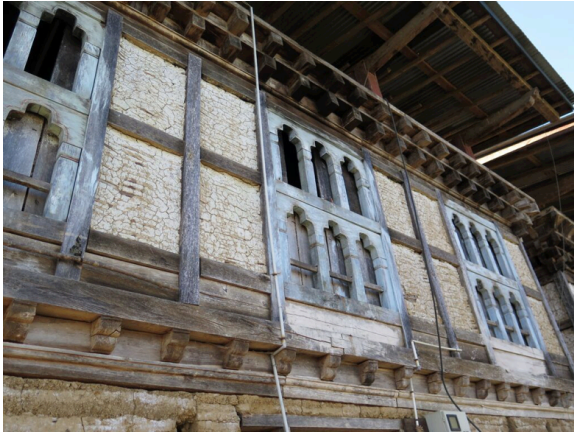
Figure 1 – Timber construction in Bhutan ©NCREP 2015

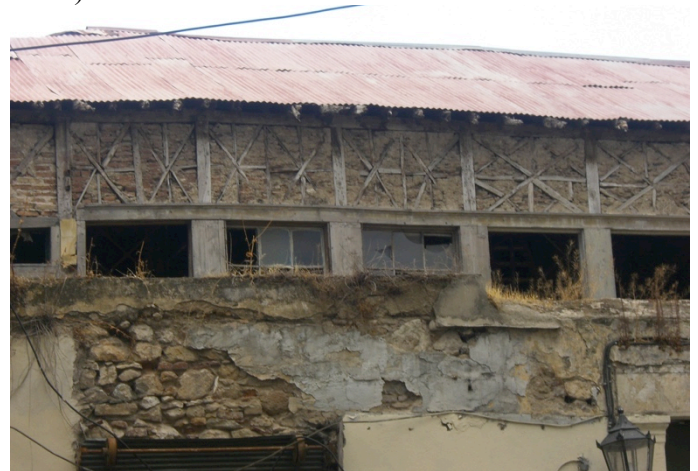
For example, the use of timber elements within walls found in Pombalino buildings, in Portugal, and in traditional constructions in Greece, Turkey and India has been used to improve the earthquake performance of these buildings (Pacheco-Torgal & Jalali, 2012).

Figure 2 – Timber elements within walls in Greece

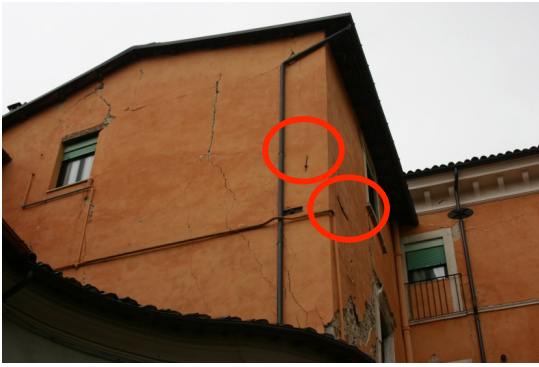
Metal and wooden ties have been applied for a long time as a reinforcement measure in highly seismic regions, such as Italy (Figure 3). This type of strengthening measure has been also adopted in Portugal in order to improve the structural stability.

Figure 3 – Ties in a traditional masonry building, L'Áquila, Italy

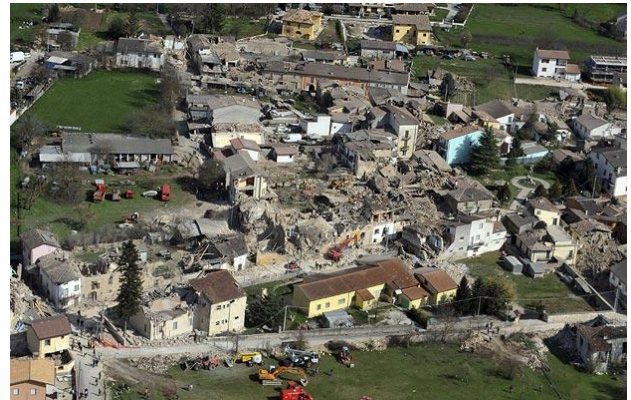
In L'Áquila 2009 earthquake, several vernacular buildings have showed a deficient behavior under the seismic demands they suffered. The substantial re-adaptation and changes of their structural system in the last 50 years, to account for a different use of the spaces, the consideration of modern residential requirements for comfort, may have influenced their seismic performance, contributing to several damage mechanisms identified (DinaF D'Áyala & Paganoni, 2011). The original structures include both, masonry vaults and timber floors and roofs, replaced in recently retrofitted buildings by lightweight jack arches or steel beams (DinaF D'Áyala & Paganoni, 2011).

Figure 4 – Village affected by the L'Áquila earthquake

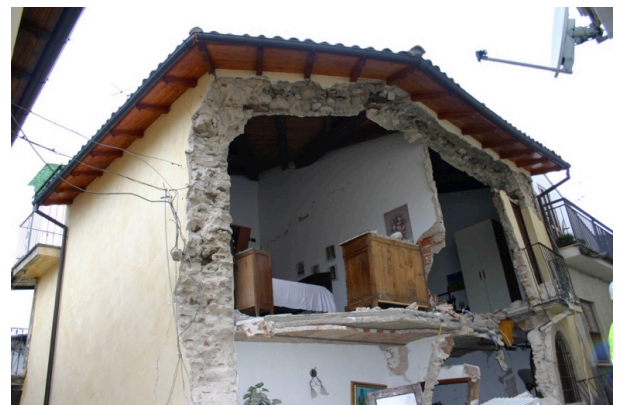
In L'Áquila, several collapses of the building façades due to poor connections between walls were found and the quality of masonry dramatically influenced the level of damage (see figure 5).

Figure 5 – Out-of-plane collapse of a façade masonry wall

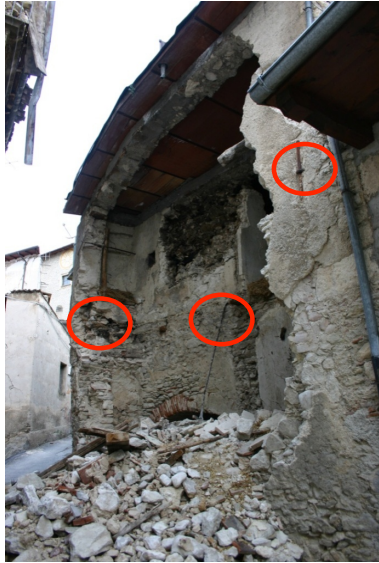
The seismic performance of traditional masonry constructions retrofitted with ties may be influenced by their location, by the material deterioration of the

anchor element, or by the lack of integrity and shear capacity of the masonry to withstand the thrust generated at the anchoring plate/element by the relative movement of the two orthogonal walls (Rodrigues et al., 2010).

Figure 6 – Collapsed façade of a building with ties, during L'Aquila earthquake

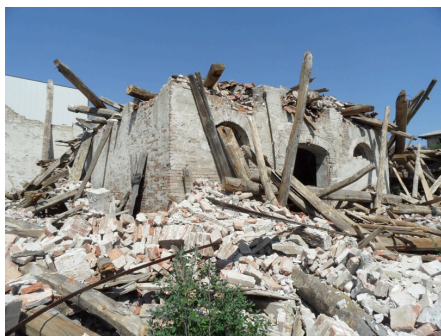
Vernacular buildings are a relevant part of the building stock affected by the Emilia, 2012, earthquakes (Paupério et al., 2012), mainly due to the overall layout, constructive details and poor maintenance. Many of the buildings in the affected area have shown a very poor seismic performance. Approximately two hundred rural buildings suffering from partial to total collapse have been counted in an area of about 500 km<sup>2</sup> (Sorrentino, Liberatore, Liberatore, & Masiani, 2014).

The main cause of damage in these buildings is associated with the higher length/thickness and height/thickness ratios of the walls and with the use of slender brick columns, connected to the roof just by friction (Sorrentino et al., 2014).

Figure 7 – Masonry buildings collapsed during the Emilia-Romagna earthquake

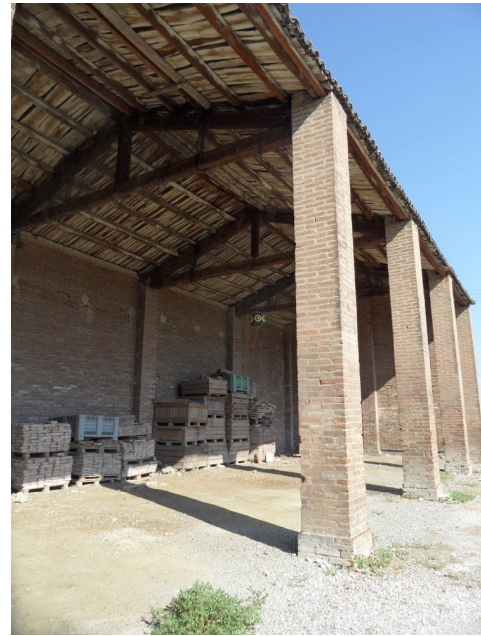
Figure 8 – Slender brick columns Emilia-Romagna region

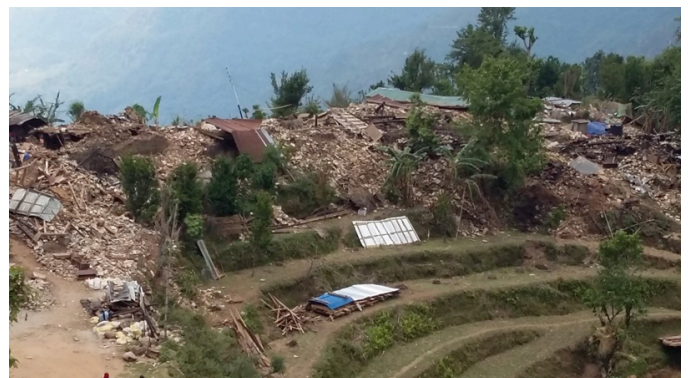
The 7.8 magnitude earthquake that hit Nepal on the 25<sup>th</sup> of April 2015, and the series of aftershocks that followed it, associated with a high number of human losses, severely affected numerous vernacular buildings. In remote areas like, Gorkha, Dolakha, Sindhupalchowk, Nuwakot, Solukhumbu, Kavre, Rasuwa and Dhading, the majority of houses were vernacular constructions. Locally available stone with mud mortar or, in many cases, without binding material are common construction solutions in those areas.

Figure 9 – Collapsed houses of an entire community near Barpak during the Gorkha earthquake, 2015  
©DipendraGautam 2015

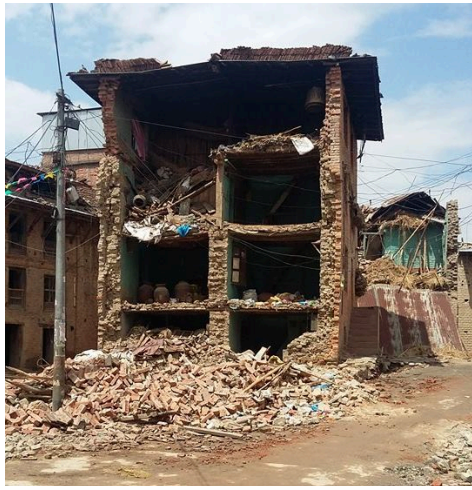
In the worst affected area, traditional single-storey masonry houses without, or with poor, binding material were the most common building typology. In Barpak of Gorkha (the worst affected area, beside the epicenter region) the majority of adobe houses collapsed. The out-of-plane failure mechanism was commonly observed in many houses.

Figure 10 – Out-of-plane façade failure during the Gorkha earthquake, 2015 ©DipendraGautam 2015

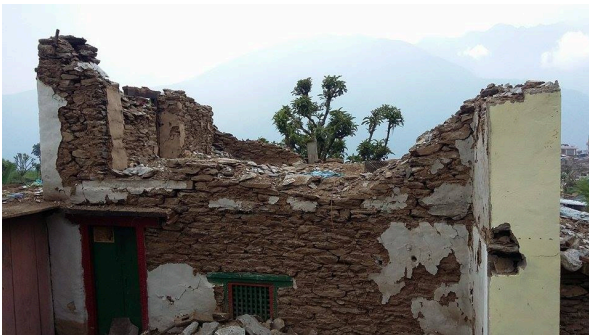
In many houses, the roofing system was found to be heavier than in other typologies. Many of those observed houses had roofing systems with stone covering (Fig. X). Due to climatic condition, people were adopting the use of heavy stone roofs and avoiding timber elements and other lighter solutions in adobe masonry houses, so probably damage was further intensified by this constructive option.

Figure 11 – Collapsed house with a heavy roof during the Gorkha earthquake, 2015 ©DipendraGautam 2015

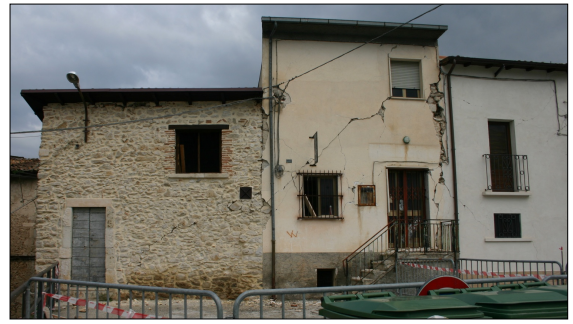
One of them is the interaction between buildings, which has a significant influence in the seismic performance of structures. The interaction between adjacent buildings with different dynamic behavior may have implications on the seismic behavior and performance of the structures.

Figure 12 – Damage associated to the interaction between adjacent buildings - L'Áquila earthquake
