SHAKING TABLE TESTS OF A TWO-STOREY LOG HOUSE

Abstract: This paper presents the findings of an experimental campaign that was conducted to investigate

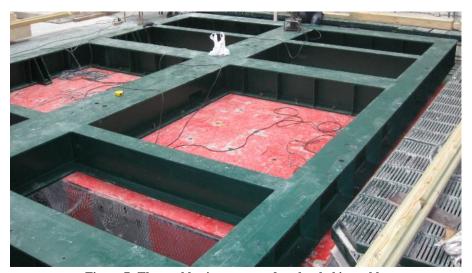
Figure 7: The steel lattice connected to the shaking table

As the shaking table at LNEC was not large enough to directly accommodate the building, a lattice of steel beams (Figure 7) was used to connect the structure to the table and provide a wider base. The steel lattice consisted of two identical sections of in-plane length 7m and in-plane depth 2.65m firmly connected to the table by means of steel bars of 36mm diameter, making a base of 7m x 5.3m for the building. Each section has two HEA 400 profile beams in the longitudinal direction and three HEA 400 beam profiles

along with two IPE 400 profile beams in the transverse direction. The building was mounted and assembled directly over the steel lattice. All primary structural elements of the building were prefabricated in a factory at Vila Nova de Cerveira and transported by truck over a distance of about 400km to Lisbon. The construction was carried out by three workers and took four days. The stages of assembly can be seen in Figure 8.
