## Timber frames as an earthquake resisting system in Portugal

E. Poletti, G. Vasconcelos & P.B. Lourenço

*ISISE, Faculty of Engineering, University of Minho, Guimarães, Portugal*

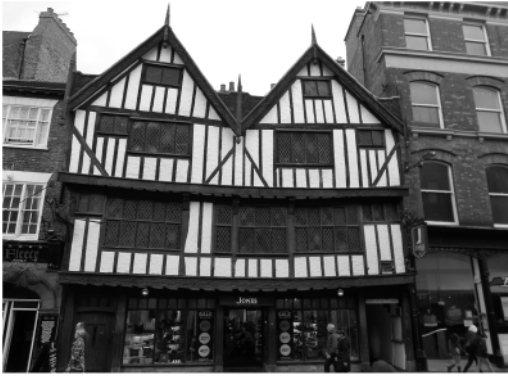
Figure 1. A XV century timber frame house in York, England (credits: E. Poletti).

Examples of timber framed construction can be found all over Europe, in North and South America, and in Asia. In England, timber frame construction evolved with the adoption of curved elements, and from the XV century the use of close studding and decorative panels, to show off the owners' wealth, (Fig. 1) became common. After the great fire of London, this type of construction was viewed with scepticism, but it was later adopted for upper storeys in revival houses from the XIX century. In Germany, *fachwerk* construction can be found all over the country, and later emigrants took this tradition with them when they left the country for the USA, or for Eastern European countries. Commonly to other central European countries, timber frame buildings (*colombages*) were introduced in France during the Middle Ages and were used until the XIX century. The buildings evolved from frames adopting long timbers, to frames adopting shorter timbers, with a lighter and stiffer structure, and the introduction of jetties. The French exported too their know-how abroad, and examples deriving from *colombages* construction can be found in Haiti and the USA.

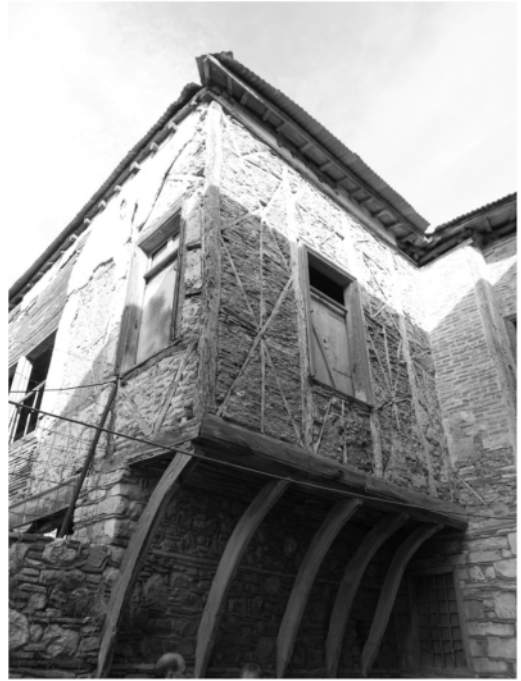
Figure 2. A traditional timber frame house in Chalkida, Greece (credits: E. Poletti).

These buildings proved to be able to efficiently resist to earthquakes in 2003, when the island was hit by a strong quake. The main damages observed were not only due to this latest earthquake but also to previous ones, and the decay was due to poor maintenance. Additionally, modifications done in the existing structure, such as removing the ground masonry walls, led to large permanent horizontal displacements, since the secondary bearing system did not have sufficient stiffness (Vintzileou et al., 2007). In fact, the damages observed were sometimes due to poor or no maintenance, and to modifications done to the buildings, pointing out the importance of preservation. But timber frame buildings are present all over Greece. Usually consist of a timber-tied ground floor, and timber-framed upper storeys (see Fig. 2).

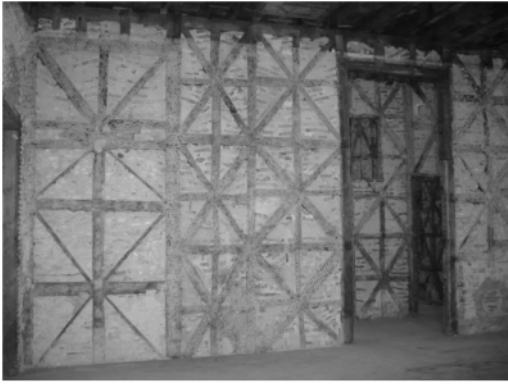
Figure 3. Internal timber frame walls in a *Pombalino* building (credits: MONUMENTA).

The buildings that derived from the proposed plan, called *Pombalino* buildings, were characterised by external masonry walls and an internal timber structure, named *gaiola* (cage), which is a three dimensional braced timber structure, similar to many half-timbered buildings that can be found in several European countries. The *gaiola* consists of horizontal and vertical elements, and diagonal bracing members, forming the typical X of St. Andrew's crosses (Fig. 3), which have a dissipative function (Cóias, 2007). The timber frame walls are usually filled, either with rubble or brick masonry, or even earth mortar and hay. Plaster was applied to frontal walls, creating small cuts in the timber elements so that mortar, generally lime-based, could adhere better. The adoption of a weak mortar and infill allowed flexibility to the wall joints, which could dissipate a higher amount of energy in case of an earthquake.

The internal walls of the *gaiola* (frontal walls) may have different geometries in terms of cell dimensions and number of elements, as it depended greatly on the available space and the manufacturer's practices. The timber elements are notched together or connected by nails or metal ties. Traditional connections used for the timber elements varied significantly in the buildings: the most common ones were mortise and tenon, half-lap and dovetail connections. Variability exists in the sectional dimensions of the elements themselves: the diagonal members are usually smaller ( $10 \times 10$  cm or  $10 \times 8$  cm), whilst the vertical posts and horizontal members are bigger (usually  $12 \times 10$ ,  $12 \times 15$  cm and  $14 \times 10$  cm or  $15 \times 13$ ,  $10 \times 13$  and  $10 \times 10$  cm respectively). The thickness of frontal walls can vary from 15 to 20 cm (Mascarenhas, 2004; Córias, 2007).

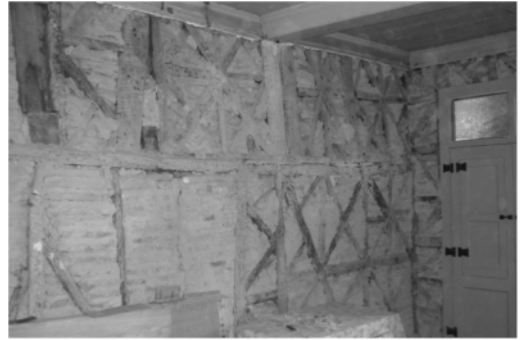
Figure 4. Timber frame walls in a traditional house in Guimarães (credits: E. Poletti).

Guimarães, the posts and main beams had a width of 15 cm, while the diagonals and the secondary elements of 7 cm (Fig. 4). *Taipa de rodizio* was typically adopted for bourgeois houses, while noble houses had external walls built in granite and timber frames were only used for internal walls (Ferrão & Afonso, 2001).

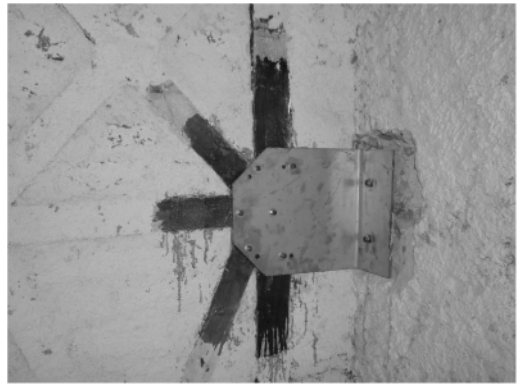
Figure 5. Timber frame to masonry wall connection by means of injected anchors and steel plate (credits: MONUMENTA).

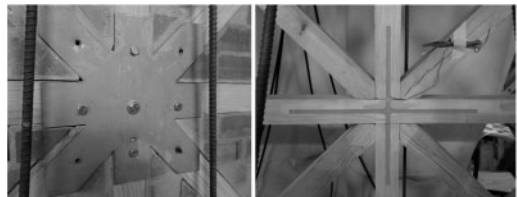
Figure 6. Steel plates strengthening (left) and NSM bars (right) (credits: E. Poletti).

Strengthening with steel plates (Figure 6) led to an increase in strength and stiffness of the wall, also greatly improving its dissipative capacity (Gonçalves, 2012; Poletti et al., 2014). When linking the diagonals to the main frame through the plates, some out-of-plane problems were encountered, as the connections

were greatly stiffened when compared to the original configuration. This problem was overcome by not connecting the bracing elements to the plate, but leaving the original connection intact (Poletti et al., 2014). Steel plates led to an increase of the lateral capacity of the walls between 50% and 200%, also improving their post-peak behaviour. This technique is simple to implement and it is removable.

Near-Surface-Mounted (NSM) steel flat bars were also applied to the connections (Figure 6) and tests showed a good response in terms of stiffness and energy dissipation, particularly for weak infill (Poletti et al., 2015). Additionally, this technique is potentially invisible, even though not removable.
