Monitoring of Railway Viaducts and Bridges

H. De Backer, A. Outtier, K. Schotte, W. Nagy and P. Van Bogaert
Department of Civil Engineering
Ghent University, Belgium

Monitoring of structural parameters during construction can be an important aid during execution. Especially when studying the long-term behaviour of structures, e.g. build-up of ground pressures or fatigue effects, it can become necessary to resort to monitoring. This research paper discusses two such projects: the “Iris” railway viaduct and the Pede viaduct, both near Brussels, Belgium.

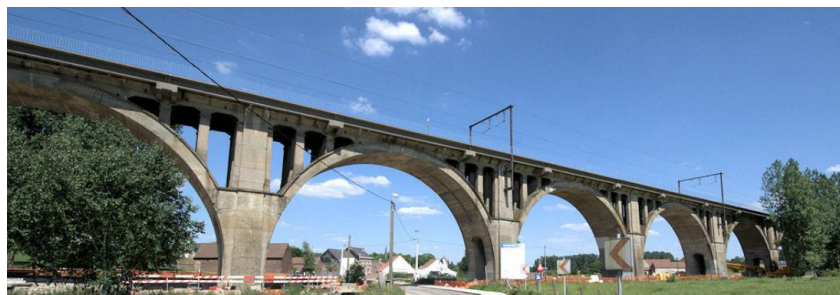
Figure 1: Front view of the historic Pede viaduct.

The second example deals with the Pede viaduct, [3]. As part of a large-scale project in order to improve the accessibility of the Belgian capital by train, the existing railway line between Brussels and Ghent is expanded from 2 to 4 tracks over a length of 25 km. This line crosses the valley of the river Pede by a 523 m long historic viaduct, built in the 1930’s. In those days the viaduct was chosen over large backfills in the valley due to poor soil conditions. The structure consists of 16 three-hinged reinforced concrete arches with a span of 32 m and a maximum height of 20 m. Four arches form an independent group, as they are separated from the rest of the viaduct by double pier structures, allowing for compensation of the thrust force of each group. In Figure 1 a front view of the concrete structure is shown. The viaduct is a benchmark in the rural environment through its dominance midst the gentle slopes of the Pede valley. Extension of the railway facilities to 4 tracks needs to widen the existing structure by two additional lateral viaducts, with respect for the heritage structure. Therefore the arch structure and the existing piers should be left apparent as much as possible. The arches should keep their function and continue to behave as a four-span group. Important guidelines in making the new design were the contrast of old and new technology, keeping the four-span static behaviour with the repetition of 32 m spans and leaving the characteristic view of the hollow piers.

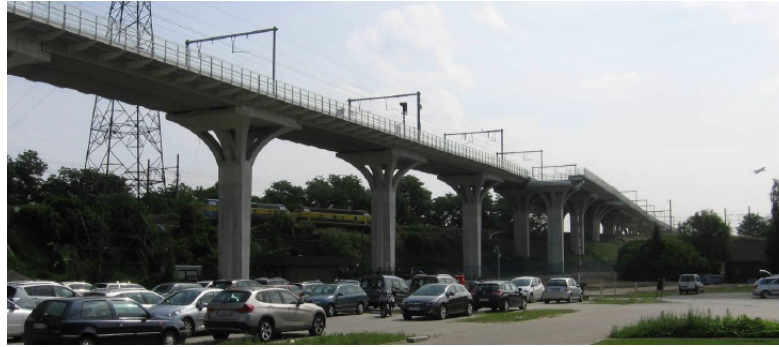
Figure 2: Part of the Iris viaduct in Haren, Brussels.

fact that the piers of this viaduct reach a maximum height exceeding 18 m, which is unusual in a rather flat countryside as the central part of Belgium. The piers consist of a vertical shaft supporting a system of curved branches, connected by a horizontal concrete slab. The shape of the piers reflects that of the iris flower, which is the symbol of the Brussels-Capital Region. Part of the “Iris” viaduct is shown in Figure 2.

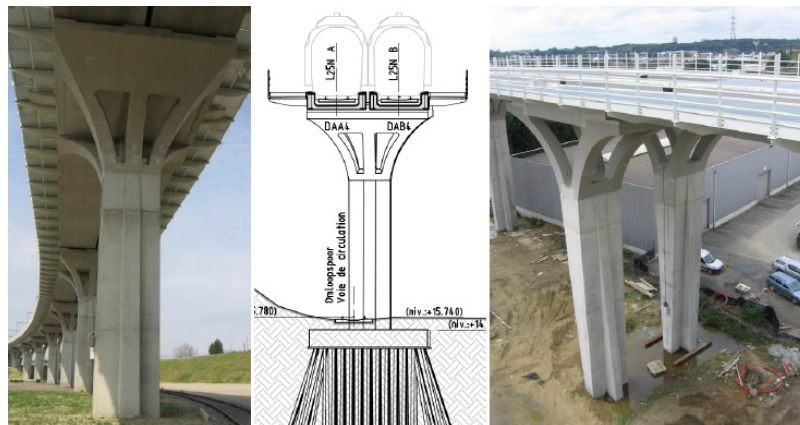
Figure 3: Double track pier (left), foundation of a double track pier (middle), single track pier (right).

Two different types of piers are used in the viaduct depending on the number of supported tracks. For the entire viaduct, 28 double track piers were constructed with six curved branches, while six single track piers were constructed with four curved branches, as shown in Figure 3. The piers themselves have a cross-shaped base and a rectangular head. Because of the variation of the ground level, the height of the piers varies from 6,0 m to 14,8 m resulting in a different body shape for every single pier. Only the pier heads have a constant height of 4,8 m. Because of the complexity of the pier heads, the curved branches were prefabricated.

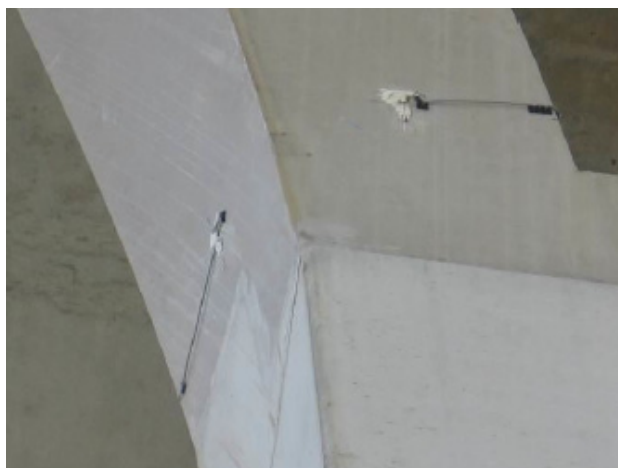
Figure 4: Installed strain gauges on a branch.

The measuring points were mainly located on the branches of the piers as shown in Figure 4. On every branch eight strain gauges were installed, four equally divided over the lower circumference and four over the top circumference. In addition, four equally divided strain gauges were installed on the pier itself, just below the connection of the pier with the branches. Finally, two strain gauges were installed between a couple of branches to measure the splitting forces. For the double track pier PA8, a strain gauge was placed between the two middle branches and one between two arbitrary chosen outer branches. In contrast, for the single track pier PC10, both outer branches were monitored because there are no middle branches.

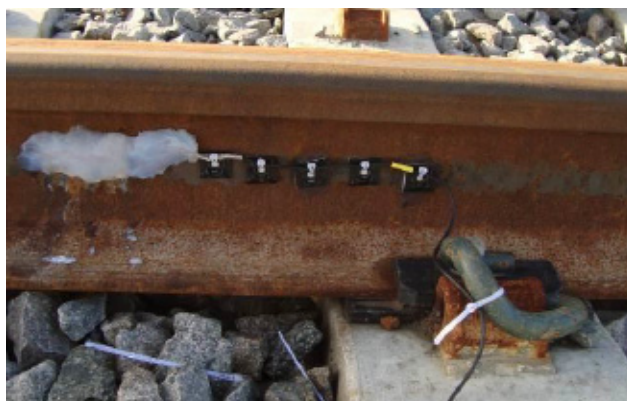
Figure 5: Strain gauge on a rail track.

In addition, six strain gauge measuring points were attached to the rail tracks itself as shown in Figure 5. Therefore, dynamic strain measurements could be registered to evaluate the distribution of the braking and acceleration forces. These strains were measured with a frequency of 10 Hz and an accuracy of one microstrain. To minimize the effects of electromagnetic noise in the recorded data, grounded shield cables were used.

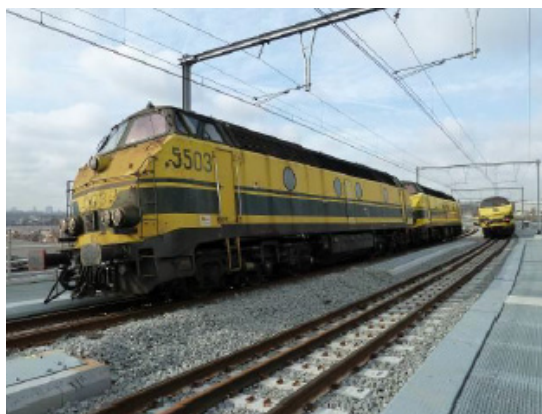
Figure 6: Two freight trains used for the load tests.

For the short-term monitoring programme, two freight trains, shown in Figure 6, were used for both static and dynamic measurements. The first freight train consisted of two locomotives of 110 ton each and five carriages of approximately 78 ton. The second train only consisted of two locomotives of 110 ton. With these trains, several static and dynamic measurements were carried out. For the static ones, four different symmetric and asymmetric positions were taken. Therefore, the most disadvantageous position and the resulting maximum stresses could be determined. Concerning the dynamic measurements, several braking tests with different speeds were performed.

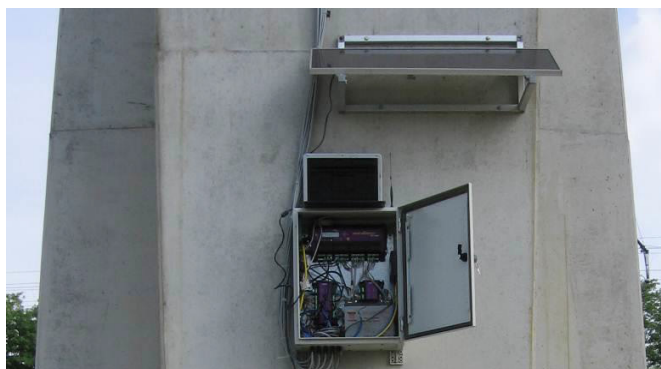
Figure 7: Autonomous measurement system.

When studying the long-term behaviour of the structure, it is necessary to monitor certain structural parameters. In the case of the Iris viaduct, the installed strain gauges of piers PA8 en PC10 were monitored during one year using an autonomous measurement system as shown in Figure 7. The advantage of using such a system is its independence, which is necessary in such a terrain. The strains of all strain gauges are automatically stored every minute on a data logger. To ensure the independence of the data logger, measures had to be taken to solve the power problems. As often the case for field measurements, no power supplies are available during a long-term monitoring programme. Therefore, a solar panel was installed to enlarge the battery life. Also a GSM-module was installed to download and verify the data directly in the office resulting in minimal maintenance.

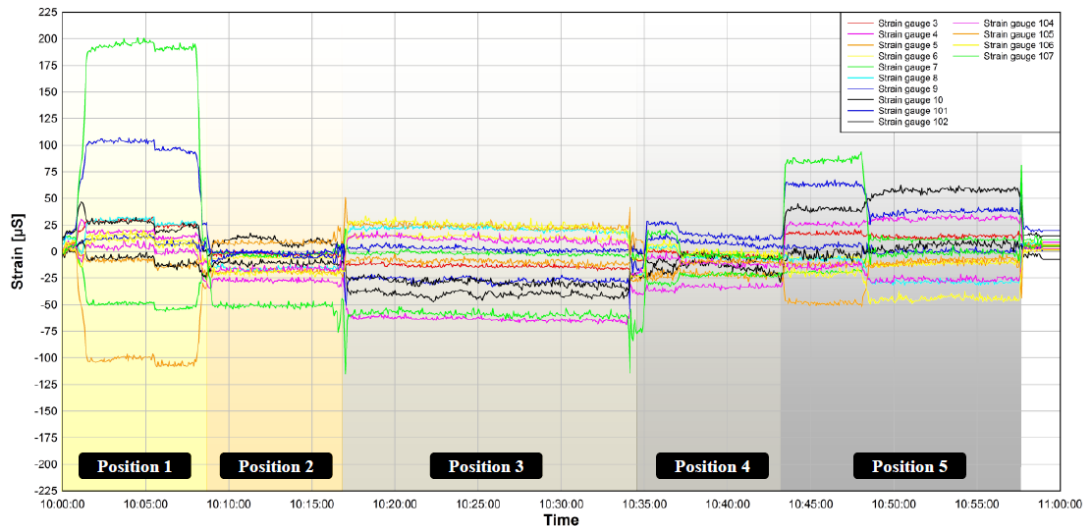
Figure 8: Strain of two branches of pier PA8 during static strain measurements.

During the one day testing programme, strains were measured of the 54 strain gauges on pier PA8 and the 38 strain gauges on pier PC10. Figure 8 illustrates the measurements of two branches of pier PA8. More particularly an outer and a middle branch were chosen (left (and middle) branches on Figure 3, left; strain gauge 3 (101) up to 6 (104) and 7 (105) up to 10 (107): upper and lower part of the outer (middle) branch). The different train positions during the static strain measurements are visible. Only the second train position reflects a symmetric position where the freight trains are equally divided over the pier. All the other positions are asymmetric ones.

It can be noticed that the asymmetric positions are the dominant ones for the resulting strains and therefore the stresses. Especially position 1 where both trains are positioned left of the middle of pier PA8. Therefore, the left branches of the pier (branches 4, 5 and 6) are directly loaded. Figure 9 illustrates the strains in all the branches of pier PA8 during the first train position. The group U1 up to U4 reflects the four strain gauges that are equally divided around the upper part of the branch, while the group L1 up to L4 reflects the four strain gauges on the lower part of the same branch. More precisely U1, U3, L1 and L3 measure longitudinally: U1 and L1 are the strain gauges inside the pier head and U3 and L3 are the strain gauges outside the pier head. U2, U4, L2 and L4 measure in a transverse direction. First of all, it is visible that the strains of the lower part of the branch are significantly higher than those of the upper part. This could be explained because the upper parts of the branches are connected with a top concrete slab and therefore working as a whole. So compared with the lower connection of the branch, the top node is more a rigid one resulting in smaller moments. This was also noticed in the theoretical models.

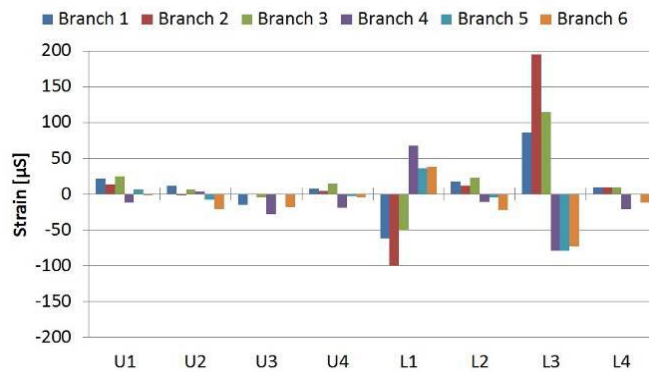
Figure 9: Comparison of the strains in branches 1 up to 6 of pier PA8 while loaded under train position 1.

Secondly, it is visible that strains in branches 1 up to 3 have an opposite sign with respect to branches 4 up to 6. This is as expected because the freight train is located on the left of branches 4, 5 and 6, resulting in a rotation of the pier head. In this respect, the strain gauges L1 of branches 4, 5 and 6 have a positive sign (tension) and the strain gauges L1 of branches 1, 2 and 3 have a negative sign (compression). The opposite applies for the strain gauges L3. Finally, the strains of strain gauges L2 and L4 are small because of small transversal resultants.

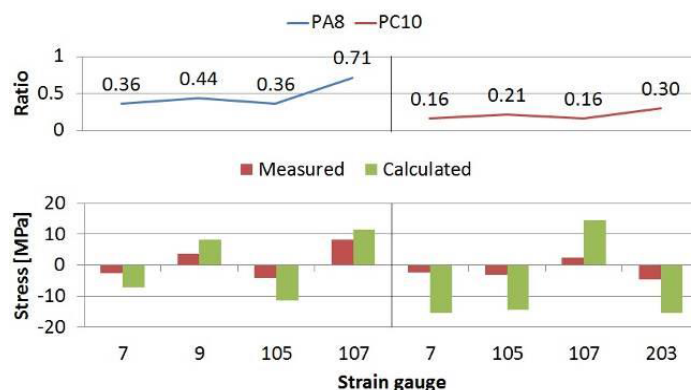
Figure 10: Comparison of the maximum measured stresses in pier PA8 and PC10 with the calculated ones (bottom), stress ratio corresponding with these stresses (top).

Knowing that self-compacting concrete C80/95 is used for constructing the prefabricated branches, young modulus of $E_{cm} = 42244$ MPa could be used for calculating the resulting stresses of the corresponding strains. Figure 10 visualizes some of the maximum stresses measured in the field (red bars) compared to those determined in a theoretical model (green bars). The four left strain gauges originate from pier PA8, while the right strain gauges originate from pier PC10. Also included in Figure 10 are the measured to calculated stress ratios. It can be noticed that the stress ratios are rather small and therefore indicate that the theoretical models are a safe prediction of the reality.

Nevertheless pier PC10 only has to carry one rail track and consists of four branches, the cross-section of the pier itself is the same as the bigger piers like PA8. Therefore, the stress ratios are even smaller here than those of PA8 and it becomes visible that the predictions were too safe concerning the smaller piers, although understandable from an aesthetic point of view.

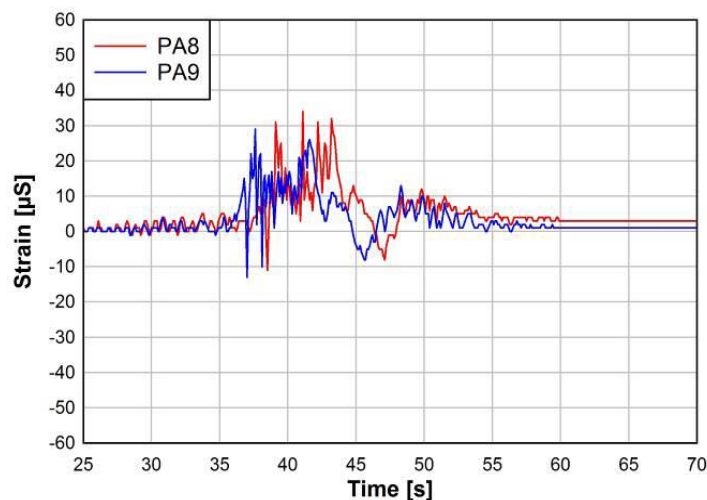
Figure 11: Braking forces in rail track A at pier PA8 and PA9.

Figures 11 and 12 are a selection of the braking operations carried out with a velocity of 80 km/h. The location of braking was at pier PA9 for Fig. 10 and slightly before pier PC11 for Fig. 11. For pier PA8, both freight trains were used to brake at the same time. Since pier PC10 only carries one rail track, logically one freight train was used. Knowing that the large freight train covers a length of approximately 3 bridge spans and a velocity of 22,22 m/s was used, it takes nearly 1,6 seconds to cross one span length and 4,8 seconds before the whole train leaves the measuring point. This is also visible in Figure 11 where the strain peaks cover the length of 5 seconds. In addition, the peak shift from PA9 to PA8 is 1,6 seconds, which indeed is one span length. In Figure 12, first a compression could be detected because the train had braked just in front of pier PC11. After the compression, a peak of 5 seconds could be detected. Finally many seconds after the peak strains, some strains are still measured while the train is already several spans further. This points the effect of the distribution of the braking forces.

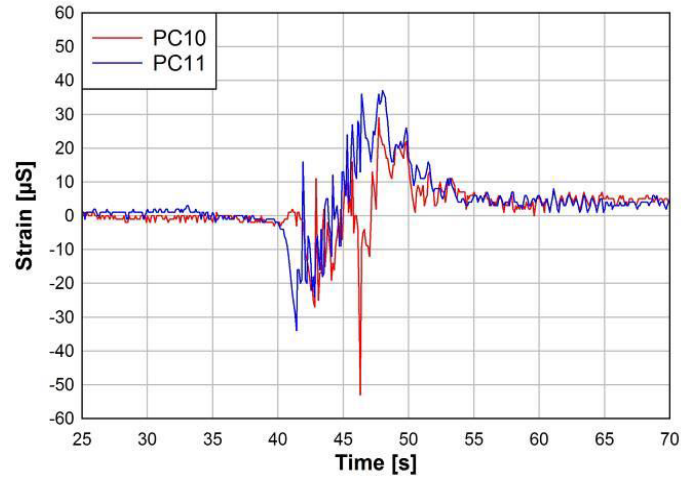
Figure 12: Braking forces in rail track A at pier PC10 and PC11.

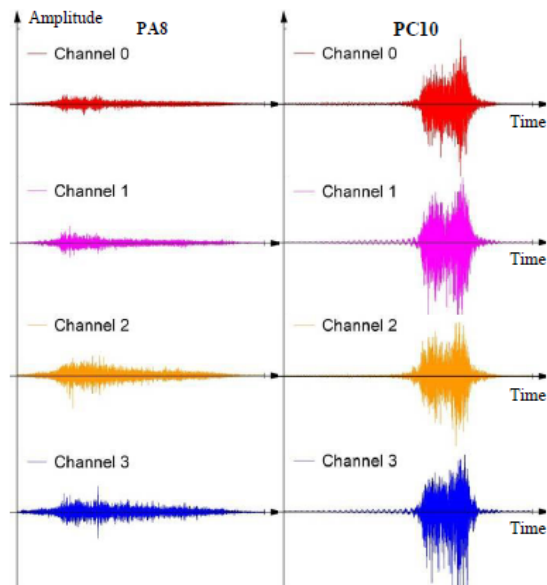
Figure 13: Acceleration measurement in both piers.

During the previous test, accelerations were measured simultaneously as illustrated in Figure 13. Channels 0 and 1 represent the accelerations on the top of a branch in longitudinal and transversal directions respectively.

The same goes for channel 2 and 3 belonging to the main part of the pier. For every axis, the same scale is used. In this respect, pier PC10 undergoes vibrations with a bigger amplitude than PA8. Nevertheless, also a bigger damping effect is visible for pier PC10 which again reflects the stiffness. It can also be observed that before the train actually reaches pier PC10, a sinusoidal signal imposes itself mainly in the transverse directions. This is because the construction for a single rail track is much more slender than that for a double rail track. It also indicates that the overall Eigen modes of the bridge are determining for the dynamic behaviour. If a frequency analysis is done on these measurements, it seems that the bridge was already vibrating in several eigenfrequencies because of ambient factors. The influence of the trains not really imposes new eigenfrequencies which implies that a forced vibration because of freight trains does not really change the behaviour of the bridge. It was also noted that a wide spectrum of eigenfrequencies existed.

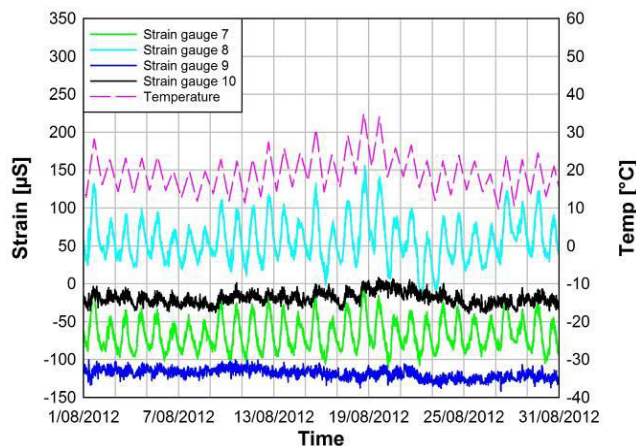
Figure 14: Daily temperature variations and the corresponding strains.

Apart from the short-term measurements, the long-term behaviour of the structure was also monitored. For that, the strains of pier PA8 and PC10 are monitored for a whole year to investigate the influence of the four seasons. Figure 14 gives an illustration of the daily temperature variations while Figure 15 illustrates the yearly variations. In the latter, a strain gauge on the lower part of a branch and orientated to the south (black curve) is compared with the yearly temperature variations (purple curve). As expected, a similar trend is visible which reflects the influence of temperature on the structure. But for most other strain gauges, no clear correlation exists because of the complexity of the structure. When looking at Figure 14 with the daily variations in the lower part of branch 1 of pier PA8, it becomes clear that not all the strain gauges have the same amplitude as the daily variations resulting in torsional forces. For those where the amplitude is clear, a great similarity is visible when comparing the amplitudes of the daily temperature and the daily strains. It must be remarked that the strain variations in these curves are sometimes 130 μS and more. This is much more than the strains detected with the static loading tests. For other strain gauges the influence of the temperature is even more important. In this respect, temperature effects are not negligible especially in combination.

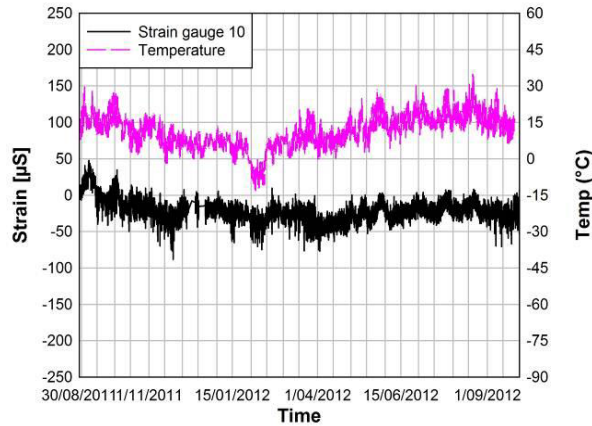
Figure 15: Yearly temperature variations and the corresponding strains.

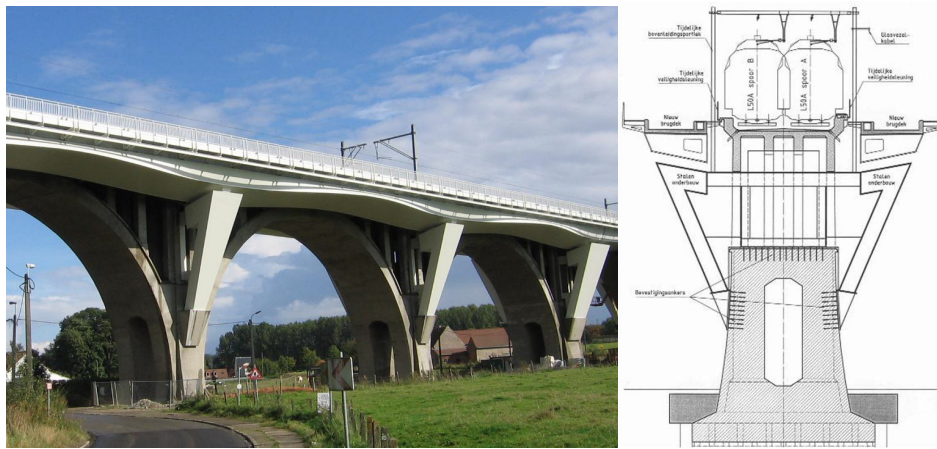
Figure 16: Final design of the integrated steel fly-overs: front view (left) and cross-section (right).

After consideration of various alternatives during the pre-design stage, the final design consists of a steel superstructure with variable hollow sections supported by integrated cantilever pier structures, as shown in Figure 16.

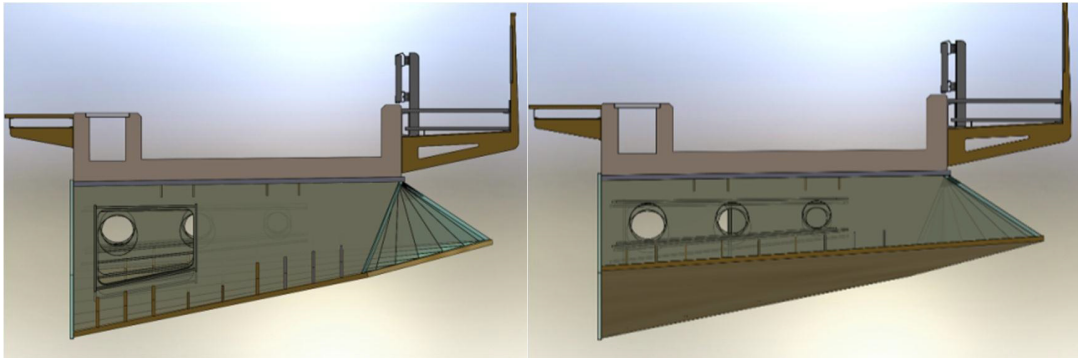
Figure 17: Cross-sections of the steel box at the supports (left) and at mid span (right).

The steel box girders of the superstructure are continuous over 4 spans, in accordance with the existing arches. The box section is characterised by waving patterns, both in plan view as in cross-section. The upper flange of the box section is constant and stays horizontal along the structure's length. The lower flange however has a variable width of minimum 3,65 m at the piers and maximum 5,15 m at the span centre. The lower flange rises according to a sine wave from the supports towards the span centre obtaining less height and is twisted about a horizontal axis as it becomes wider. As a result, the vertical box web near the existing concrete arches has variable height, whereas the outer web plate shows torsion along the

bridge axis. This creates a waving pattern of the steel structure complying with the existing arches, both in horizontal plane as in the front view, as illustrated in Figure 17. To raise the torsion stiffness, internal diaphragms of 20 mm thickness on a distance of approximately 2 m each were installed. Additional stiffness is realised by providing a concrete deck plate of 0,25 m thickness, which allows for spreading the traffic loads and limiting local fatigue problems of the steel structure. The total construction height remains limited in order to guarantee a full front view on the existing viaduct.

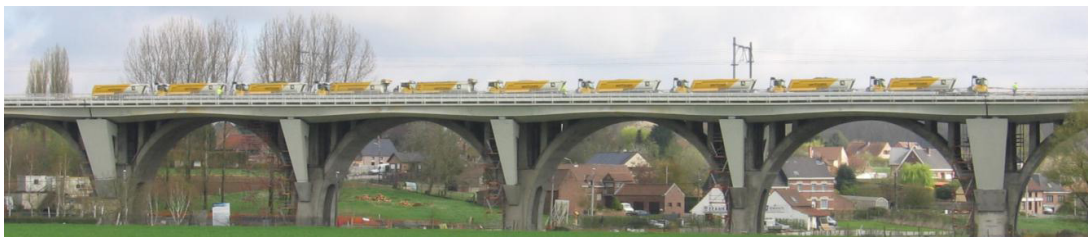
Figure 18: Load test of a continuous 4-span deck using heavy lorries.

A total of 12 heavy lorries were applied as loads during the load test, each lorry having a mass of approximately 44 tons. Over the course of two days, the lorries were placed in various positions along the longitudinal bridge axis, in order to investigate the effect on different structural members. As an example, the full loading condition of a 4-span deck is shown in Figure 18. Lorries could be placed on both sides of the bridge, for example to obtain maximum loading of the local pier structure, or only on one side, for instance to investigate the asymmetric loading of the internal pier framework. During the test, strains were recorded with an accuracy of 1 microstrain (μS) as has been proven on many other cases. Prior to every monitored sequence of consecutive lorry configurations, a zero measurement of the unloaded viaduct was registered in order to discard the measurement results from daily thermal effects.

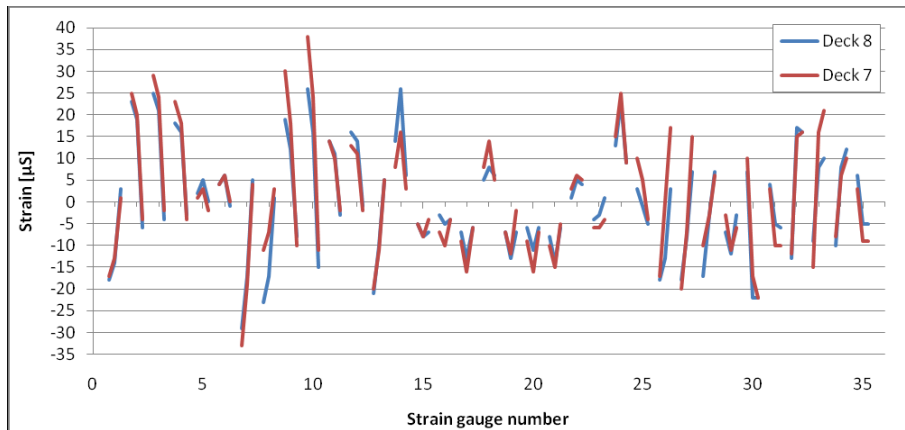
Figure 18: Comparison of strain variations of deck 7 and 8 over three consecutive lorry configurations.

As part of the two-day load test, strains were measured in corresponding sections of deck 7 and 8. Both are continuous 4-span decks, but located on opposite sides of the historic arch bridge at the same position along the longitudinal axis. Figure 19 shows the comparison of strain results from deck 7 and 8 in 35 measurement points for three consecutive lorry configurations. In each of these configurations, the positioning of the lorries was identical for deck 7 and deck 8. Each line in Figure 19 corresponds with the strain variation of a single measurement point over the three load states. As the graph shows, strain results from deck 7 correspond well to strains measured in deck 8 and their variation over the sequence of lorry configurations shows the same tendency for every measurement location. As the absolute values of the measured strains are quite small, some caution is advised in performing extensive statistical analysis on the monitored data. Nonetheless, an average difference of 3 μS between results of deck 7 and 8 can be noted, with a standard deviation of 3 μS , which demonstrates the good agreement between the corresponding measurement sections.

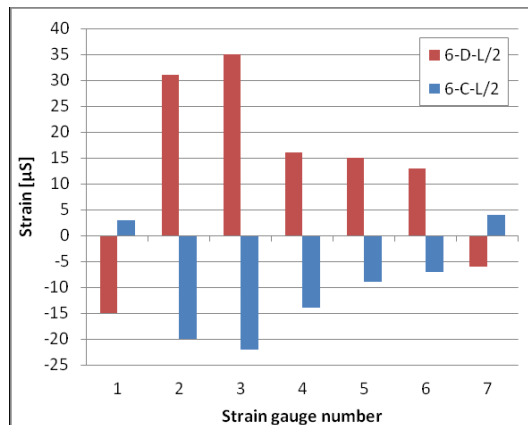
Figure 19: Strain results of deck 6 (only span D loaded).

Figure 19 shows strain results of deck 6, where only the first span (D) was loaded and no lorries were positioned on the other spans (A,B,C). Strain gauges 1 and 7 are located at the top of the box section, while the other gauges are located at the bottom, as shown in Figure 20. Loading of span D results in compressive stresses at the top of the cross-section at mid span and tensile stresses at the bottom.

Simultaneously, the upward response of the adjacent and unloaded span C (due to the deck being continuous over four spans) results in tensile stresses at the top and compressive stresses at the bottom of the cross-section at mid span. Figure 21 shows

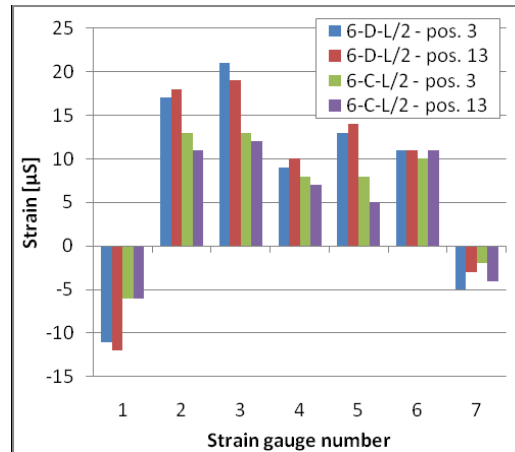
Figure 21: Strain results of deck 6 (spans C and D loaded).

strain results of the same cross-sections in span C and D of deck 6, this time under simultaneous loading of both spans. This condition was found in two different lorry configurations, being positions 3 and 13, which allows for a comparison of monitored strains in both positions. The results depicted in Figure 21 show a good resemblance between positions 3 and 13 in both cross-sections of deck 6. In general, the strains in span C remain smaller as in span D, which corresponds to the smaller bending moment in span C under the applied loading condition.

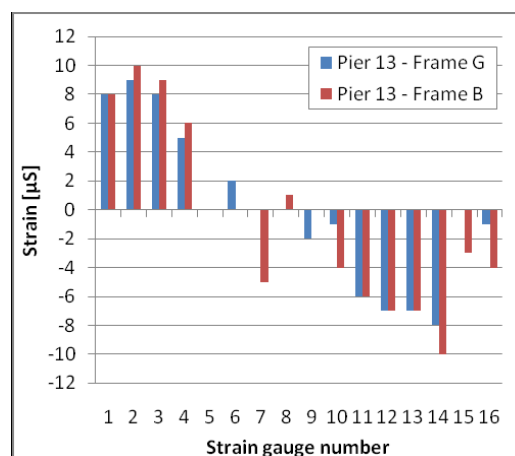
Figure 21: Strain results of both frames of pier 13 (maximum loading condition).

During the load test, the maximum loading condition of the piers was simulated by positioning lorries on both sides of the pier in longitudinal direction and at the same time on both decks of the fly-over in transverse direction. As the cantilever piers of a double pier structure are joined by two separate transverse internal frameworks, strain data from corresponding locations on both frameworks can be compared. Therefore, results of this loading case for the double pier structure of pier 13 are shown in Figure 22. In spite of the small absolute values of the measured strains, a good resemblance of the results for both frames can be observed.

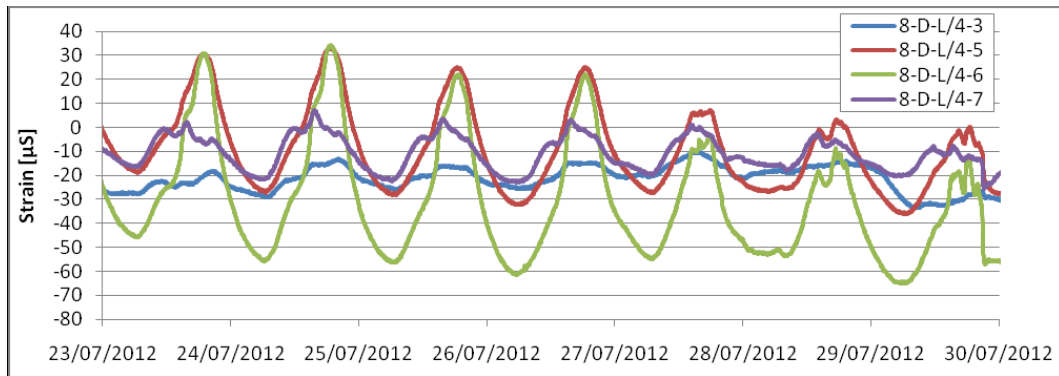
Figure 22: Strain variations in steel superstructure due to temperature variations during summer.

Long term monitoring of the steel box section of the fly-overs allows for evaluating the effect of temperature gradients on the superstructure. Figure 22 gives an illustration of the daily temperature variations during the summer in several cross-sections of deck 8, which is oriented to the southwest. The graph shows that the temperature of the inner web plate near the existing concrete arches ('in') is almost identical along the entire length of span D of deck 8, and shows rather small variations between day and night temperatures. On the other hand, temperatures on the outer web plate ('out') become much higher during daytime and cause a temperature gradient in the steel box section. In addition, the outer web plate at mid span shows significant higher temperatures than the cross-sections at L/4 and the supports, due to a larger exposure to solar radiation on the inclined steel surface. As a result, the largest temperature gradient between inner and outer web plate occurs at mid span and reaches almost 15°C, while this difference is only 6°C at the supports.

As an example, Figure 22 shows the impact of the temperature variations on monitored transverse strains in the cross-section at L/4. The numbering of the strain

gauges is similar to Figure 20. When temperatures rise during daytime, an increase of tensile stresses can be observed due to the thermal expansion of the steel superstructure. The largest strain variations occur in gauge numbers 5 and 6, which are located at the lower outer corner of the steel box section. The temperature effects on the superstructure can also be observed in the monitoring results of the pier structures, as illustrated in Figure 23. Corresponding measurement locations in piers 10 and 13 give a comparable response to the thermal effects, with maximal tensile stresses generated in strain gauge number 3, located on the lower connection plate between the conical box section of the piers and the internal framework.

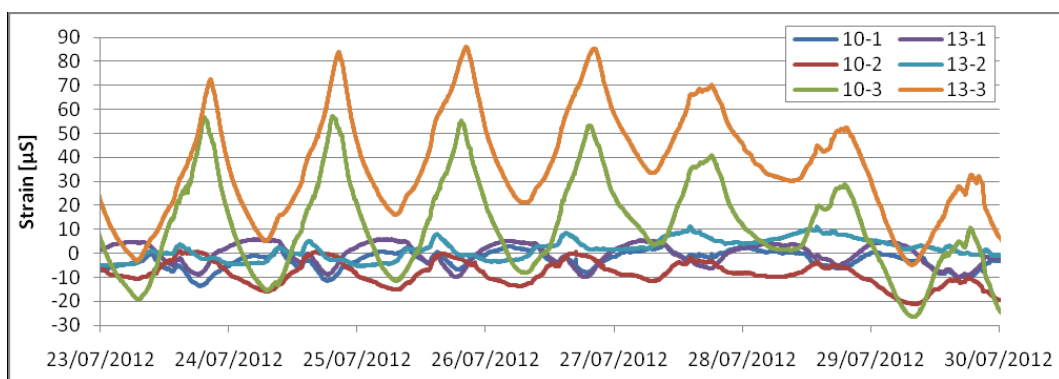
Figure 22: Strain variations in pier structures due to temperature variations during summer.
