Approach for comparing design and as built models based on data acquisition using a 3D terrestrial laser scanner, a case study.

Case study: Bridge element at Lummen (Belgium)

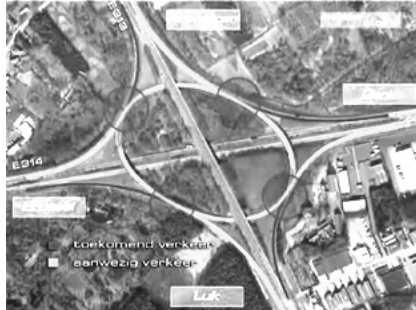
Fig. 2: Motorway interchange - Lummen (old situation: conflict traffic flows) - source: www.klaverbladlummen.be, 2008

The Lummen (Belgium) motorway interchange connects the European motorways E313 and E314. To address safety and traffic congestion issues, all conflict situations will be resolved by reshaping the interchange. An innovative concept, in which new bridge elements are prefabricated alongside the existing infrastructure, makes it possible to move the elements into their final location in merely one week-end, hence reducing the hinder for the daily traffic. The company responsible for the realization is Jan De Nul NV.

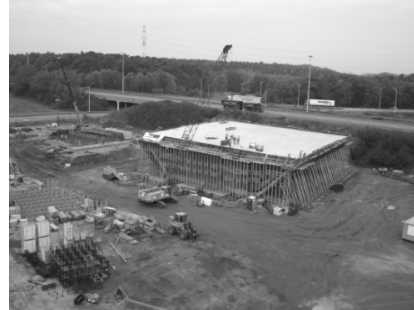
Fig. 3: Construction site near E313 – Lummen - source: Jan De Nul NV, 2008

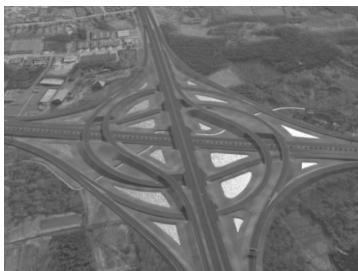
Fig. 4: Design visualisation

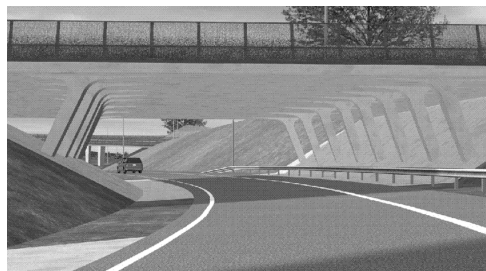
Fig. 5: Design visualisation: case study element

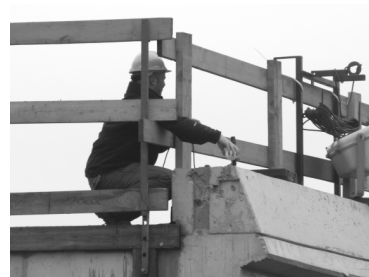
Fig. 8: Attachment of spherical target to upper side bridge element

In the case study at hand ten scan positions and seventeen targets were used to assure full coverage of both the inside and outside of the bridge element.

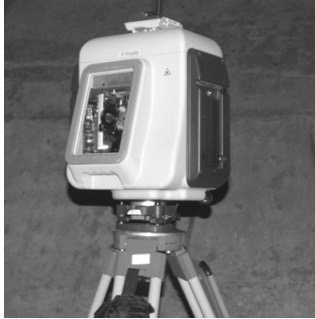
Fig. 9: Trimble GX Advanced

For the data acquisition two Trimble GX Advanced 3D (Fig. 9) scanners were used.

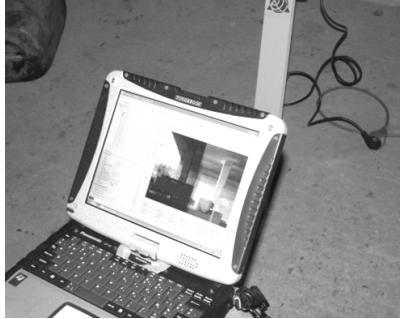
Fig. 10: Control of laser scanner with Trimble® PointScape™ Software

The scanner is operated by the Trimble® PointScape™ Software, installed on a Panasonic Toughbook CF-19 (Fig. 10).
