THE PROPERTIES AND PERFORMANCE OF LEDE STONE IN CULTURAL HERITAGE: NEW INSIGHTS FOR ITS PRESERVATION AND REPLACEMENT

Thesis submitted in fulfillment of the requirements for the
degree of Doctor of Science: Geology

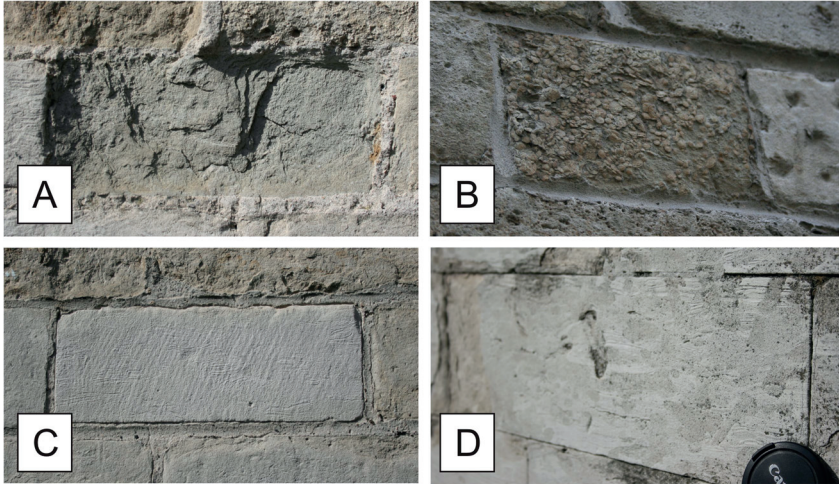
Figure 2.5: Macroscopic example of A) Ypresian stone perpendicular to bedding, with green colour and exfoliation; B) Ypresian stone perpendicular to bedding with Nummulite concentrations; C) Brussels stone and D) Gobertange stone; all in the same scale.

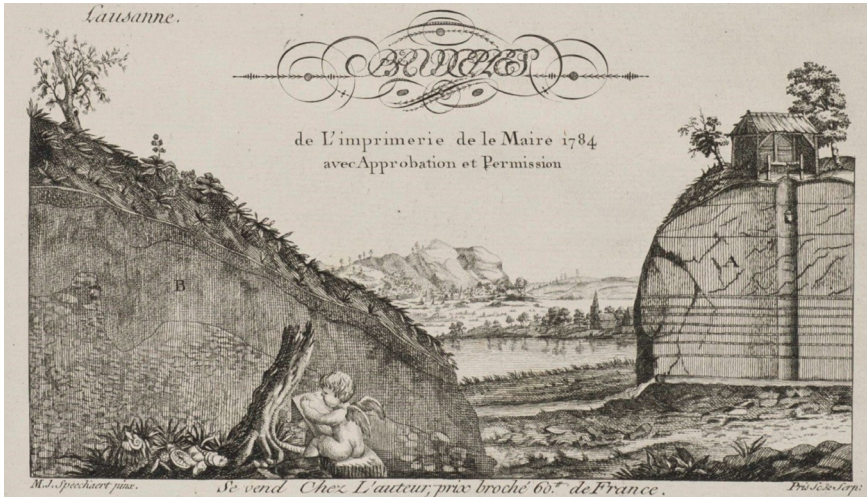
Figure 3.1: Cover page of *Oryctographie de Bruxelles* (Burtin et al., 1784), showing an open air quarry (left) and a subsurface mine (right) in Brussels.

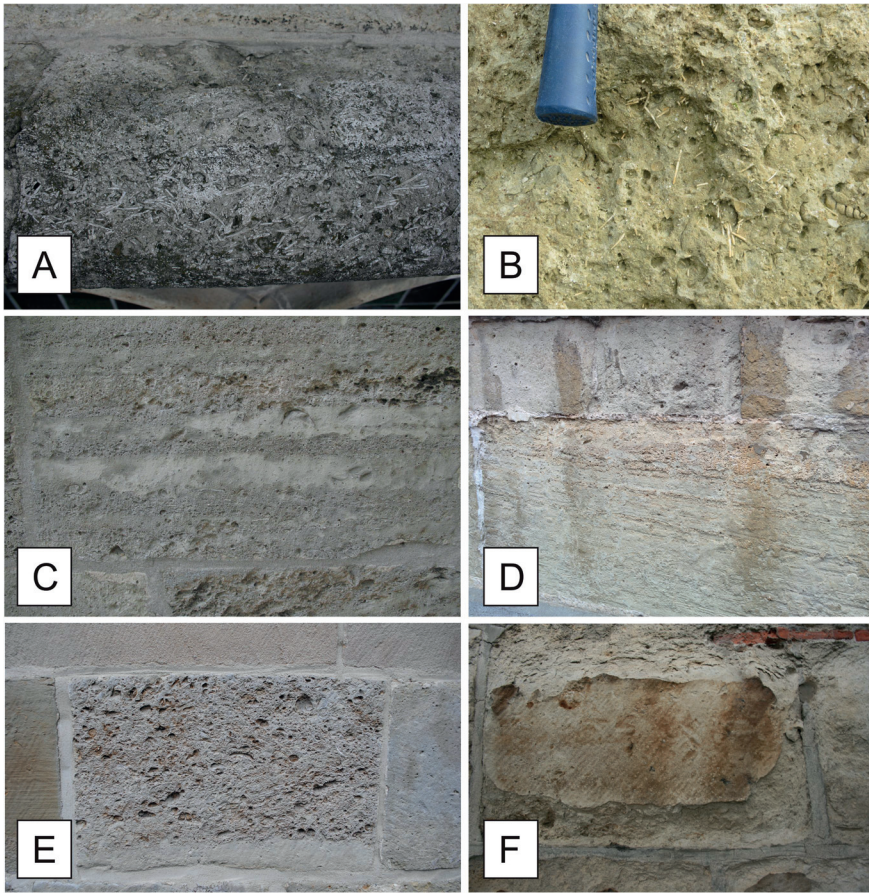
Figure 3.3: Examples of Lede stone. A) accumulation of *Nummulites variolarius* and *Ditrupea strangulata*; B) dispersed occurrence of *Nummulites variolarius* and *Ditrupea strangulata*; C) layering; D) stratification, pronounced by *Nummulites variolarius*, E) coarse, porous shell bed, F) orange-brown patina, with contour scaling.

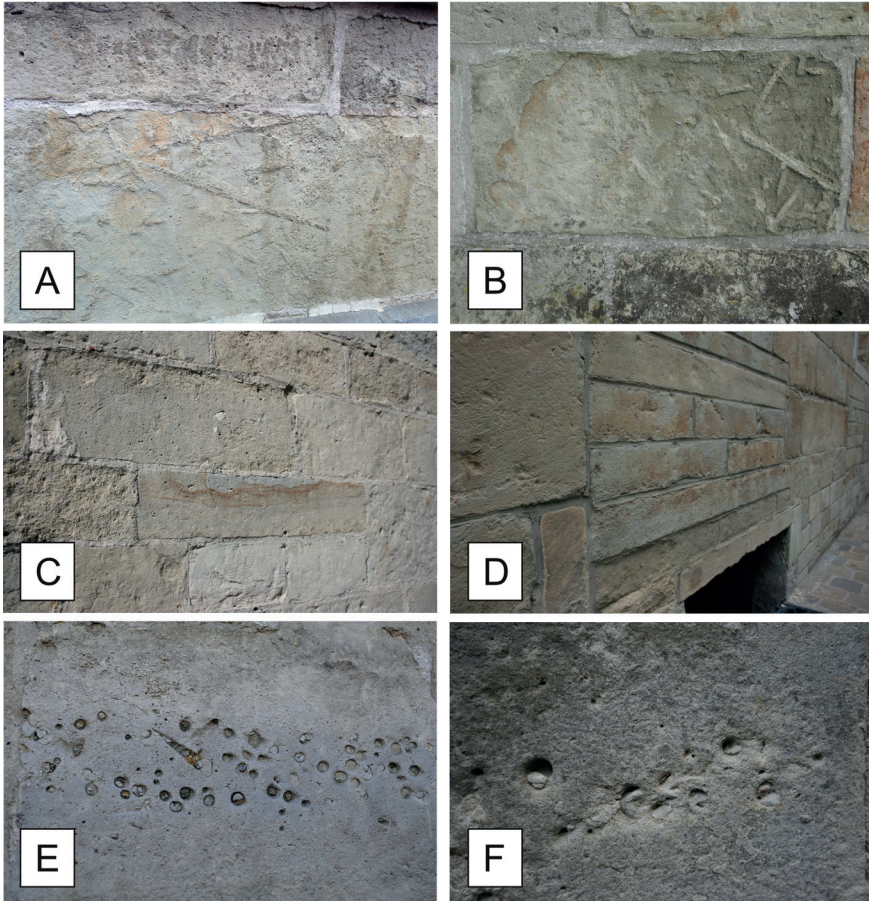
Figure 3.4: Examples of Lede stone. A and B) subhorizontal bioturbation; C) liesegang structures (central); D) elongated stone; E) casts of Turritella; F) detail of Turritella casts.

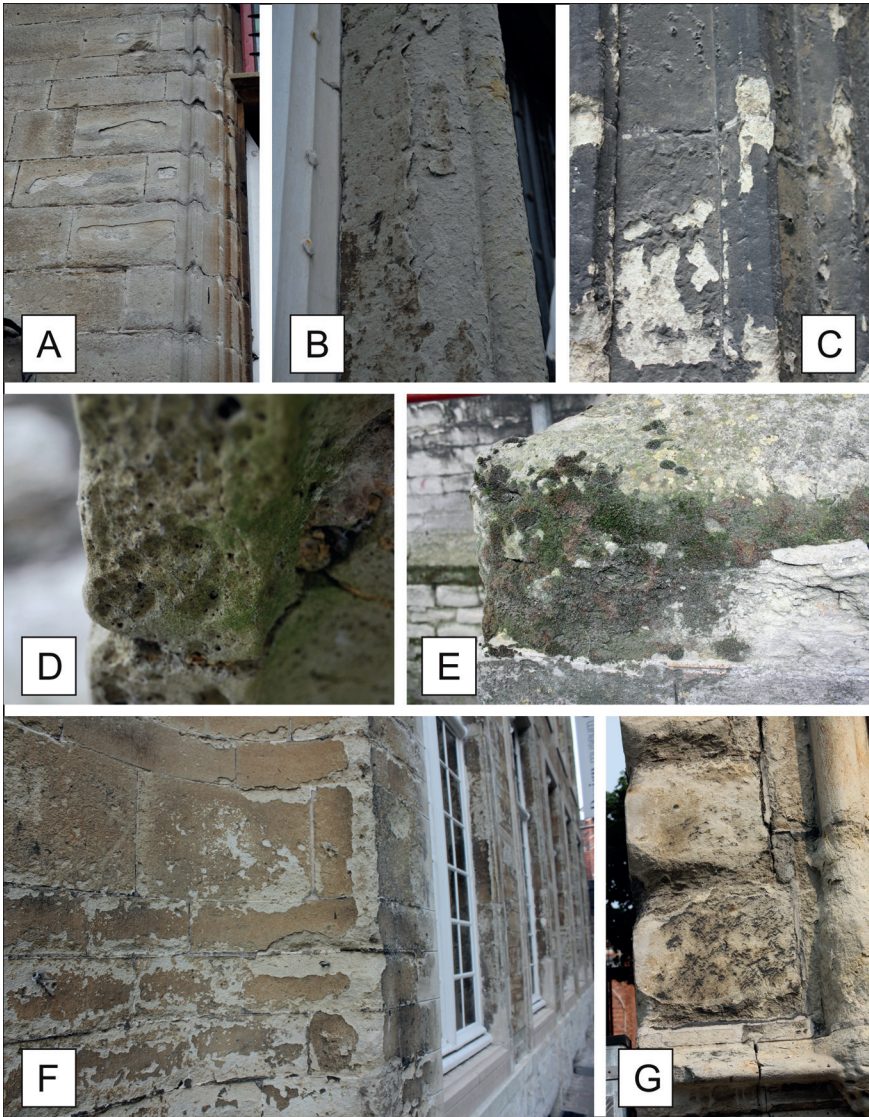
Figure 3.5: Deterioration processes; A: Blistering of masonry; B: Flaking at stone frame; C: Black crust on sheltered blocks; D: Alveolization and biological colonization (green algae) in a near coastal setting; E: Biological colonization (algae, lichens and mosses); F: Scaling originating along joints; G: Rounding of corner blocks along joints.

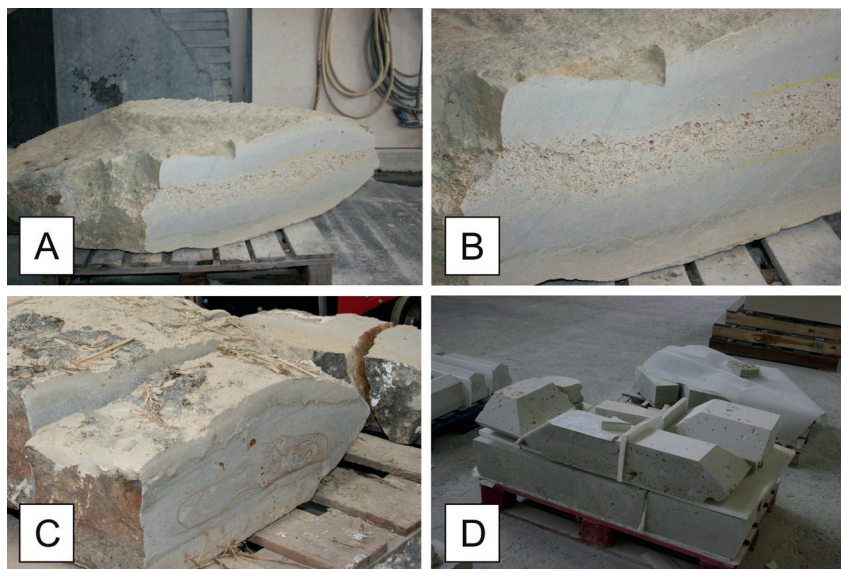
Figure 3.7: New blocks of Lede stone. A) with a porous shell layer central, thickness ± 40 cm; B) detail of A; C) compact block with liesegang structures, thickness ± 40 cm; D) cut to size for finishing, height ± 20 cm.

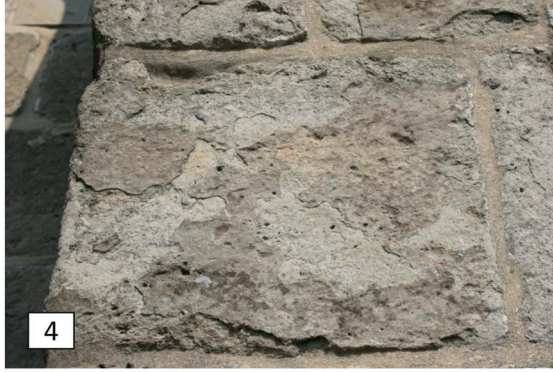
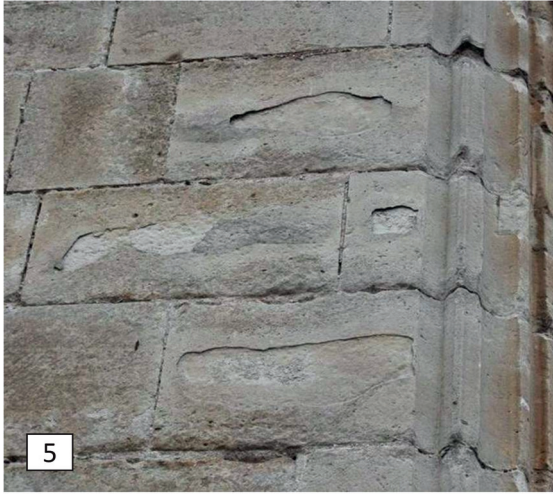
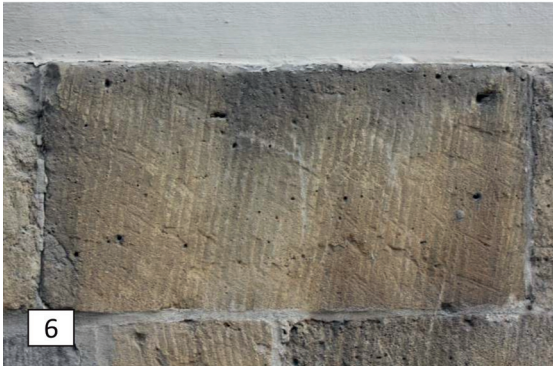
Figure 4.4: Photos 4–6 related to damage of white limestone.

The photos 1–11 (Fig. 4.3, 4.4 and 4.5) relate to damage with the aim to investigate the human perception of loss of value. All photographs show Lede stone, with the exception of photo 2 which is dominantly Brussels

Photo 4: peeling of the patina crust

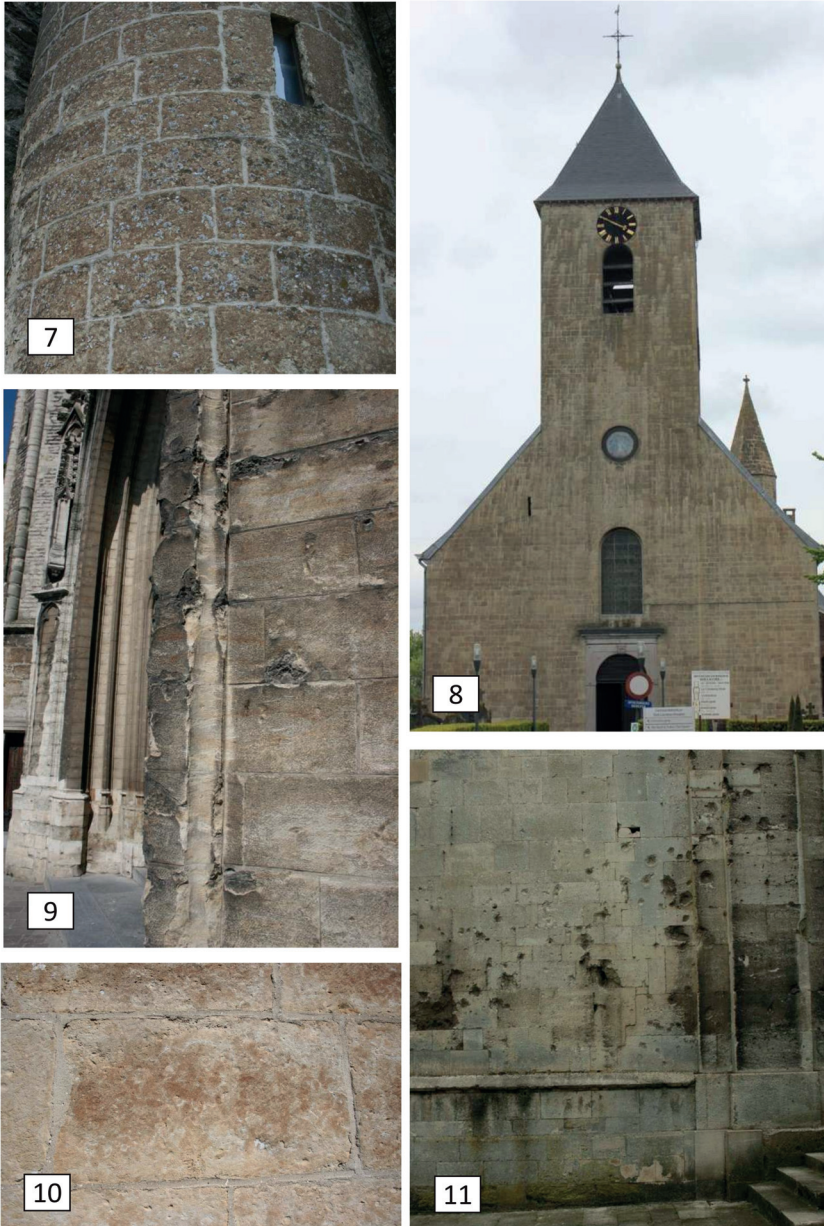
Figure 4.5: Photos 7–11 related to damage of white limestone.

Photo 7: biological colonization (lichen)

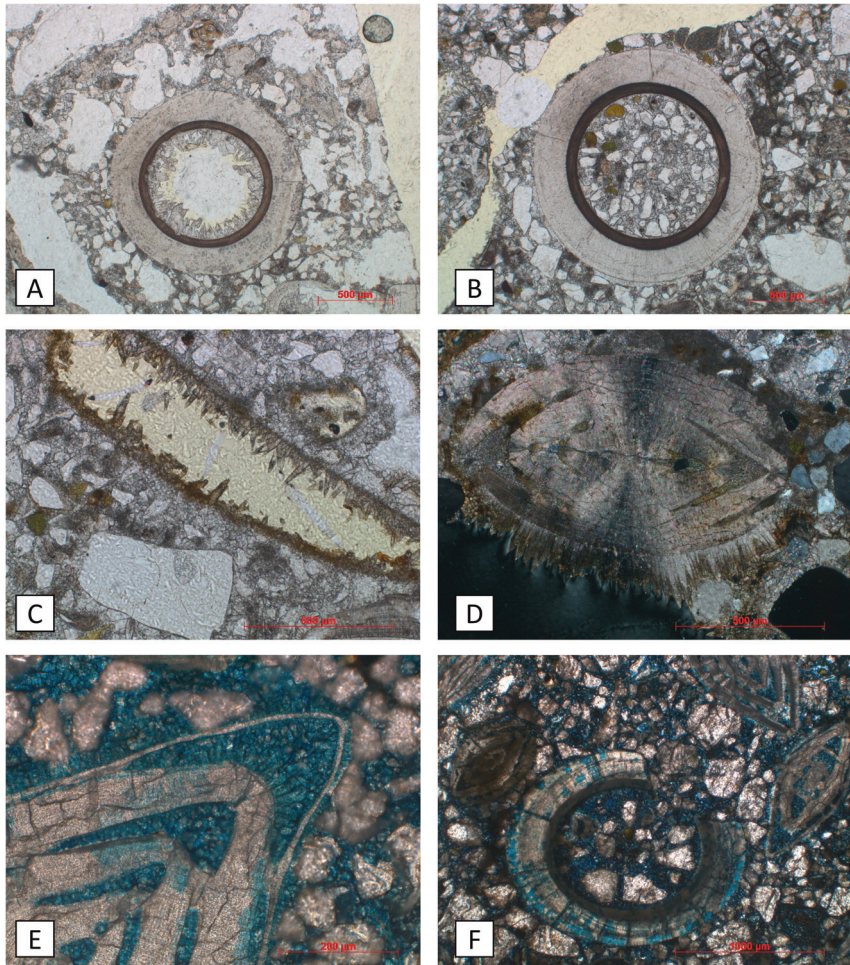
Figure 5.4: Micrographs of different features. A) *Ditrupa* sp. with infilling of dog tooth cement; B) *Ditrupa* sp. with sediment infilling; C) Moldic porosity with dog tooth cement lining the porosity; D) Nummulite with dog tooth cement and iron oxides, E) K-ferricyanide staining of dog tooth cement on Nummulites and microsparite indicating the carbonate is ferroan calcite (blue), the tests of Nummulites are not ferroan; F) K-ferricyanide staining of microsparite and parts of *Ditrupa*.

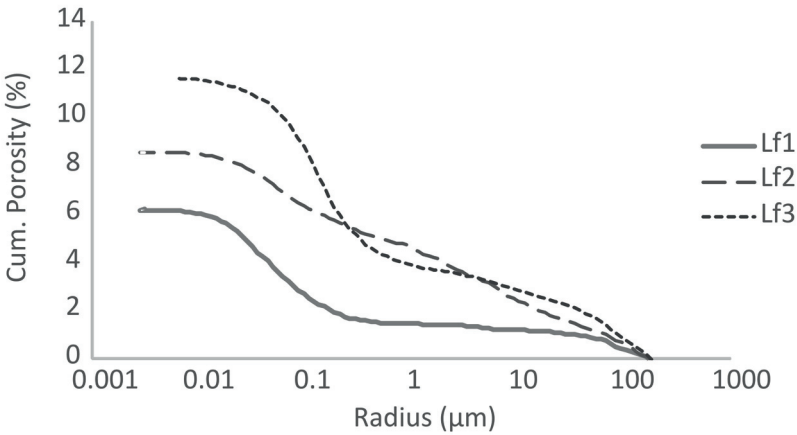
Figure 5.7: Cumulative absolute porosity measured by MIP in function of the pore radius.

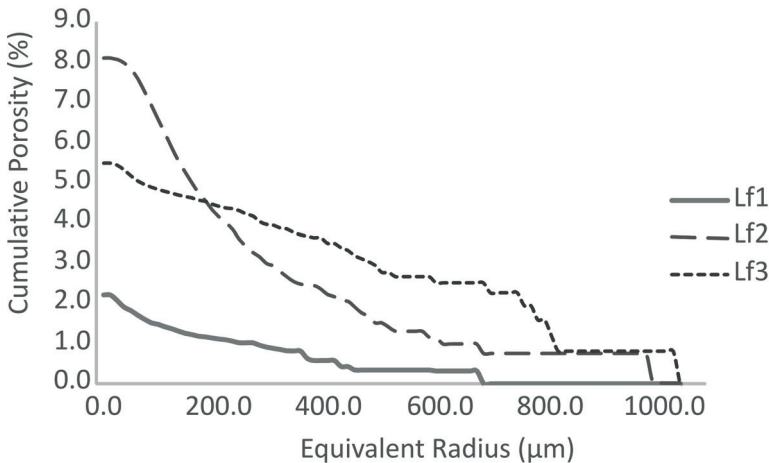
Figure 5.8: Cumulative absolute porosity for μ CT analysis in function of the pore radius.

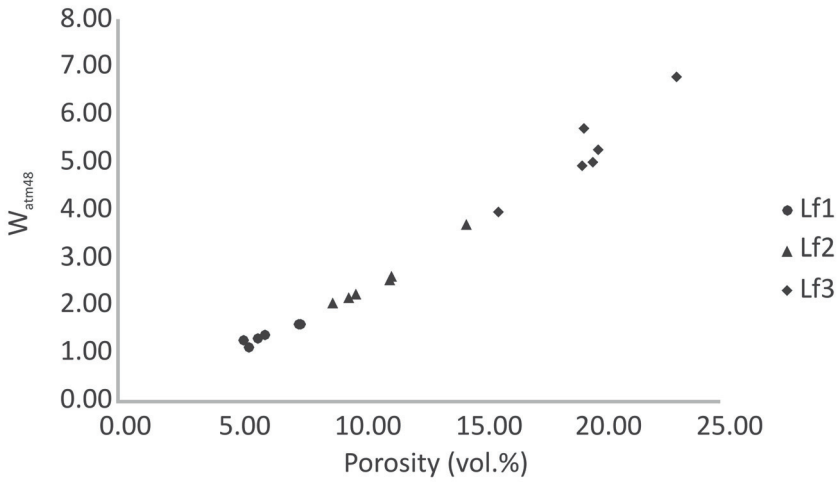
Figure 5.10: Relation between the water absorption in wt% and the porosity.

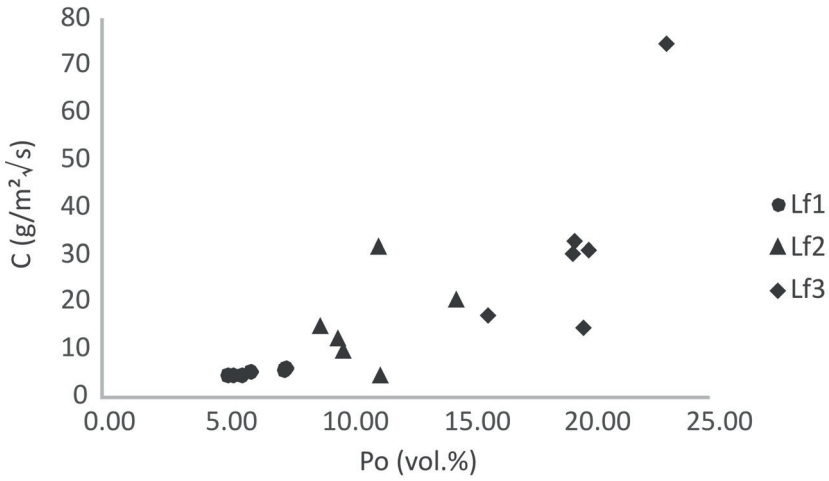
Figure 5.13: Relation between the coefficient of capillarity and the total porosity.

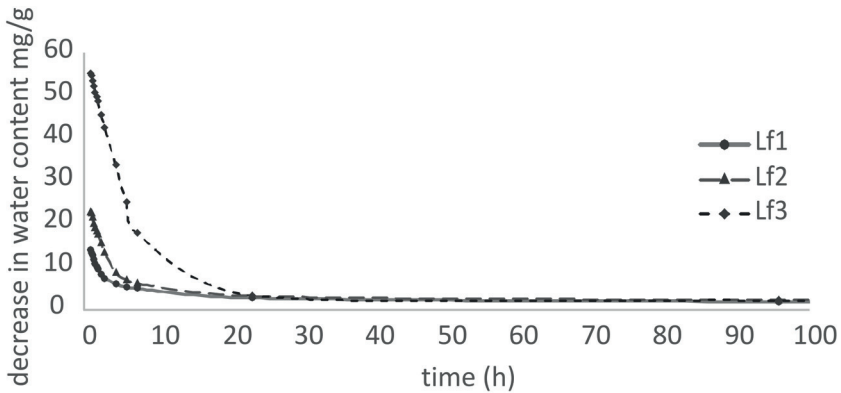
Figure 5.15: Decrease in water content in function of time for a representative sample for each microfacies, with the measurements indicated as bullet points. The graph is cut off at 100 h.

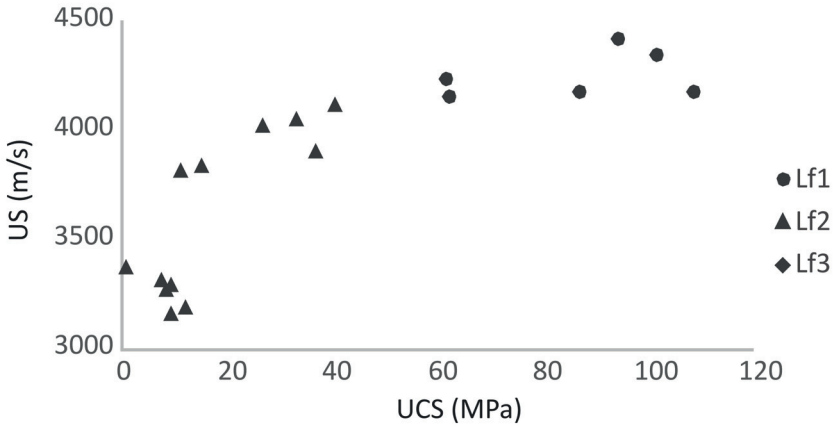
Figure 5.19: Values for the sound speed propagation in relation to the uniaxial compressive strength.

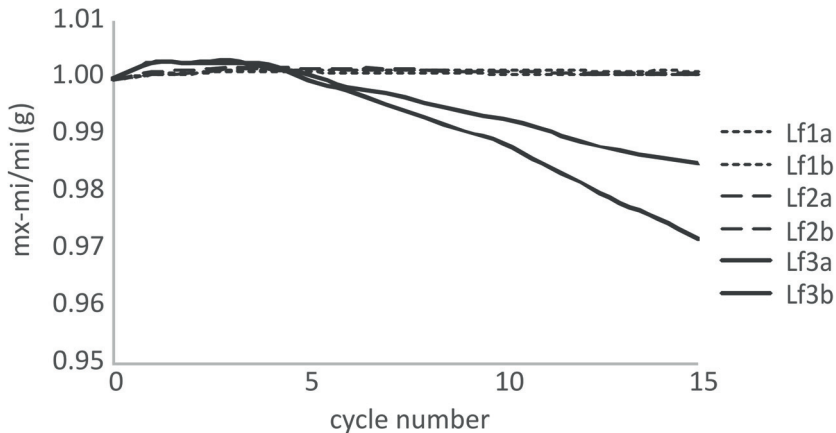
Figure 5.22: Normalized weight evolution during 15 cycles of the salt test for the different microfacies.

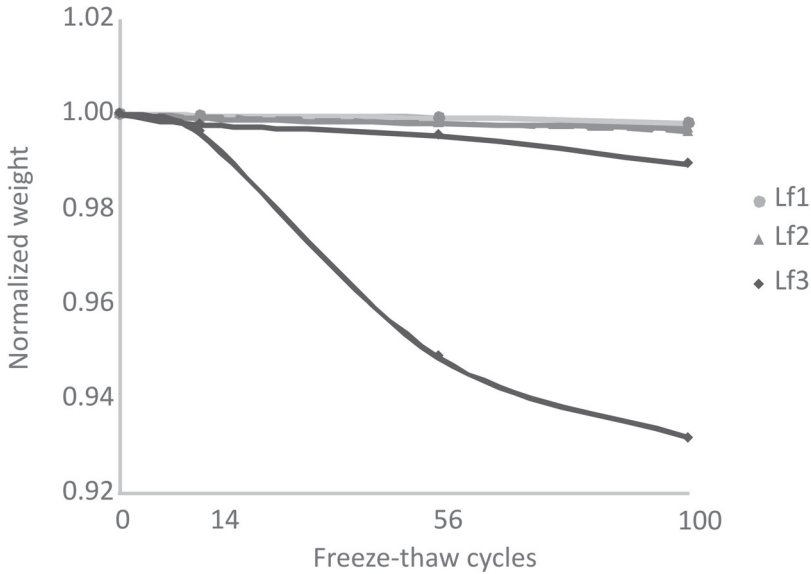
Figure 5.26: Normalized weight evolution after 14, 56 and 100 freeze-thaw cycles for two samples of each microfacies.

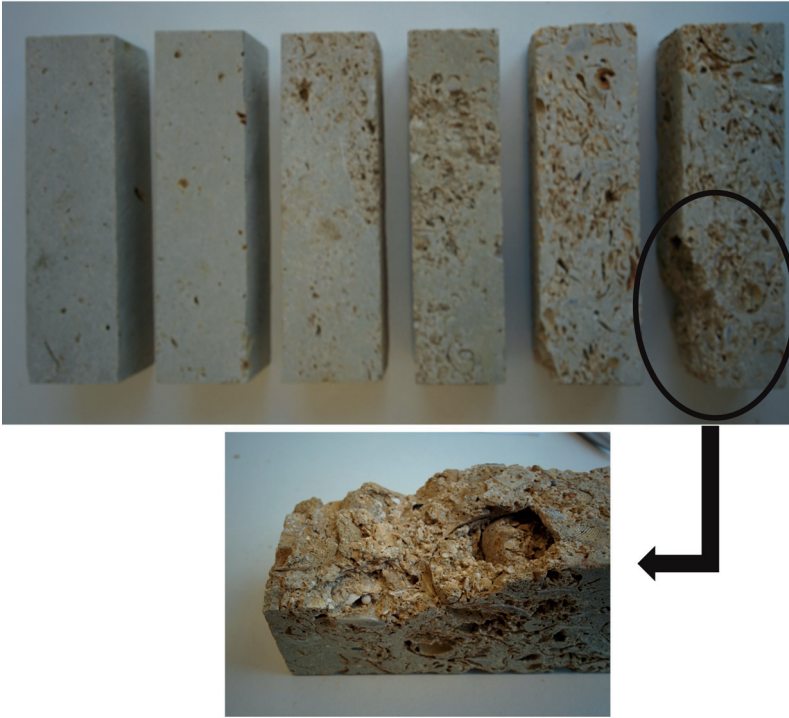
Figure 5.27: Photograph of the samples after 100 freeze-thaw cycles, with detail of the damage of sample 3.1 (bottom). From left to right: Lf1.1, Lf1.2; Lf2.1, Lf2.2, Lf3.1, Lf3.2.

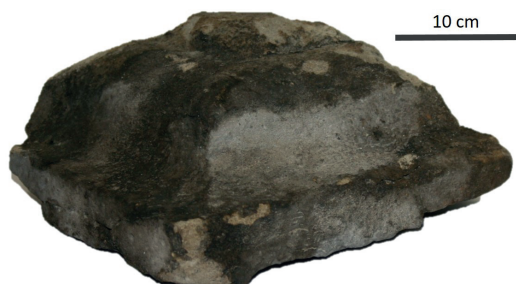
Figure 6.1: Image of the Lede stone sample with gypsum crust from the Sint-Salvator church in Wieze.

A weathered Lede stone was collected from the Late Gothic Sint-Salvator church in Wieze (Belgium) from the ventilated top of the tower where they were protected from direct rain impact (Fig. 6.1). In these conditions, a

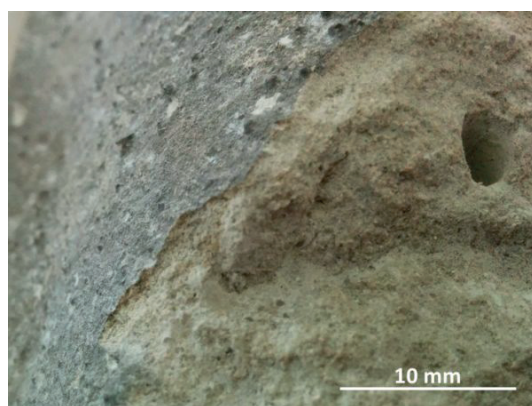
Figure 6.2: Cross-section photograph of Lede stone with gypsum crust from the Sint-Salvator church in Wieze.

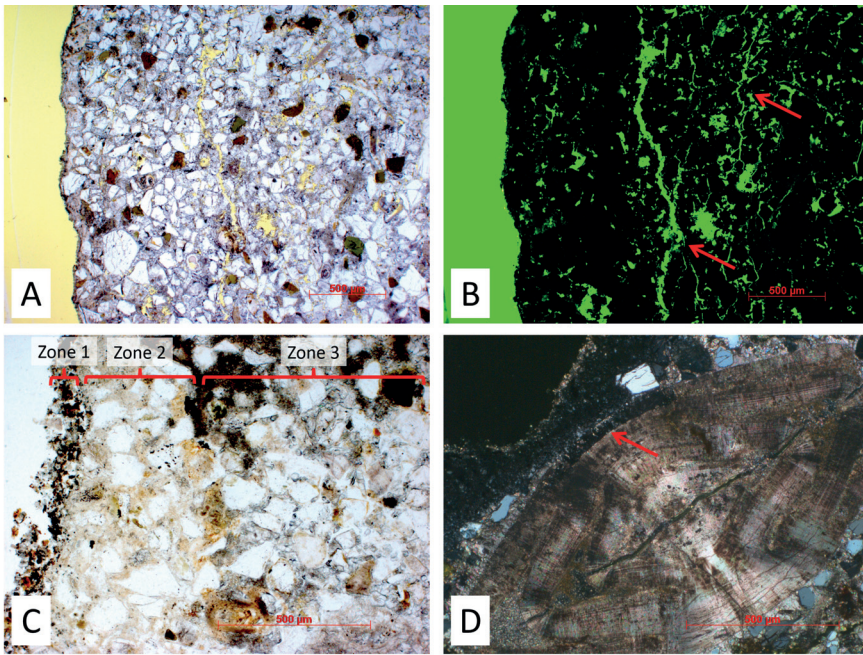
Figure 6.3: A) thin sections micrograph of gypsum crust; B) fluorescent image of the same view as A, illustrating the porosity and fractures in green; C) indication of opaque upper layer (zone 1), gypsum crystallization layer (zone 2) and sound stone with fractures (zone 3); D) *Nummulites variolarius* with partial dissolution of the outer shell, indicated by arrow. Scale bars are 500 μm .

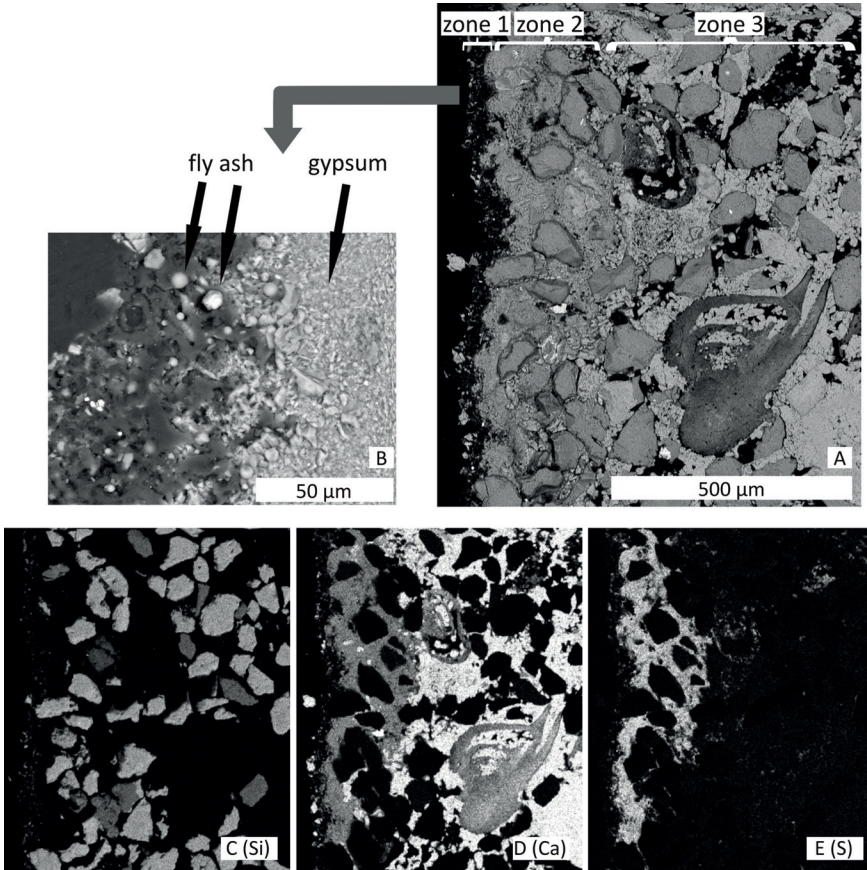
Figure 6.4: A) SEM-BSE image of gypsum crust oriented to the left with indication of zones 1, 2 and 3; B) detailed SEM-BSE image of the crust with particulate matter in the outer layer and intertwined gypsum crystals underneath; C-E) SEM-EDX mapping of Si, S, Ca with the same field of view as A.

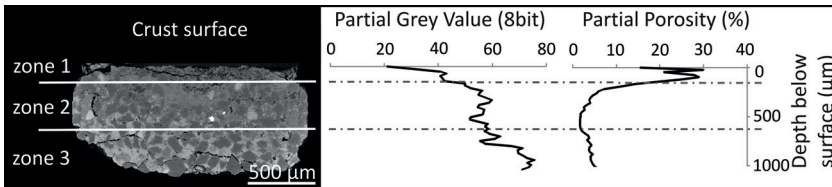
Figure 6.6: Sagittal slice obtained with μ CT and correlated Partial Grey Volume and Partial Porosity graphs of the total volume in function of depth beneath the crustal surface.

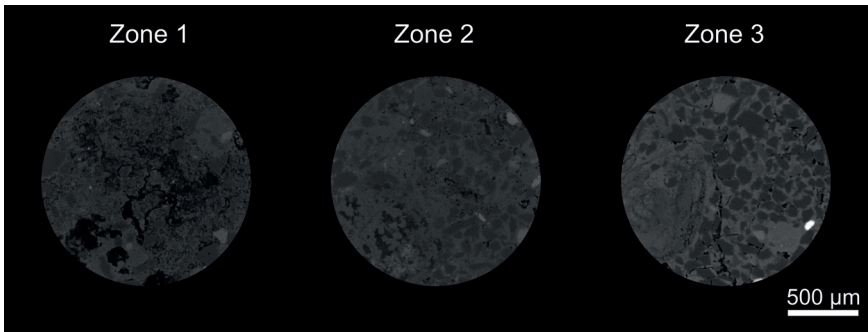
Figure 6.7: Frontal slices obtained by μ CT through each zone. Zone 1 consists of fine grained accretionary material. Zone 2 consists of dark grey quartz grains in a matrix with higher grey value (gypsum). Zone 3 consists of similar quartz grains in a lighter matrix (calcite) and fractures. Grains with higher grey value represent glauconite, calcite and accessory dense mineral phases; black zones are porosity.

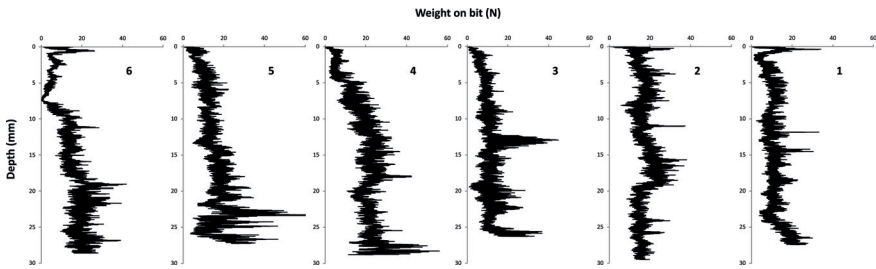
Figure 6.10: Depth logs of the drilling strength measurements. Average weight on bit around 20 N corresponds to average initial rock strength, while lower average weight on bit corresponds to the decayed zone near the surface. The decayed zone is thinnest in profile 4 (± 5 mm) and thickest in profile 1 and 3 (± 25 mm).

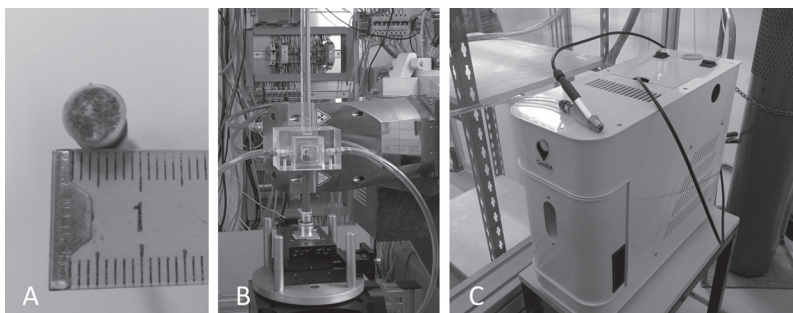
Figure 6.11: A) 6 mm diameter sample for acid weathering experiment sleeved with heat-shrink tubing; B) climatic cell set-up on HECTOR; C) GenRH humidity generator.

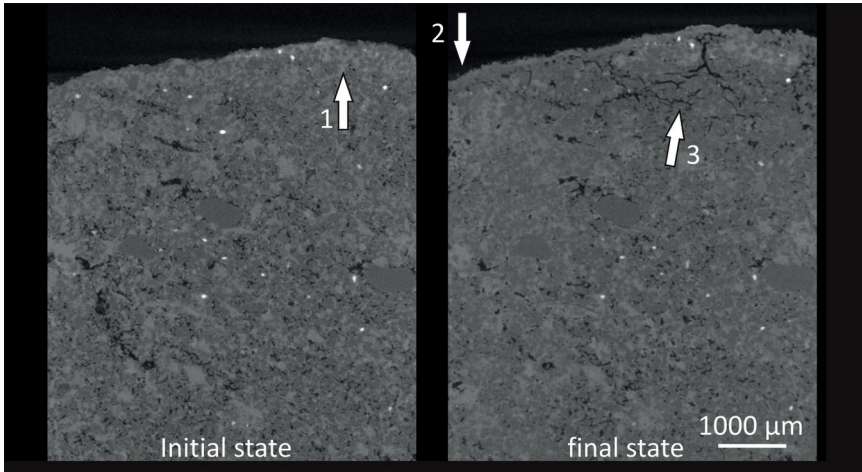
Figure 6.12: Sagittal cross section of μ CT with the crust on top of the initial state (left) and the final state (right). Arrow 1 indicates the depth of the original gypsum crust. Arrow 2 indicates superficial gypsum crystallization crust after 21 days acid exposure. Arrow 3 indicates a zone with a development of cracks. Relative grey scale given in the histogram of Fig. 6.13.

Figure 6.16: Detail of Figure 6.12 showing the top of the sample in the final state together with a zonal model. A superficial gypsum crystallization can be observed, with the development of a crack network underneath.

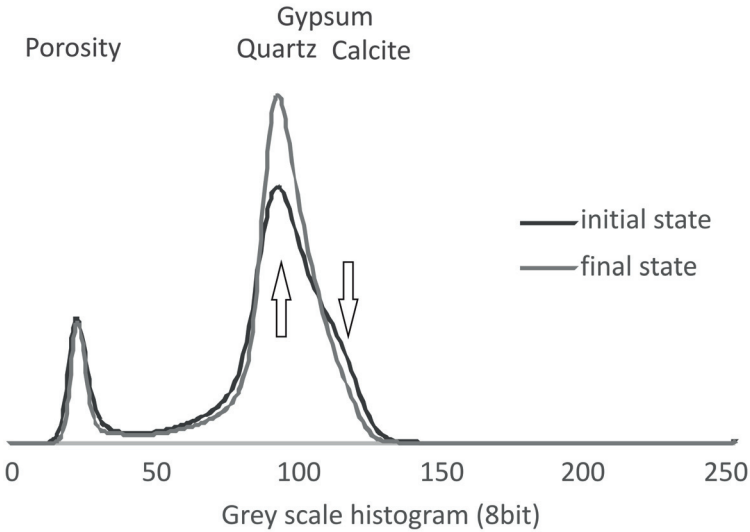
Figure 6.13: Histogram of the grey values (relating to the attenuation) obtained with μ CT of the initial state and final state. First peak represents porosity, second peak represents the bulk with quartz for the lower grey values, calcite for the higher and gypsum in between both.

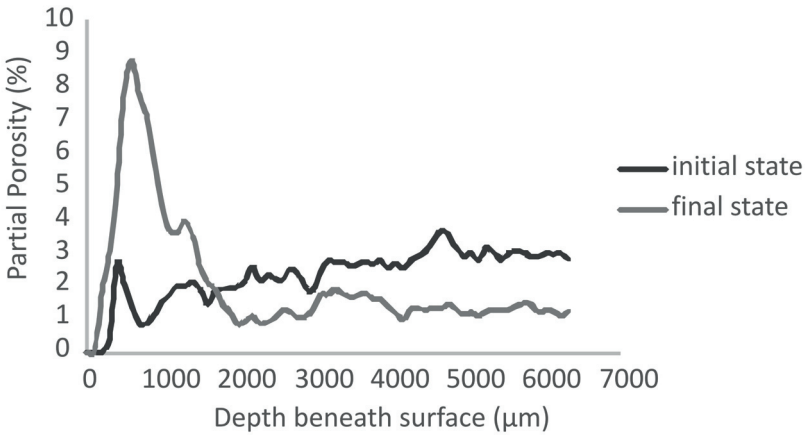
Figure 6.15: Plot of the partial porosity in function of depth for the initial and final state. The partial porosity in the final state increased in the top part and decreased deeper in the sample.

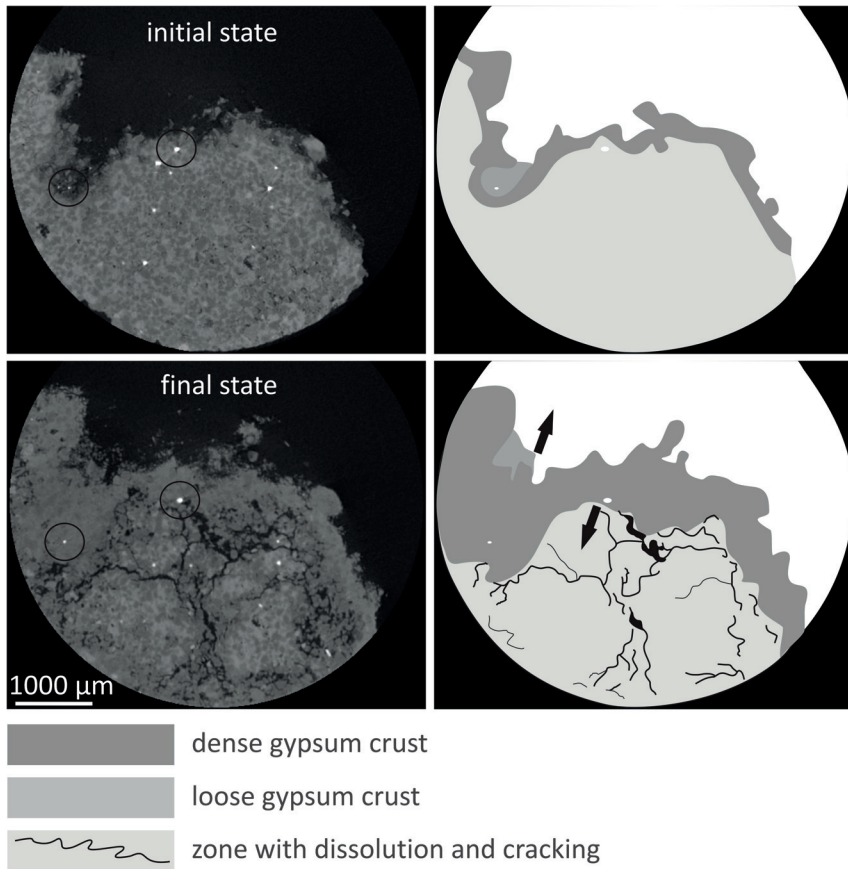
Figure 6.17: Slice through the crust of the initial and final state together with a zonal model. Arrows indicate the growth direction of the crust, which is observed by tracking the encircled dense grains on top (left) and beneath (right) the original crust. Both become incorporated in the final crust, illustrating crystallization on top and below the original crust. The view on the crack network is subparallel to the surface. Two dense grains used for tracking are encircled.

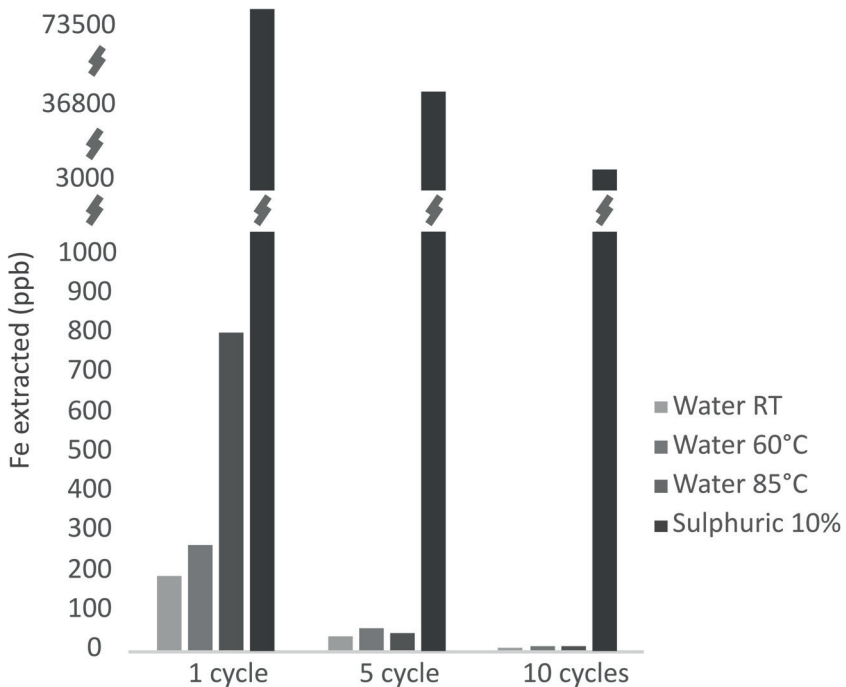
Figure 6.18: Leached Fe in ppb after 1, 5 and 10 cycles of wetting 200 mg of glauconite at room temperature, heating in water to 60 °C, heating in air to 85 °C and immersion in an aqueous 10 % H_2SO_4 solution.

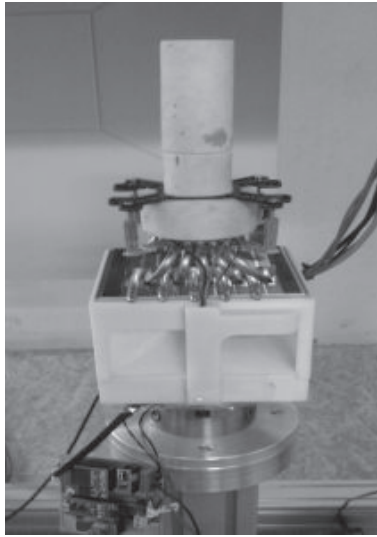
Figure 7.1: Photo of the custom designed cooling stage for μ CT (De Schryver et al., 2014).

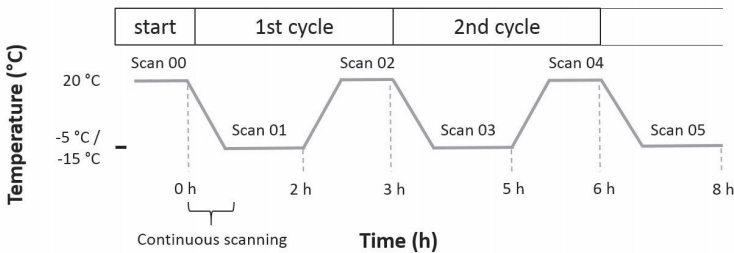
Figure 7.2: Visual representation of the freeze-thaw cycles and the moments of scanning.

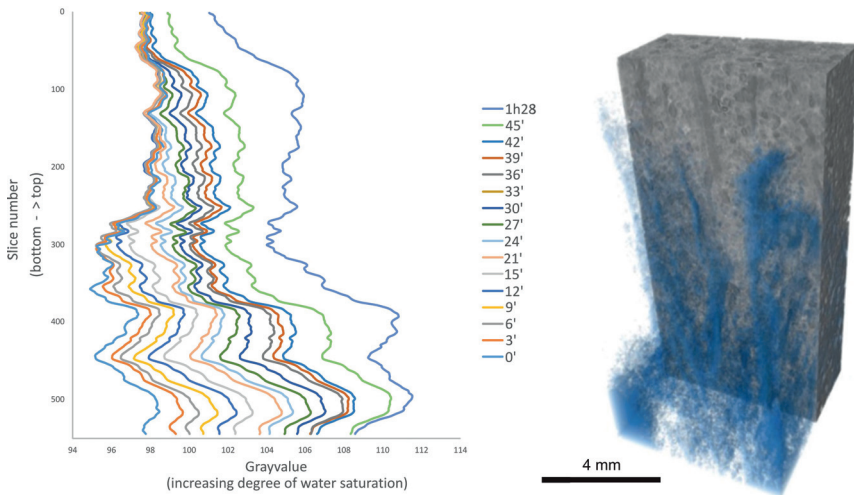
Figure 7.4: Left: graph with temporal evolution (in minutes, indicated in legend) of the partial grey value (ordinate) during capillary uptake. The increase in gray value is the result of water progressively saturating the pore system in time and height. Right: visualization of water uptake through preferential flow paths within the rock; the rock rendering has been partially cut, showing the location of water in blue at a specific time.

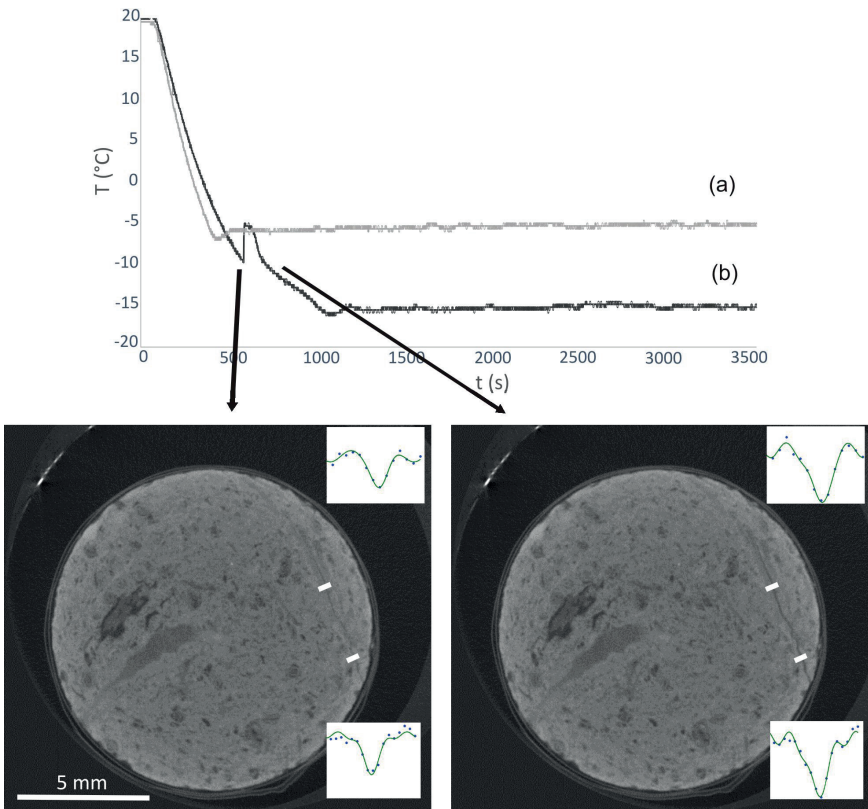
Figure 7.7: Readout of the temperature sensor in function of time, with set point -5°C (a) and -15°C (b). A small undershoot is visible after reaching the set point temperature. Note the sudden increase in (b) at $t = 547$ s after the start of the cooling stage, caused by the release of latent heat upon ice crystallization at a temperature of -9.7°C . This is not observed in (a), suggesting no crystallization takes place and the water is only supercooled within the pores. Below, the reference slice is reconstructed for the situation just before and just after crystallization, showing the opening of the existing fracture. Graphical insets of FWHM have the same scale.

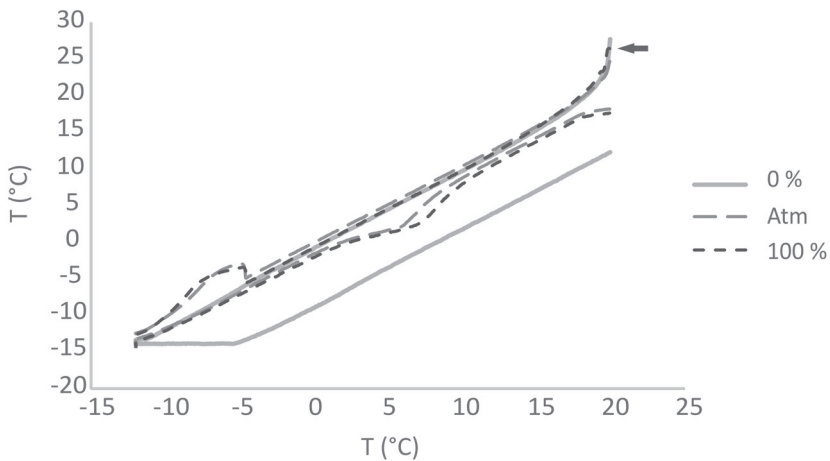
Figure 7.9: Temperature evolution of the Lf2 sample (ordinate) for 0 %, atmospheric and 100 % water saturation in relation to the chamber temperature (abscissa) during a freeze-thaw cycle. The start point is indicated by the black arrow.

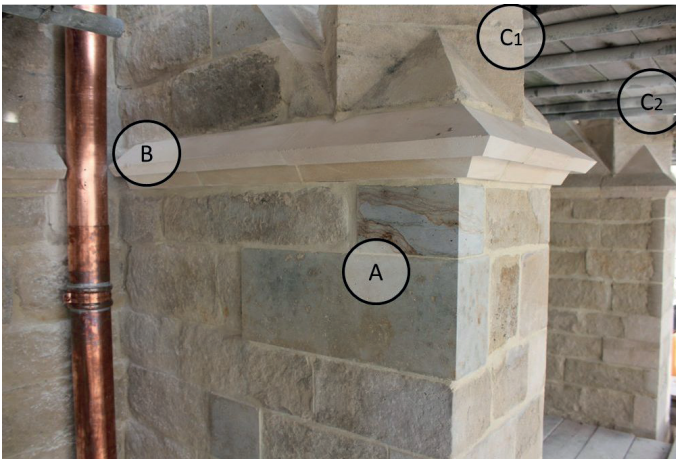
Figure 8.1: Replacement of Lede stone at St Martinus Basilica in Halle. A) Use of new Lede stone to replace Lede stone; B) the use of Massangis to replace Massangis that formerly replaced Lede stone; C1) old replacement of Lede stone in Savonnières; C2) replacement of Savonnières that formerly replaced Lede stone by Savonnières.

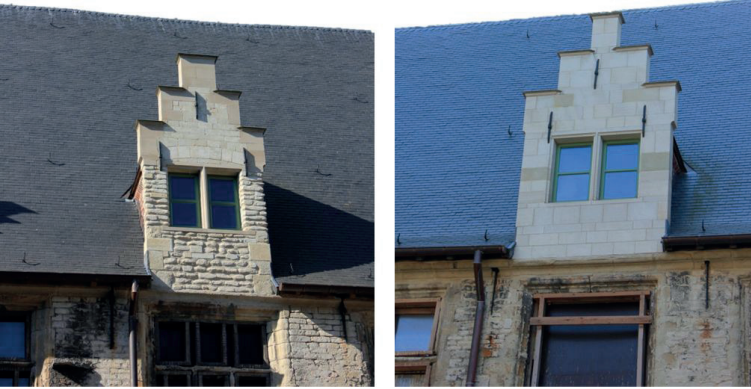
Figure 8.2: Wall dormers in the Caermers monastery in Ghent. Left: the bottom of the water dormer is retained in Brussels stone (masonry) and Lede stone (corners), whilst the top of the wall dormer is replaced with Gobertange stone (masonry) and San Louis (corners). Right: wall dormer originally in Lede stone which is now completely replaced by San Louis.

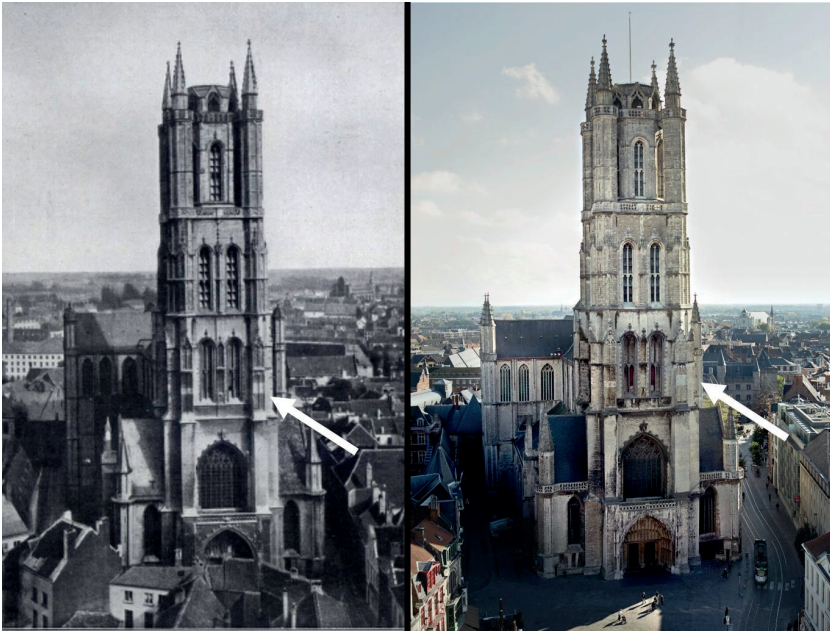
Figure 8.4: Frontal view of the tower, pictures taken in between 1866–1885 (left; Ghent University Library, topographical collection, BRKZ.TOPO.558.A.02) and in 2011 (right; photo Visit Gent). Arrow points out Gobertange stone, which were already present by the time the left photograph was taken. These are also indicated on Fig. 8.3.

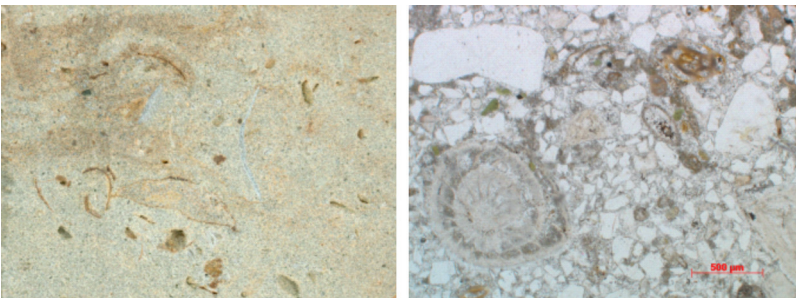
Figure 8.5: Macroscopical and microscopical photograph of Lede stone.

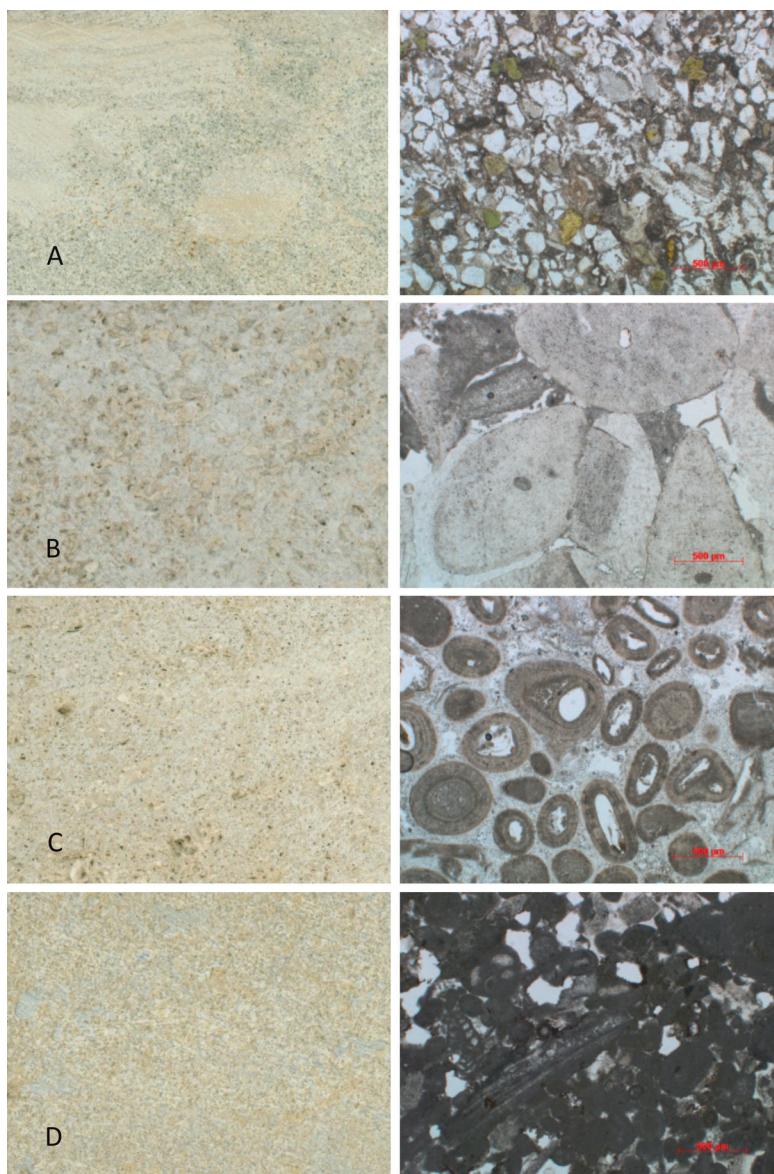
Figure 8.6: Macroscopical and microscopical photograph of A: Brussels stone; B: Euville stone; C: Savonnières stone; D: Massangis roche jaune.

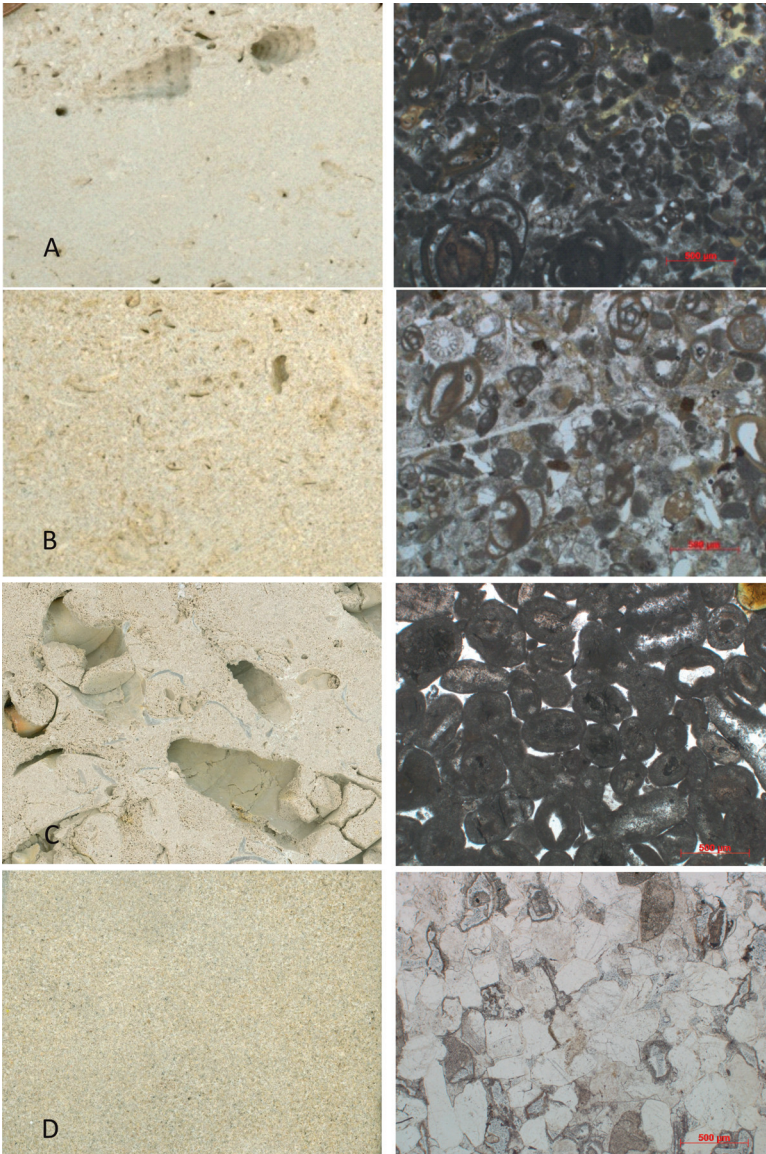
Figure 8.8: Macroscopical and microscopical photograph of A: St Pierre-Aigle stone; B: St Maximin stone; C: Portland stone; D: Larochette stone.
