THE PROPERTIES AND PERFORMANCE OF LEDE STONE IN CULTURAL HERITAGE: NEW INSIGHTS FOR ITS PRESERVATION AND REPLACEMENT

Thesis submitted in fulfillment of the requirements for the
degree of Doctor of Science: Geology

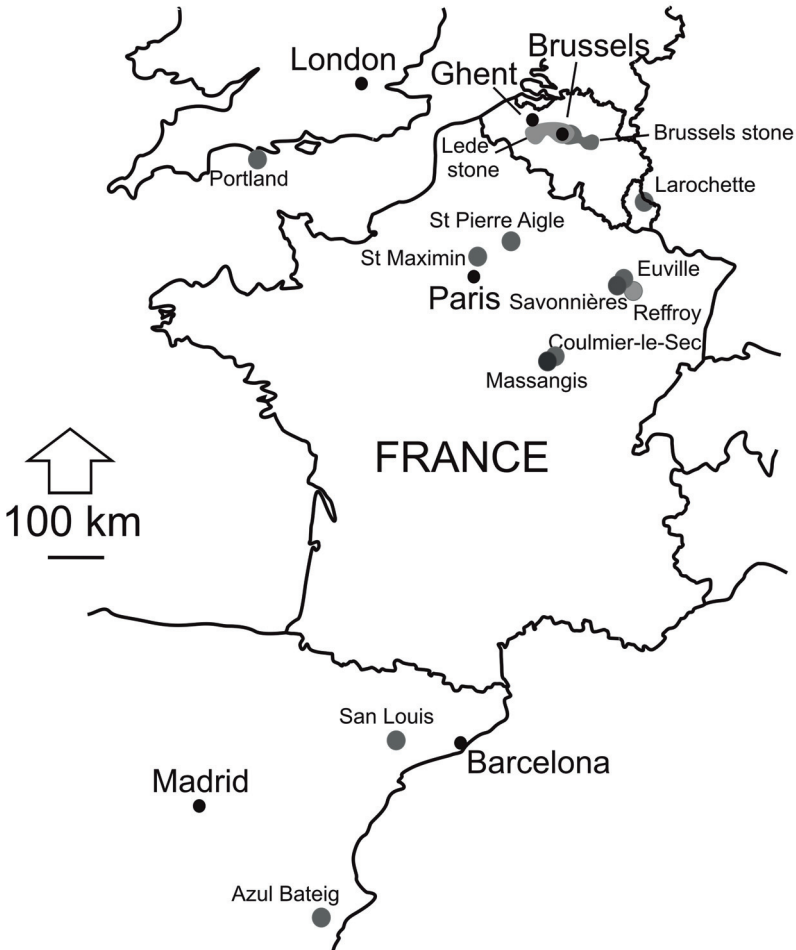
Figure 8.9: Source locations of the different replacement stones mentioned in Section 8.3.1.

St Bavo's Cathedral tower is a textbook example for the historical use of white stone in Ghent, and by expansion the rest of northwestern Belgium. Today, six different white stone types can be found in the tower (Fig. 8.3). Two of them come from the Belgian Cenozoic deposits and are considered as original building materials or as authentic replacement stones: Brussels stone and Lede stone. The other four come from the Mesozoic Paris Basin in France (see also Fig. 8.9): Reffroy stone, Euville stone, Savonnières stone and Massangis stone. These were used as replacement stones during previous restorations over the last two centuries. Two stones were nominated as replacement stones, but were finally discarded: Larochette stone from the Mesozoic Paris Basin in the Grand Duchy of Luxembourg and St Maxim from the Cenozoic Paris Basin near Paris (see also Fig. 8.9).

The properties of Lede stone have already been discussed in Chapter 3 and 5. Nevertheless, Figure 8.5 gives a random macroscopical and microscopical view for comparison with the replacement stones listed below. The source locations of all stones is given in Figure 8.9.

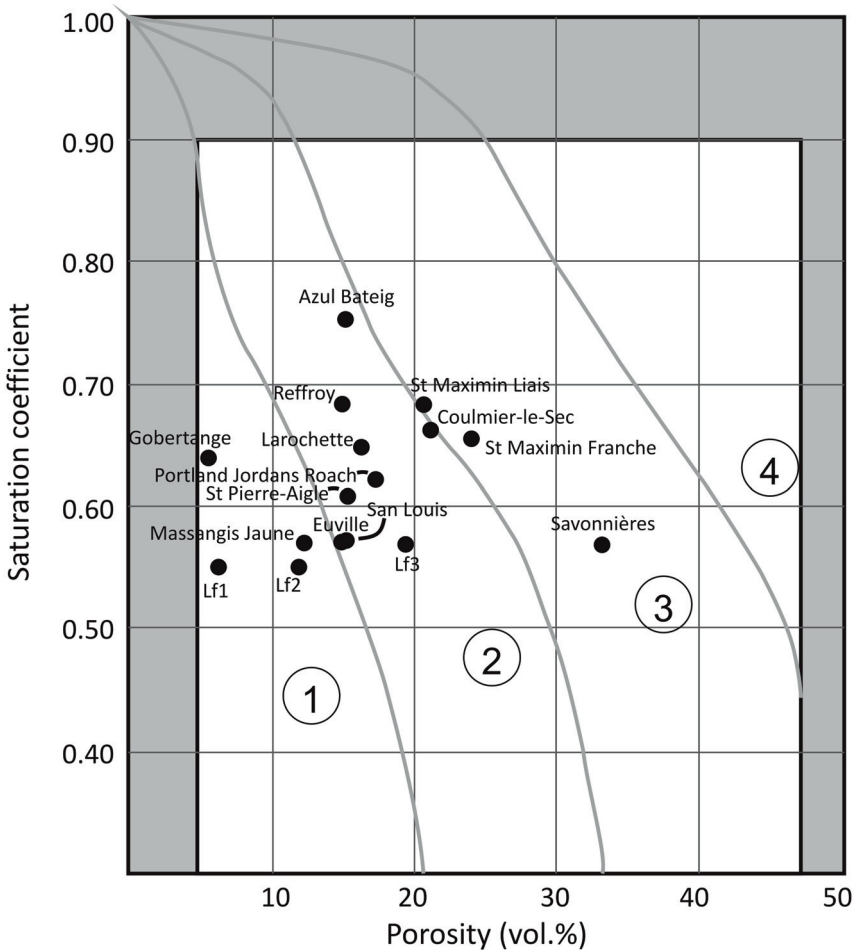
Figure 8.10: Performance diagram (see Figure 5.28) with a plot of the replacement stones based on the properties of Table 8.1.

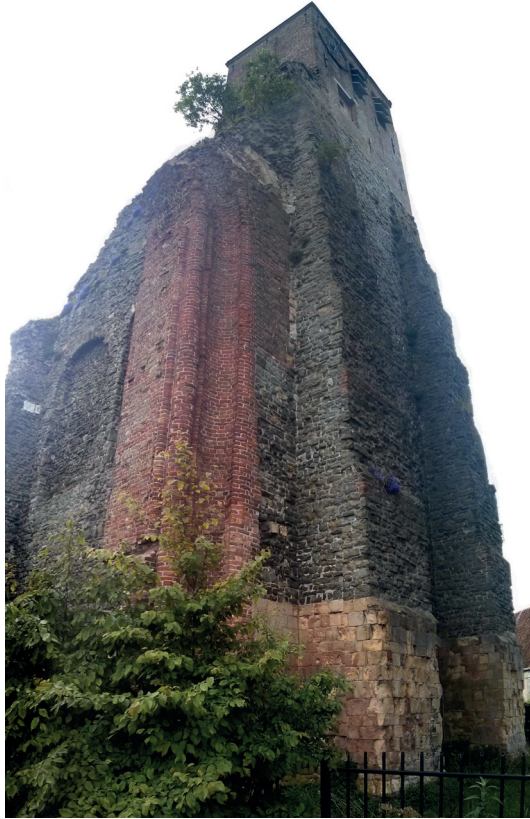
Figure 9.1: Tower ruin in Dudzele as seen from the northwest. The lower façade is mainly built with buff-coloured limestone, the upper masonry with Fieldstone and parts in brick.

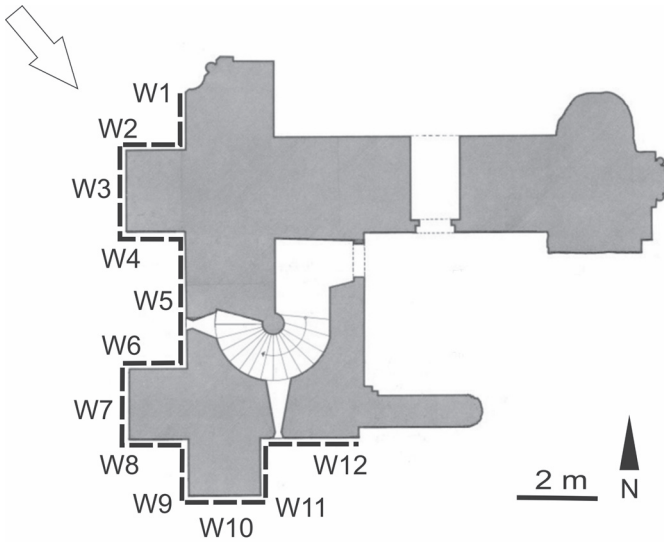
Figure 9.3: Floor plan of the tower ruins. Dashed lines indicate where the lower ashlar masonry is composed out of buff-coloured limestone and where cartography was performed.

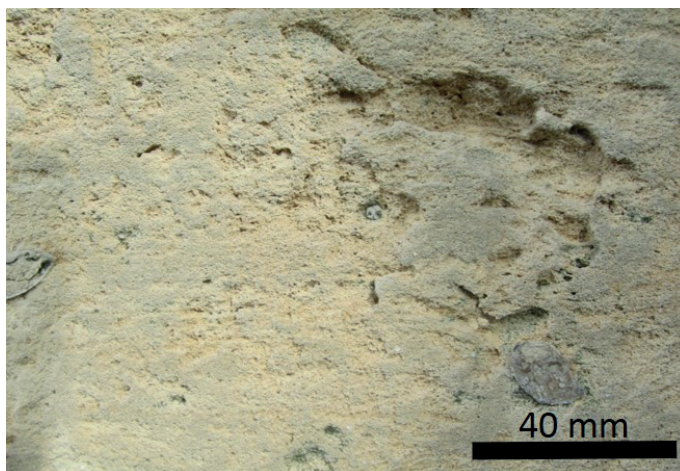
Figure 9.5: Macroscopic image of the buff-coloured limestone from Dudzele, identified as Caen stone.

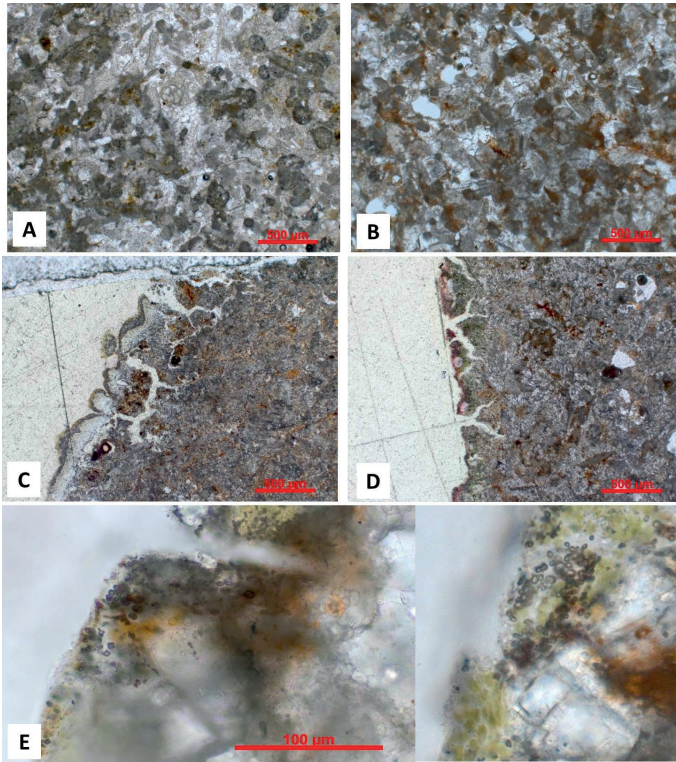
Figure 9.6: A) Thin section micrographs of buff-coloured limestone illustrating the packstone texture with dominant pelloidal components; B) discolouration in the crust section; C and D) growth of saxicolous lichens; E) detail of lichens with individual cells.

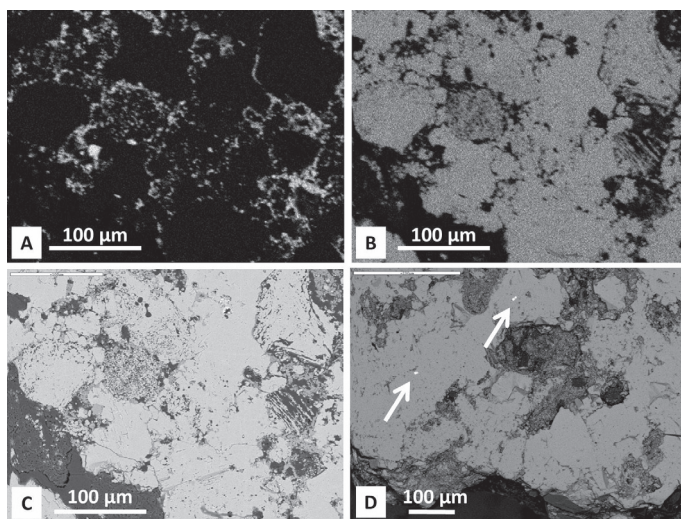
Figure 9.7: SEM-EDX images with A) Si-map; B) Ca-map; C) SEM-BSI image of mapped area; D) SEM-BSI image with pyrite particles indicated by arrows.

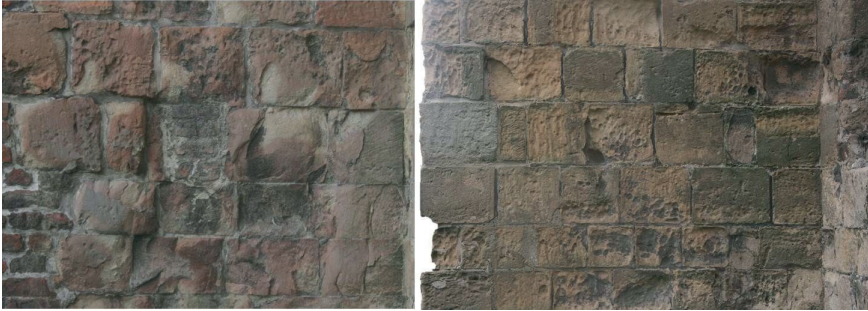
Figure 9.8: Macroscopic view (field of view approximately $1.5 \times 1.5 \text{ m}^2$) of lower ashlar masonry of buff-coloured limestone with fissures and cracks, spalling, sanding, alveolization, soiling and red discolouration with large scaling.

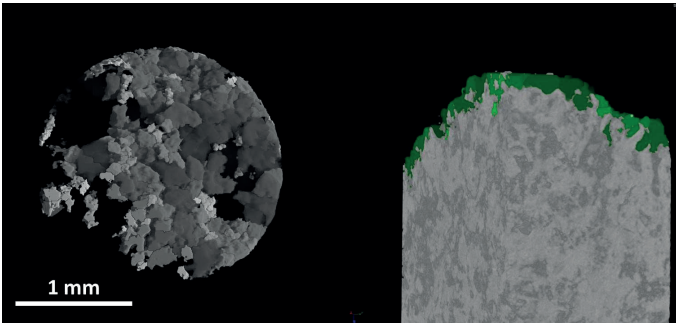
Figure 9.9: μ CT rendering of the crust with lichens (scale bar for both images). Left: top view with puzzle pattern of lichens. Right: sagittal section through stone with lichens in green showing limited lichen penetration.

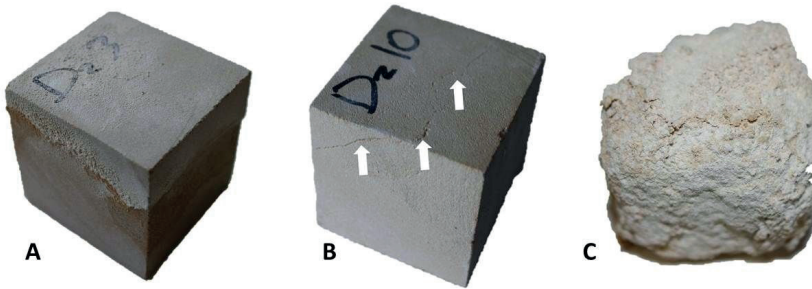
Figure 9.10: A) Salt efflorescence after capillary rise tests; B) sample with the most severe damage after freeze-thaw tests; C) decay pattern after salt weathering tests; all samples retrieved from the tower ruin of Dudzele.
