The use of a DMT to monitor the stability of the slopes of a clay exploitation pit in the Boom Clay in Belgium

Herman Peiffer

ABSTRACT: *In Belgium the Boom Clay is a well know overconsolidated clay formation. This Tertiary clay, with a same geological origin as the London Clay, is used for the fabrication of bricks, roofing tiles, expanded clay,.....*

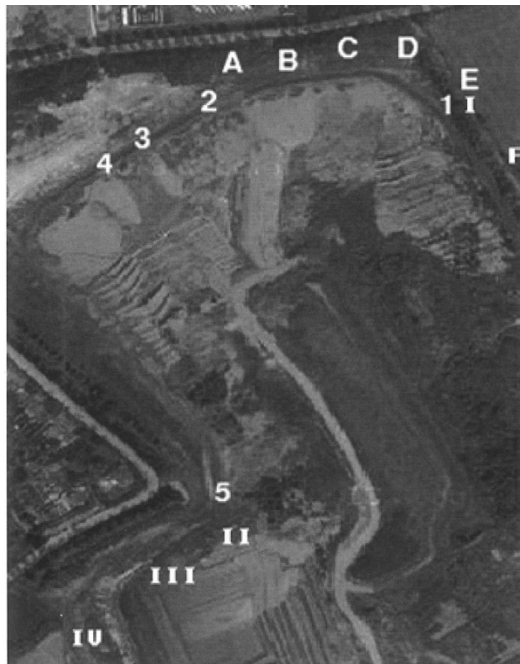
Fig. 2. – photo view of the site

In the figures 2. (photo view) and 3. (map) an overview of the site and the DMT-tests is presented.

In the second half of 2013 a more important slide occurred in the neighborhood of point 5 on figure 2. The number 5 refers to DMT 5 executed in the beginning of 2014 at a distance of 5 m from the top of the slope.

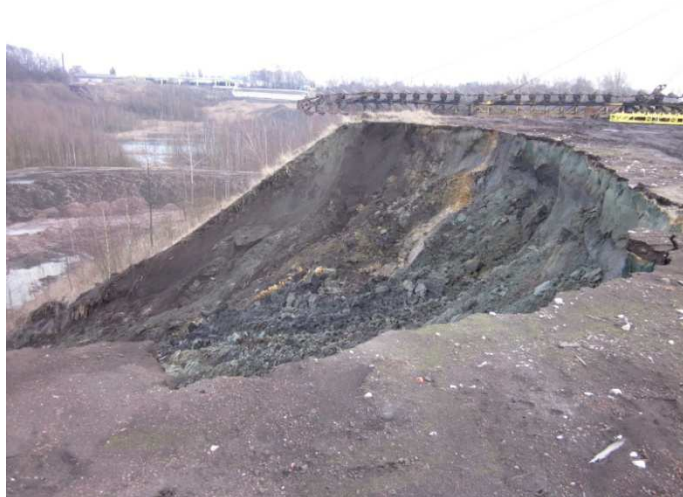
Fig. 6. Photo of the unstable zone after sliding

In the figure 6 a photo of the slide is presented.

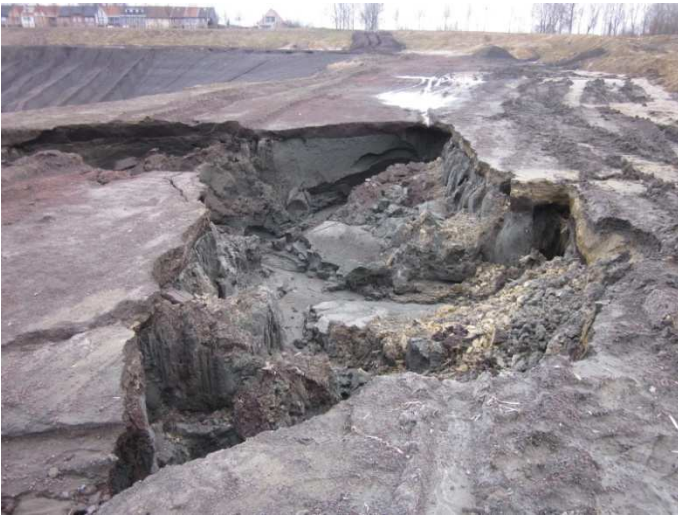
Fig. 7. Sliding mass (June 2014)

In June 2014 an important sliding occurred (area of about 100 m x 50 m) between DMT 1 and DMT 2

The extent of the affected zone can be seen on the figures 7 and 8. Two profiles are presented in the figures 9. and 10.

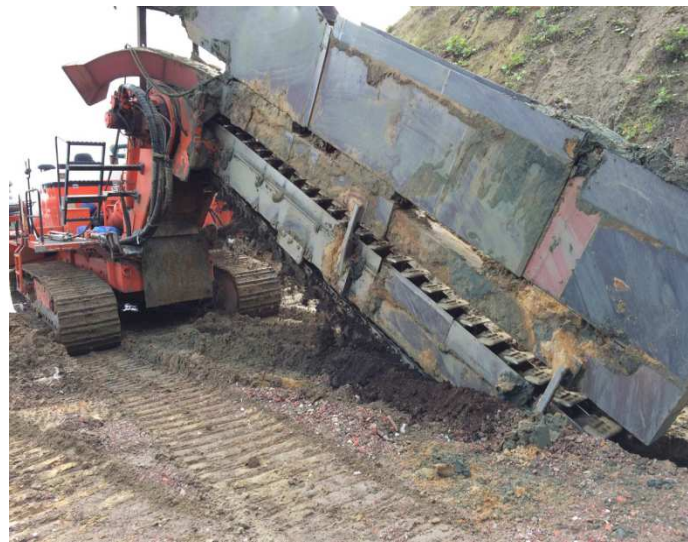
Fig. 14. Installation of the deep drainage.

The analysis resulted in a design where a deep drain has to be installed at a depth of 5 m., as shown in the figures 14 and 15. This drain was installed at the beginning of November 2015. The red line in figure 15 is the position of the drain in plan view.

After the installation of this drain, there was an immediate effect on the depth of the groundwater. The original depth of 1,5 m increased to a depth of about 4.5 m. The safety of the slope stability increased from 0,9 to 1.31.
