# Using 3D terrestrial laser scanning as data acquisition technique for the assessment of deviations in geometry between design and as-built models of large structures. A case study.

## CASE STUDY: BRIDGE ELEMENT AT LUMMEN (BELGIUM)

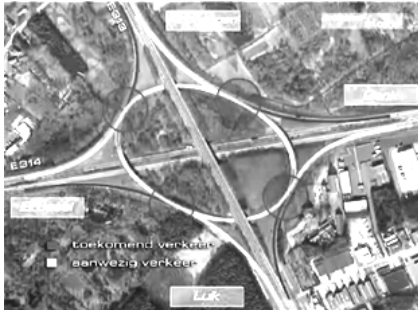
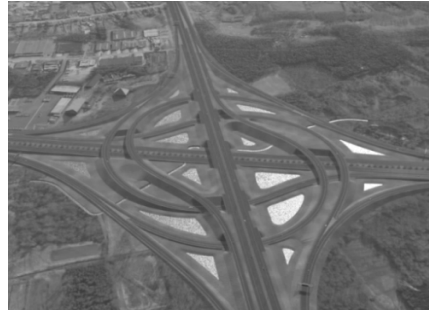
Fig. 1: Motorway interchange – Lummen. Left: old situation with confliction traffic flows. Right: design visualisation. (source: [www.klaverbladlummen.be](http://www.klaverbladlummen.be), 2008)

The Lummen (Belgium) motorway interchange connects the European motorways E313 and E314. To address safety and traffic congestion issues, all conflict situations will be resolved by reshaping the interchange. An innovative concept, in which new bridge

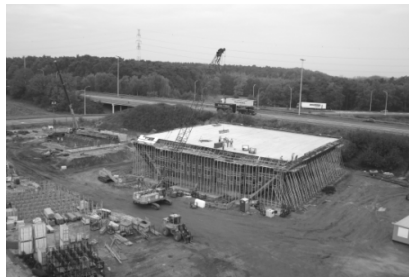
Fig. 2: Construction site near E313 (source: Jan De Nul NV, 2008)

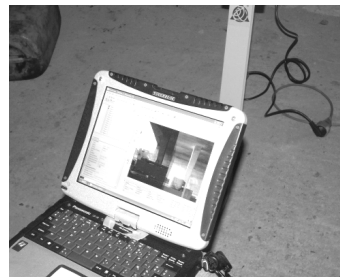
Fig. 4: Trimble GX Advanced controle (left) controlled by Trimble® PointScape™ Software on Panasonic Toughbook CF-19 (right)

For the data acquisition two Trimble GX Advanced 3D scanners (Fig. 4 - left) were used. The scanners are operated by the Trimble® PointScape™ Software, installed on a Panasonic Toughbook CF-19 (Fig. 4 - right).
