Science and Art: A Future for Stone

PROCEEDINGS OF THE 13TH INTERNATIONAL CONGRESS ON THE
DETERIORATION AND CONSERVATION OF STONE

***IN SITU* ASSESSMENT OF THE STONE CONSERVATION STATE BY ITS WATER ABSORBING BEHAVIOUR: A HANDS-ON METHODOLOGY**

D. Vandevoorde^{1,2*}, T. De Kock² and V. Cnudde²

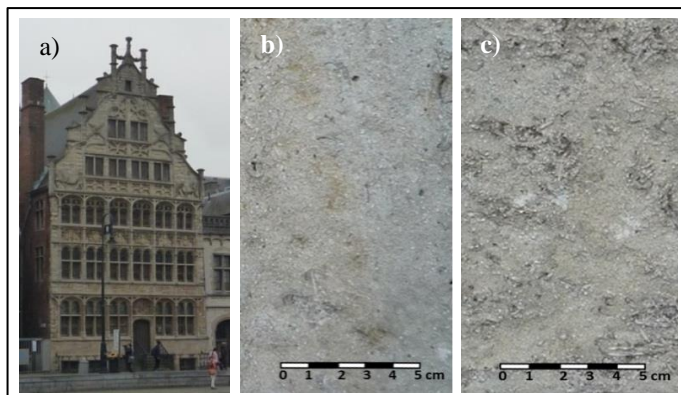
Fig. 1: Facade of the Free Boatsmen's Guild House in the historic centre of Ghent, Belgium (a) and details of the fine grained (b) and coarse grained (c) Lede stone.

The case study on WAB was part of a more elaborate study of the condition the medieval facade of the Free Boatmen's Guild House (1531) in the centre of Ghent, Belgium (Fig. 1a). The Lede stone was aged and weathered and was subjected to several restoration campaigns in the past. In order to define an adequate restoration strategy, which would ensure an optimal conservation of the facade, a pre-investigation of the conservation state and study of consolidation treatments was prescribed. The examination of the conservation state consisted of a historical study of the facade, a thorough visual analysis, determination of deterioration patterns, analysis of types of Lede stone, laboratory investigation of samples, measurement of stone strength with a Schmidt hammer, measurement of the WAB, and IR-thermography. This paper will focus on the measurement of the WAB.

The Lede stone is a sandy limestone with a high historical importance in north eastern Belgium and adjacent parts of the Netherlands. Due to the natural variety within the stones components and fabric, porosities can range from below 5 vol-% to above 10 vol-%. This is mostly related to the amount of macrofossils and concomitant moldic pores. Microscopically, the stone is a packstone to grainstone with a large siliciclastic fraction, mainly quartz and some glauconite. When exposed outside an iron rich patina will form at the surface. Taking into account the geological variability, the stones in the facade were macroscopically divided in a fine grained and a coarse grained type (Fig. 1b and Fig. 1c). The fine grained type was defined by a compact, low porous and homogeneous texture with a low macrofossil content. The coarse grained type is defined by the presence of foraminifera (*Nummulites variolarius*) and serpulids (*Ditrupa strangulate*), which results in a rougher surface due to differential erosion.
