MESO-SCALE ANALYSIS OF DUCTILE STEEL FABRIC/EPOXY COMPOSITES: NUMERICAL MODELLING AND EXPERIMENTAL VALIDATION

J. C. Faes^{*}, A. Rezaei, W. Van Paepegem, J. Degrieck

Department of Materials Science and Engineering, Faculty of Engineering and Architecture, Ghent University, Technologiepark-Zwijnaarde 903, B-9052 Zwijnaarde, Belgium

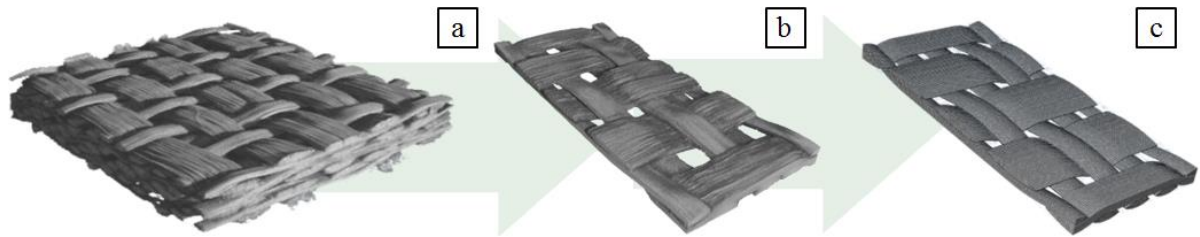
Figure 6. Rendered micro CT-scan images of the full laminate slice (a), the RVE (b) and the corresponding finite element RVE of the fabric (c)

The fabric architecture was studied using micro-CT scans of a laminate slice of approximately 25 x 25 x 3 mm³ (Figure 6.a). Micro-CT results were reconstructed and analyzed with Volume Graphics software. Based on these analyses, an RVE was identified (Figure 6.b) and implemented into Abaqus finite element software (Figure 6.c).
