The Comparison between Sulfate Salt Weathering of Portland Cement Paste and Calcium Sulfoaluminate Cement Paste

ABSTRACT

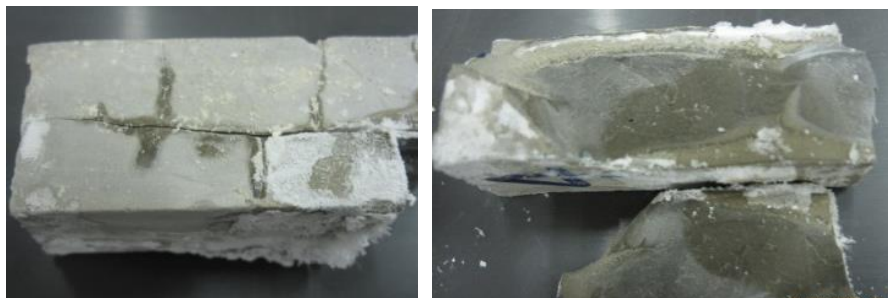
After 5 months partial exposure, the Portland cement paste with a W/C ratio of 0.45 were damaged. The deterioration observation of paste specimens is presented in Fig.1.

Fig.1 Visual observation of Portland cement paste specimen exposed to 10% Na_2SO_4 solution

Based on the visual observation, the main differences between two pastes are presented as follows:.

- The CSA cement paste was severely failed just after 7 days. The exposure time was quite shorter than 5 months exposure for Portland cement paste deterioration. It should be noticed that the damage process of sulfate salt weathering of limestone sample was also quite quick. After 8 days exposure the sample had begun to crack [Scherer GW (2004)]. Another research [Rodriguez-Navarro C (1999)] indicated that after 30 days exposure the limestone sample was deteriorated as shown in Fig. 3.

- The CSA cement paste sample showed much more severe deterioration characterized by successive paste layers with a paste core formation. This appearance was quite similar to the typical salt weathering of porous rock [Rodriguez-Navarro C (1999)]. The Portland cement paste samples were just split into several pieces along the shrinkage cracks without surface layers scaling as shown in Fig.1, but the edge and surface of paste samples looked sound. Two different zones can be distinguished on the surface of the crack: an inner dark grey zone and an outer white grey zone with white substances at the edge of the surface shown in Fig.1. According to the above comparison, it can be sure that the damage mechanisms for these two cement pastes are different. The pore structures of these two pastes may be different, causing different crystallization distress, however, there could not be so significant a difference due to the crystallization distress on the pastes. The deterioration information of CSA paste seems more like sulfate salt weathering, characterized by a quite short failure time and the successively detached paste layers.

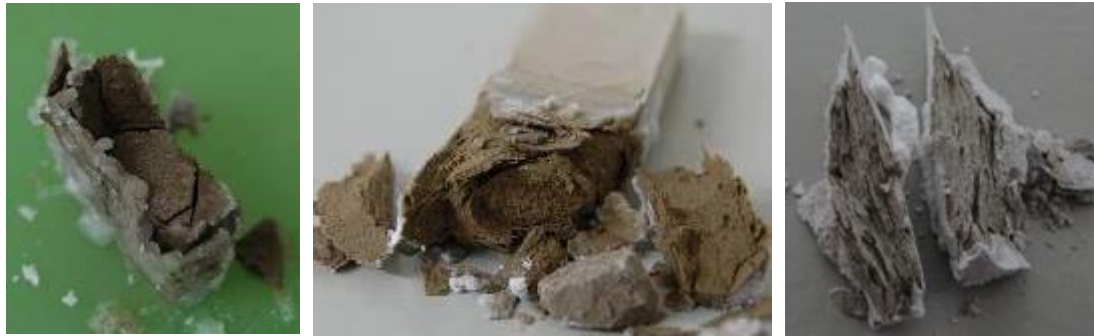
After 7 days exposure. The deterioration image of CSA cement paste specimen is showed in Fig.2.

Fig.2 Visual observation of CSA cement paste specimen exposed to 10% Na₂SO₄ solution

Calcium sulfoaluminate (CSA) cement paste. According to Fig. 2, a small piece of the paste layer was dried and analyzed by means of ESEM, EDS and XRD. The products on the surface of the paste core were analyzed by means of ESEM and EDS. The products in the core paste were identified by means of XRD.

Based on the observation in Fig. 2, the paste core can be regarded as the last layer of successive paste layers after 7 days of exposure. A reasonable assumption is that the paste core would become smaller due to new layers detaching after 8 days of exposure. Obviously, Na_2SO_4 crystallization in the pores is the mechanism causing the CSA cement paste damage.

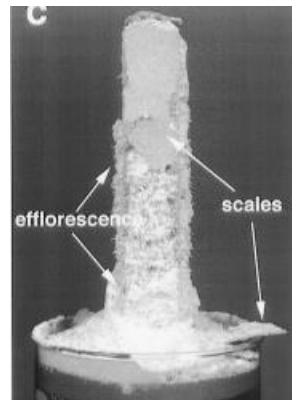
Fig. 3 Sodium sulphate crystallization at 60 per cent RH and 20 °C for 30 days

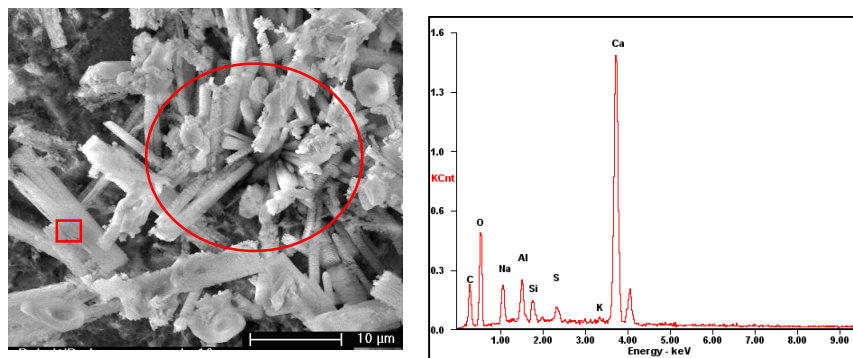
Portland cement paste. As abovementioned, the products on the outer and inner zones and the white substances were identified. Figs. 4 to 8 show the ESEM, EDS and XRD analysis results. From Fig.4, it can be found that (1) the surface of the inner dark grey zone is covered by a large amount of short needle-like crystals, (2) on the right hand side of the image, a cluster of needle-like crystals stretches outwards (in the black circle). The following elements were found in the crystals using EDS: C, Na, Al, Si, S and Ca. There may be several products in the crystals. In order to further identify the products, a layer of powder scraped from the inner dark grey zone was analyzed with XRD. Fig.5 shows the XRD pattern.

Fig.4 ESEM and EDS analysis of the products on the surface of inner dark grey zone

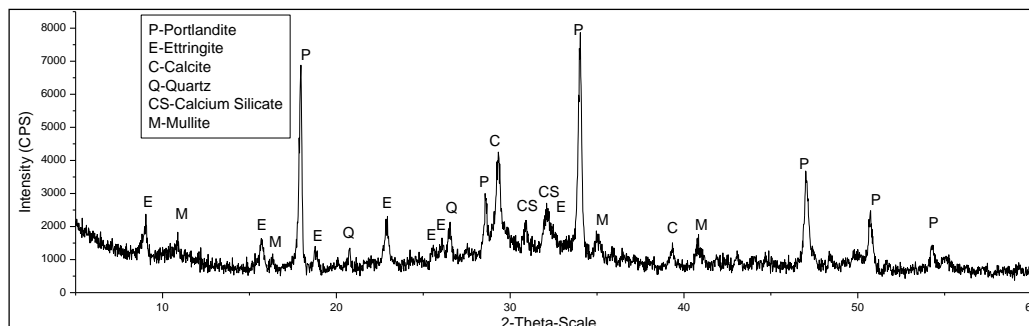
Fig.5 XRD pattern of the products in the inner dark grey zone of cement paste

According to this XRD pattern, the main products found are calcium hydroxide, ettringite and calcite. Based on the results of ESEM, EDS and XRD, the main products of the needle crystals should be ettringite and some calcite. Thenardite was not found in the inner dark grey zone.

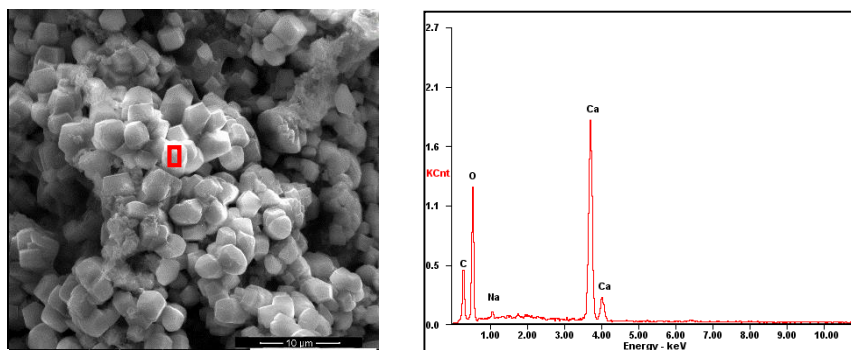
Fig.6 ESEM and EDS analysis of the products on the surface of outer white grey zone

Fig. 6 shows the ESEM image and EDS analysis of the outer white grey zone. Compared to the inner dark grey zone, the products in the outer white grey zone are relatively simple. A large amount of dense popcorn-like crystals were discovered in this zone. According to the EDS analysis, these crystals should be CaCO_3 . A layer of powder scraped from the outer white grey zone was also analyzed by means of XRD. Fig. 7 shows the XRD pattern. Compared to Fig.5, a larger amount of calcite was formed. This means that more of the hydrated cement paste was carbonated. Fig. 8 shows the ESEM image and EDS analysis of the white crystal on the surface of the outer white grey zone. This white crystal was identified as thenardite (Na_2SO_4).

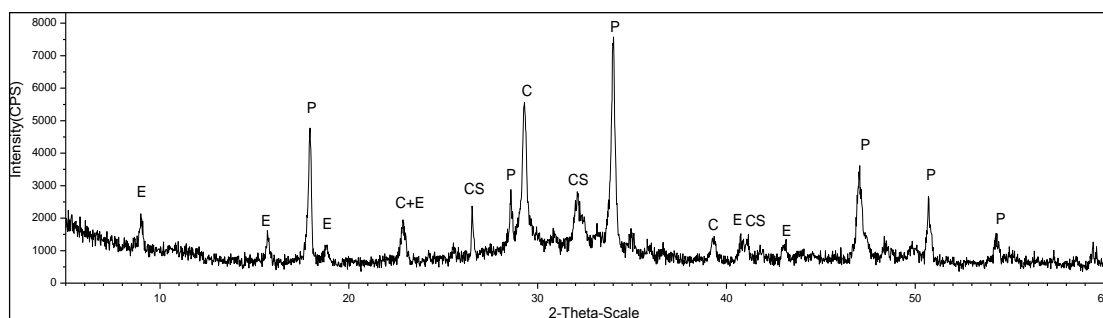
Fig.7 XRD pattern of the products in the outer white grey part of cement paste

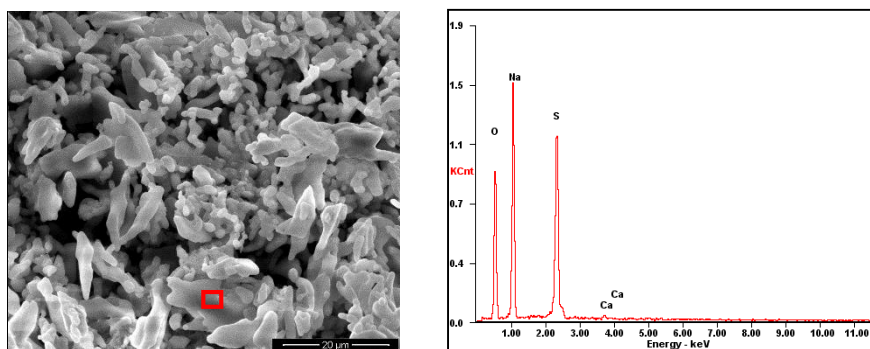
Fig.8 ESEM and EDS analysis of the white crystal on the surface of the outer zone

From the micro-analysis on the surface of the shrinkage cracks in the cement paste specimens exposed to sodium sulfate solution, the following conclusions can be drawn: (1) sodium sulfate crystals could not be identified in the cement paste; (2) crystallization of sodium sulfate occurred on the surface of the CaCO_3 crystals, the carbonated products of hydrated cement paste.

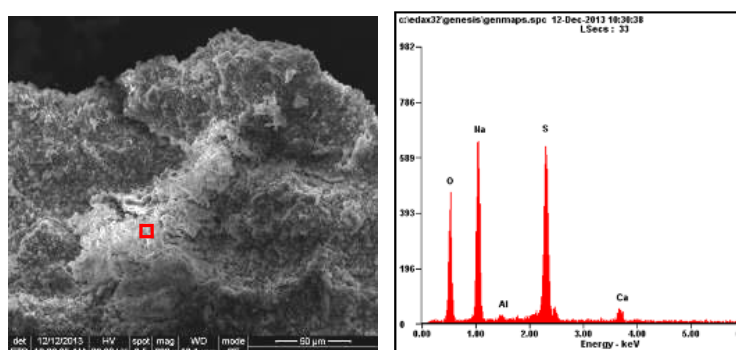
Fig. 9 shows the ESEM image and EDS result for products on the surface of the paste layer. A large bunch of crystals were generated on the surface of the paste layer, and could be identified as Na_2SO_4 crystals by EDS analysis.

Fig. 9 ESEM image and EDS analysis of products in successive layers

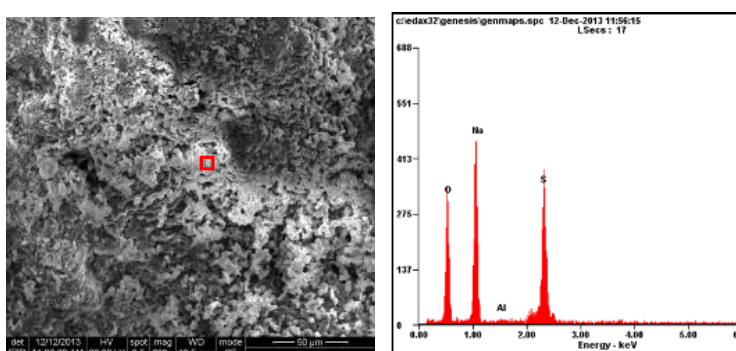
Fig. 10 shows the ESEM image and EDS result of the products on the surface of the paste core. The surface of the paste core was almost covered by a layer of white crystals. These crystals can also be identified as Na_2SO_4 according to EDS analysis.

Fig. 10 ESEM image and EDS analysis of the products on the surface of the paste core

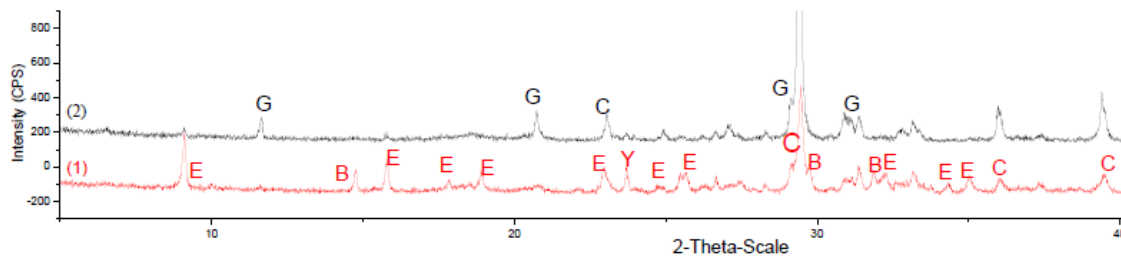
In Fig. 11, the products from the surface paste and inner paste of the top part of specimens in contact with air, but not immersed in the Na_2SO_4 solution, were identified by XRD analysis. The XRD Pattern 1# can be regarded as the reference pattern that was isolated from the sulfate solution and atmosphere. In Pattern 1#, the main phases were ettringite and unhydrated $3\text{CaO} \cdot 3\text{Al}_2\text{O}_3 \cdot \text{CaSO}_4$. However, Pattern 2# indicated that ettringite diminished when accompanying the formation of gypsum and calcium carbonate, and this result occurred even in the absence of the sulfate solution.

Fig. 11 XRD patterns of the surface paste and the inner paste of the top part. (1)- the inner paste of the top part; (2)-the surface paste of the top part (B-Bassanite: $\text{CaSO}_4 \cdot 0.5\text{H}_2\text{O}$; C- calcite: CaCO_3 ; E-Ettringite: $\text{CaO} \cdot \text{Al}_2\text{O}_3 \cdot 3\text{CaSO}_4 \cdot 32\text{H}_2\text{O}$; G-Gypsum: $\text{CaSO}_4 \cdot 2\text{H}_2\text{O}$, Y- Yeelimite: $3\text{CaO} \cdot 3\text{Al}_2\text{O}_3 \cdot \text{CaSO}_4$)

Combining the results in Figs. 11 and 12, the phase changes in the CSA cement paste immersed in the sodium sulfate solution should be influenced by carbonation but not sodium sulfate.

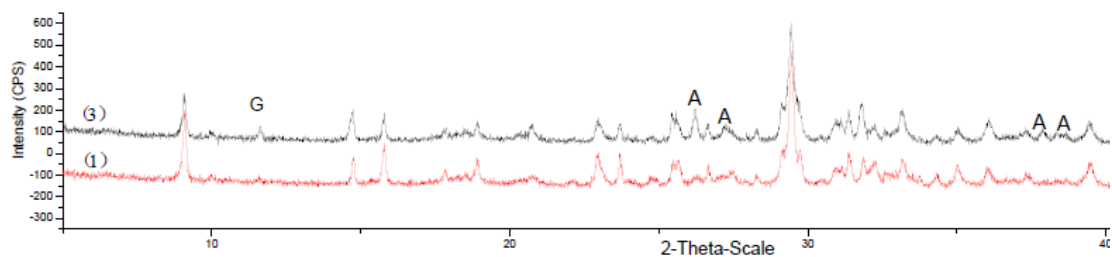
The paste of the specimen in the sulfate solution (Pattern 3#) was also compared with the reference pattern, as shown in Fig. 12. The products in the paste were the same as the products after carbonation of ettringite as described in the literature [Nishikawa T (1992)]: calcium carbonate in the form of aragonite and gypsum. No new phase was generated in the paste in contact with the sodium sulfate solution.

Fig. 12 XRD patterns of the paste in the sulfate solution and the inner paste of the top part. (1)- the inner paste of the top part; (3)-the paste in the solution (A-Aragonite: CaCO_3)

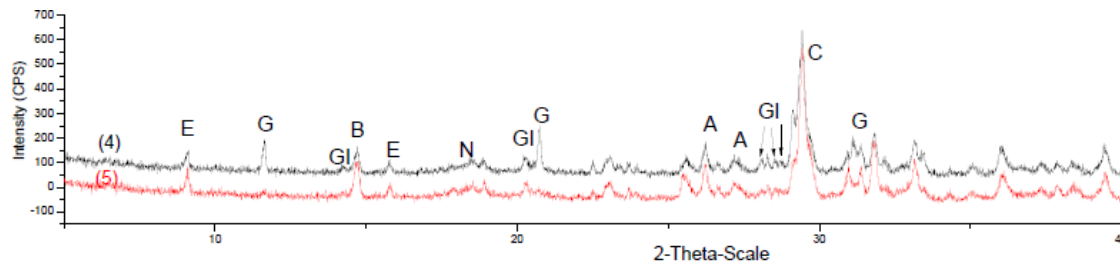
Fig. 13 shows the XRD patterns of the successive paste layers (Pattern 4#) and paste core (Pattern 5#).

Fig. 13 XRD patterns of the successive paste layers and the paste core in the evaporation zone. (4)- the successive paste layers; (5)- paste core. (A-Aragonite: CaCO_3 ; GI-Glauberite: $\text{Na}_2\text{SO}_4 \cdot \text{CaSO}_4$; N-Sodium Sulfate: Na_2SO_4)

- Compared to Pattern 3#, Patterns 4# and 5# contained gypsum and aragonite, but ettringite had diminished;
- Compared with Pattern 1# and 3#, no other new phases were formed in Patterns 4# and 5# except for the sodium sulfate and double salt of glauberite ($\text{Na}_2\text{SO}_4 \cdot \text{CaSO}_4$).

- The formation of glauberite indicated that the formation of gypsum was not influenced by the sodium sulfate solution and that sodium sulfate could stably accumulate in the CSA cement paste;

- The appearance of glauberite in the evaporation zone of the damaged paste seems strange because sodium salts could not be found in the paste directly exposed to the sodium sulfate solution. The solution transport mechanisms in the different pastes were the key factors to answer this question. We know that ions penetrated into the paste when the paste was immersed in the solution, as the Na_2SO_4 concentration of the pore solution in the paste was far lower than the concentration of the external Na_2SO_4 solution. However, due to the wicking action, the concentrations of the ions in the pore solution in the evaporation zone reached super-saturation [Liu Z (2012)], causing sodium sulfate crystallization in the paste and the formation of successive paste layers. The damaged paste evidently aggravated the carbonation-induced decomposition of ettringite, causing a large amount of gypsum to form. In the pore solution with the higher concentration of sodium sulfate and gypsum, the double salt of glauberite was generated.
